BRIDGE OF REMEMBRANCE SEISMIC STRENGTHENING

F SHERSON¹; D COOK²

SUMMARY

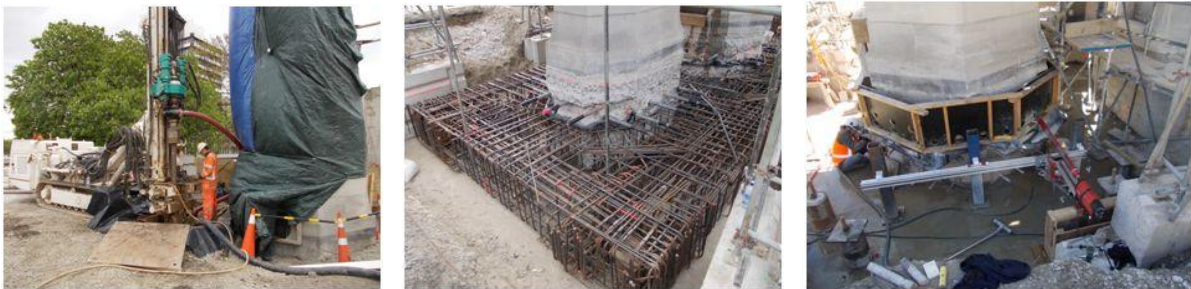
Figure 6. (L-R) Piling Work, Pile Cap reinforcement, Rocking Collar Coring

The columns of the existing structure were founded independently on separate shallow foundations. To transfer the load from the structure to the new piles, two 900mm thick pile caps were constructed to create a single bearing slab surrounding all columns below the rocking collars. The construction of the main pile cap was not just a straightforward operation. There was risk of ground heave around the existing shallow foundations when excavating for the new pile cap. To mitigate this risk the excavation for the new slab had to be carried out in alternating bays, similar to underpinning, replacing the removed overburden pressures of excavated material with a lightly reinforced 150mm thick blinding slab.

The main pile cap construction involved the placement and tying of 30 tonnes of reinforcing steel consisting of over 250 different tagged items. A large number of DH32 bars were required in the bottom mat in long sections, which proved particularly difficult to install in the excavation. The reinforcing cage was already too congested to allow standard laps, so Ancon threaded couplers were utilised to provide full strength connections to multiple DH32 bars. To connect the pile cap to the structure, over 200 holes were cored horizontally into the base of the columns so that DH25 L-Dowels could be epoxied in. Starter bars for the rocking collar perimeter retaining walls also had to be hung inside the congested steel cage with couplers positioned at the finished concrete height with zero tolerance for misalignment.
