Proof of Concept Tests for Hollowcore Floor Unit Connections

Professor Des Bull and Jeff Matthews

This report has been prepared for Precast NZ Inc.

Research Report 2003-1

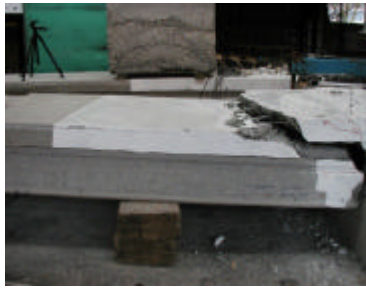
(b) South side failure

On the next cycle to 4.0% the unit failed completely and fell off its seat. Photos of both the failure and removal of the specimen is shown in Figure 5-9.

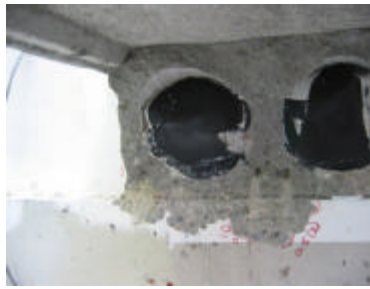
(d) A photo showing when the prestressing strands pulled out of the end of the hollowcore unit

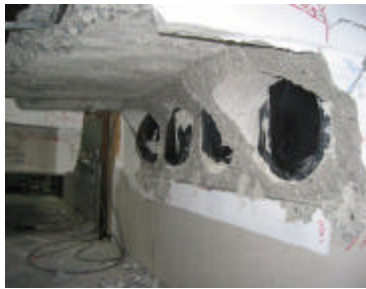
(e) The section of hollowcore unit attached to the beam (similar to the failure in the Matthews test)

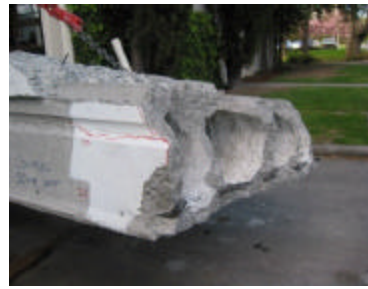
(f) The end of the hollowcore unit after removal. Note the kinked prestressing strands.

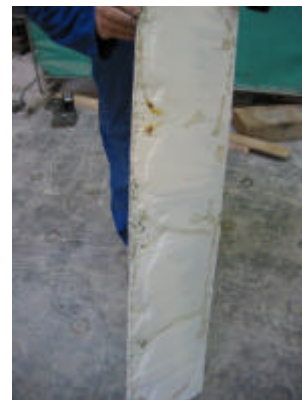
(b) Compressible backing board removed.
Note indentations when it has been compressed.

One point to note regarding the performance of the compressible backing material is that the void within the material did fill with grout that reduced the compressibility of the material. Further comment on this is given in Section 7.1.2.

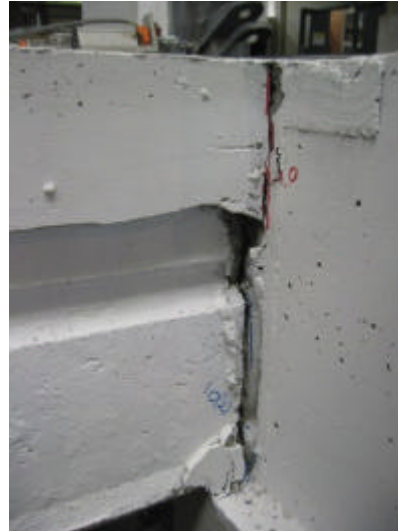
(b) South side

No major new cracks formed on the way to 3.0% (2.69%) drift. The crack at the interface between the hollowcore unit and the beam was now 8mm wide at the base of the crack. A small hairline crack was observed to have formed between the hollowcore unit and the cast in-situ topping. This can be seen in Figure 5-21.

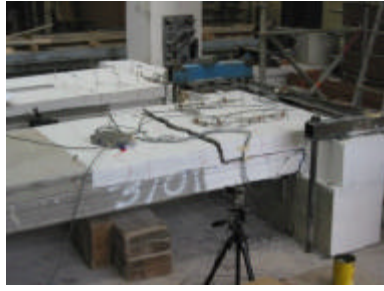
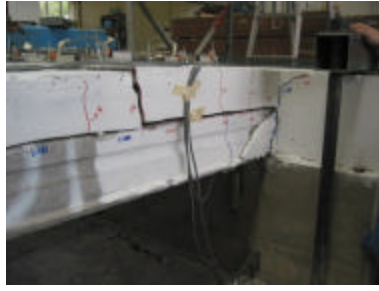
Figure 5-30. Damage after the $\pm 3.0\%$ (2.99%, -2.78%) drift cycle.

The second cycle to $\pm 3.0\%$ (2.99%, -2.78%) drift saw no change to the performance. The entire hollowcore unit had separated itself from the supporting beam, see Figure 5-30. It is only the kinked strands that were holding the unit up.

(a) Overall photo showing performance

(b) Photo showing separation of topping from hollowcore

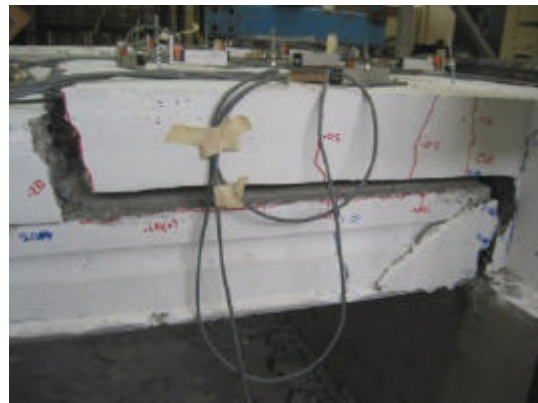
(b) Elevation of HC4 at the end of test

The two cycles to $\pm 4.0\%$ (3.95%, -3.9%) saw a very similar response. The test was left over night to dismantle the next day but upon arrival to dismantle it the unit had collapsed. The kinked strands cannot maintain the self weight of the unit. The end of the test for HC4 can be seen in Figure 5-31 while Figure 5-32 shows HC4 being dismantled.

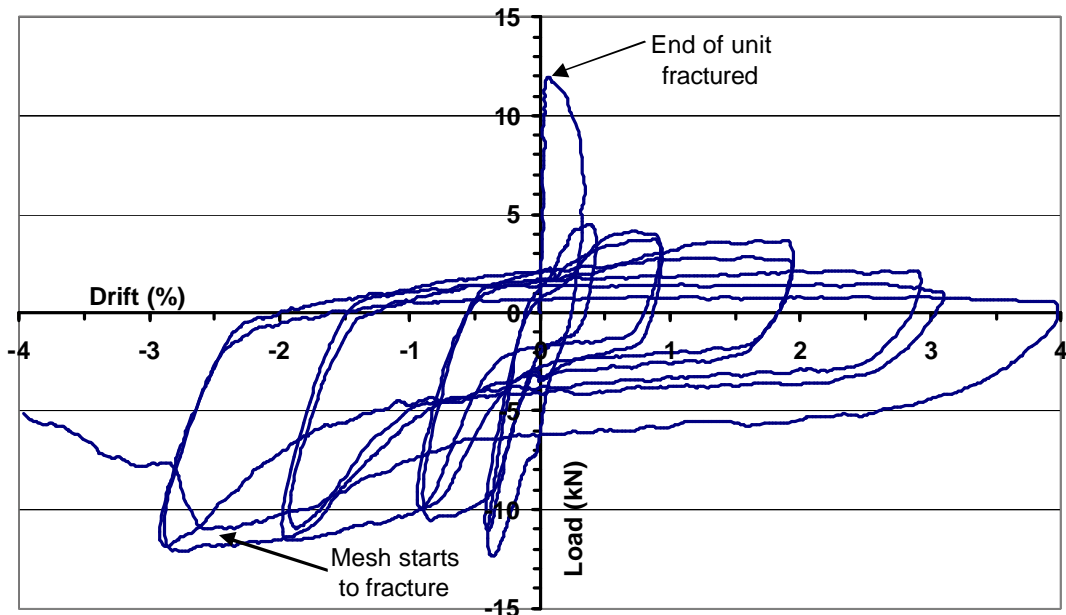
Figure 6-1. Hysteresis plot for HC1.

By examining the hysteresis loop for HC1 it clearly shows the point in which the end of the hollowcore unit fractured. It was at the first cycle to 0.5% (0.35%) drift. This point is marked on Figure 6-1. Further cycles in the positive drift direction saw much smaller loads required to reach the target drift levels. This was because the bottom of the unit was no longer fixed to the beam. As the drift increased the required load to reach that drift reduced as the connection between the hollowcore unit and the supporting beam became increasingly damaged.

The complete opposite occurred for the negative drift direction. The reason for this complete reversal, when compared to the positive direction, is because as the drift increases the connection starts to activate the starters bars. More load is required as more of the starter bars are activated. It was not until the topping failed at the termination of the starter bars (and the mesh started to fracture) was there any drop off in applied load. This point is also shown on Figure 6-1.

Most of the load cycles saw very little difference between the first and second cycle to that particular drift level. The only exception to that was the two cycles to 0.5% (0.35%) drift. The reason for that has been explained above.

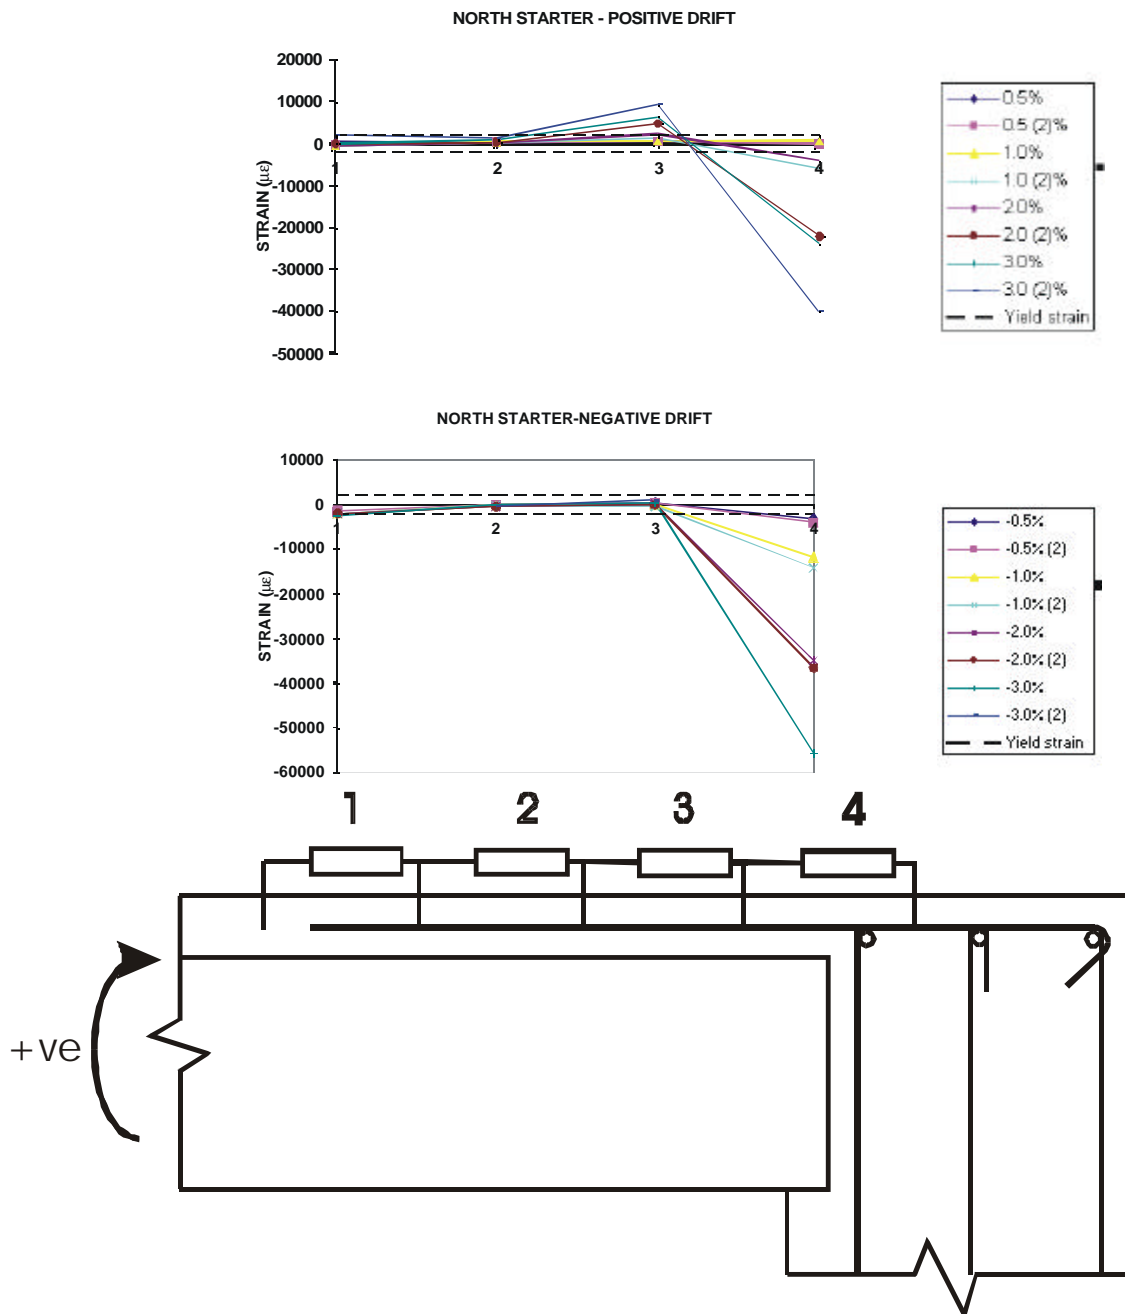
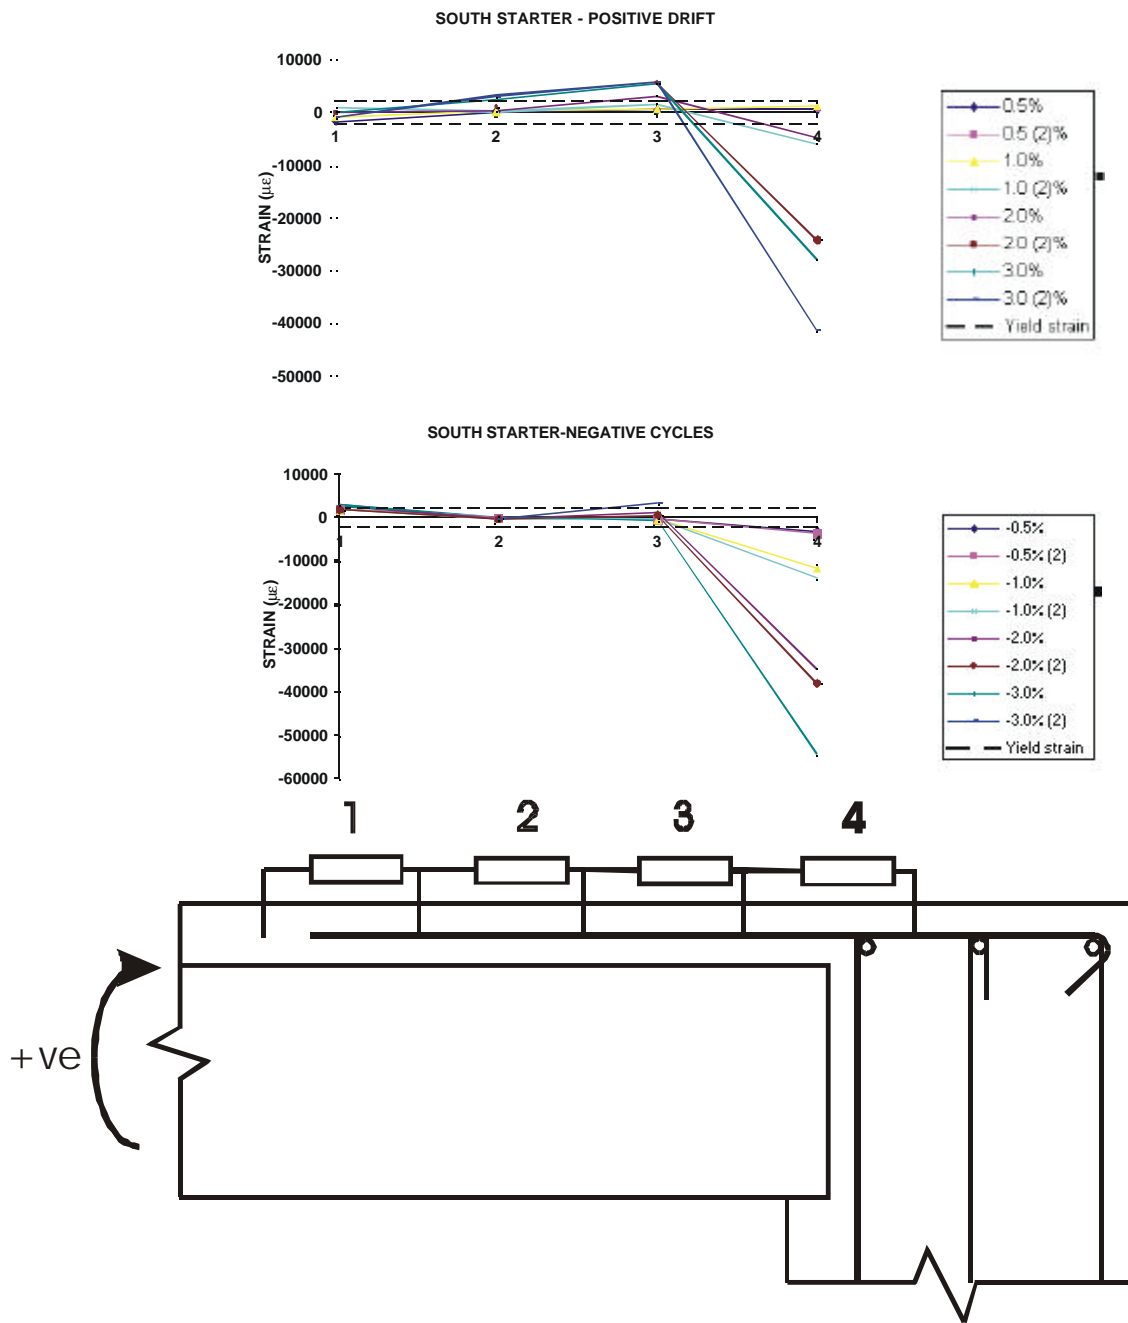
Figure 6-2 and 6-3 illustrates the distribution of strains along the 12mm diameter deformed starter bars during the test and the region of topping concrete at the end of the bars. The diagram shows values from both the northern and southern starter bars (Figure 4-2). Instrument failure and the preservation of instrumentation prevented a complete set of results to be shown. The results clearly show that a majority of the strain induced in the starter bar is from the crack(s) that formed across the interface between the end of the hollowcore unit and the supporting beam (continuity crack). Smaller strains, but strains that were large enough to yield the starter bar, also occurred in the next section as well.

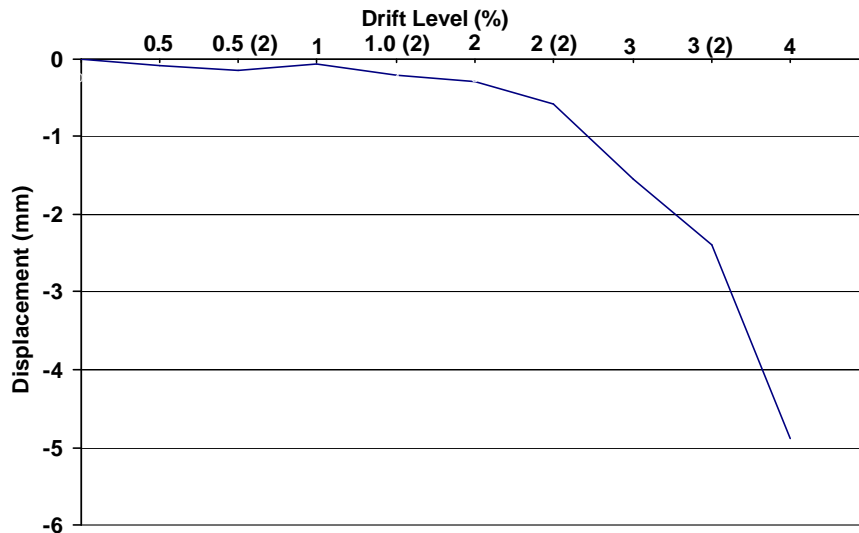
Figure 6-4. The vertical displacement of the hollowcore unit versus drift

During the test the vertical displacement of the hollowcore unit at the floor-beam junction was monitored. As can be seen from Figure 6-4 the unit did drop with increasing displacement. The unit had dropped by 5mm, at the floor-beam junction, at the time the potentiometers were removed so they would not get damaged if the unit failed.

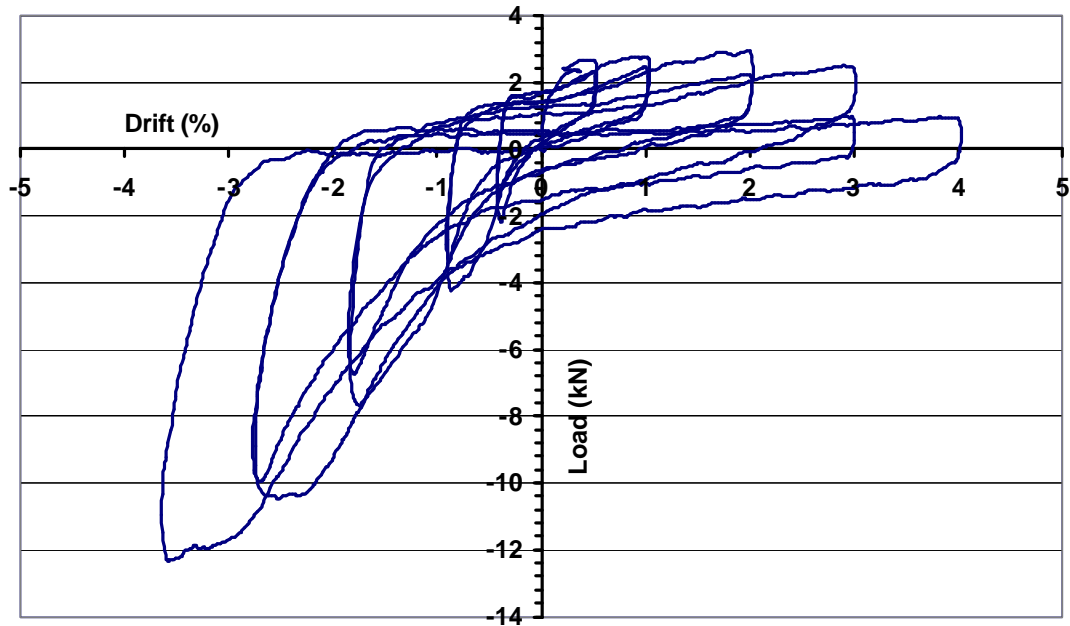
Figure 6-5. Hysteresis plot for HC2.

The hysteresis loops for HC2 (Figure 6-5) were similar to that seen in HC1 for the negative drift cycles. The increasing drift level saw an increase in the applied load, as expected. The magnitude of applied load was very similar to that when compared to HC1, at the -3.0% drift level. At negative drift levels lower than -3.0% the amount of applied load was less. This difference was due to having the compressible material (backer) placed behind the hollowcore unit. As the unit rotated the material compressed so that the unit was unable to form the couple between the tension in the starters at the top of the unit and the compression strut that would have normally formed at the bottom of the unit. This compression strut did form later as the backer material compressed significantly so that some bearing was possible between the concrete of the beam behind the compressible backing material and the bottom edge of the hollowcore unit. The authors' feel using a thicker backing board could reduce this bearing and perhaps increase the performance of the connection.

During the positive drift cycles it is possible to see the benefit of having both the backing board plus the low friction bearing strip. The load required to rotate the unit to a specific drift is virtually constant. The load that is required was due to the friction of the unit sliding against the low friction bearing strip.

The bearing strip also ensured that the end of the unit did not fracture as it did within the control specimen (HC1). This meant that at no stage during the test was the seating lost.

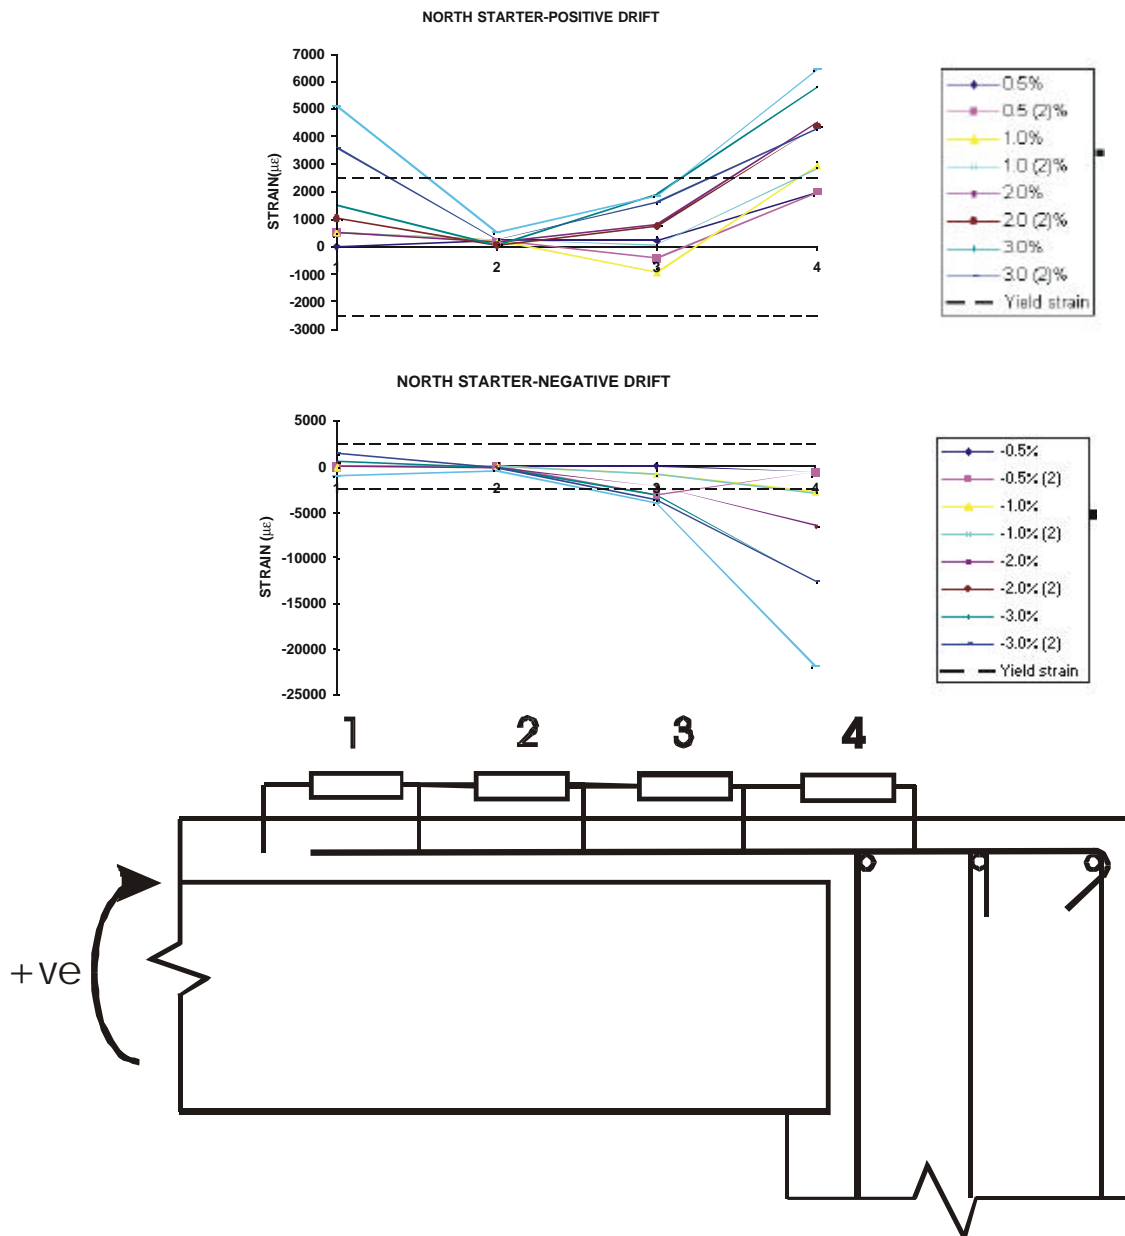
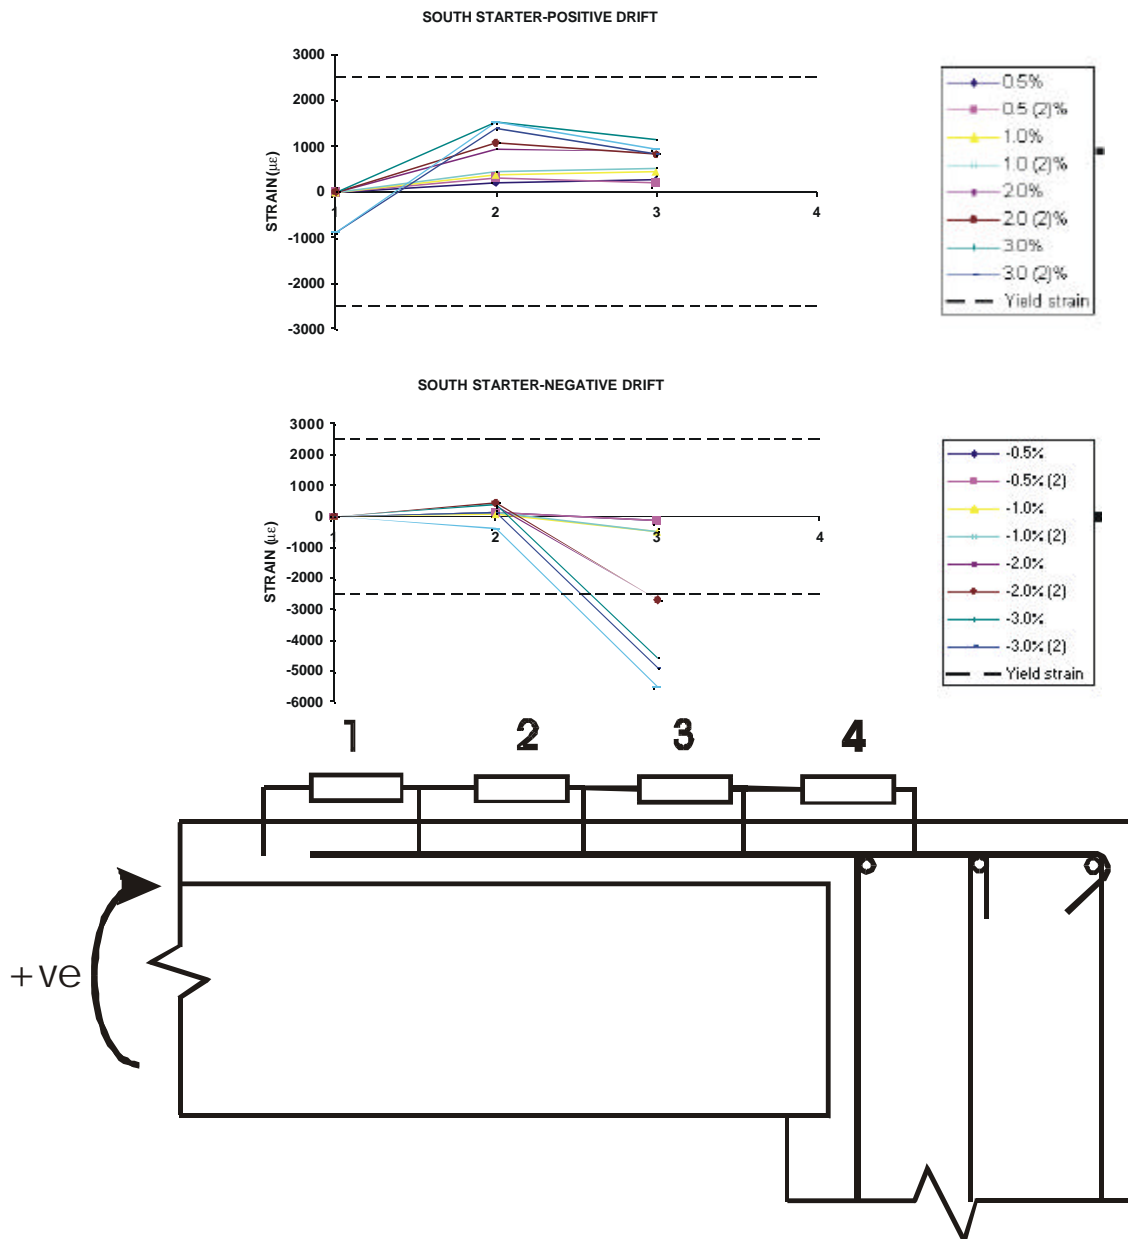
Figure 6-6 and 6-7 illustrates the distribution of strains along the 12mm diameter deformed starter bars during the test and the region of topping concrete at the end of the bars. The diagram shows values from both the northern and southern starter bars. Instrument failure and the preservation of instrumentation prevented a complete set of results to be shown. The results show that a majority of the strain induced in this region occurred in two places. Firstly at the continuity crack(s). The second region was in the concrete between the end of the starter bar and the stub that was placed within the topping concrete. This location was expected as there is a large stress concentration at the end of the starter bars and it is common to find some cracks opening at this location.

Overall, when comparing the results with HC1, the strain in the starter bars for HC2 was less. This is due to the reduced applied moment to the system due to the presence of the compressible backing material. Although the reduced flexural strength and continuity effects is good for reducing the amount of strength enhancement to the perimeter beam it may cause other problems as the floor itself is more likely to be livelier, causing vibration issues. This is because the compressible backing board and the low friction bearing strip reduce the fixity at the end of the hollowcore units.

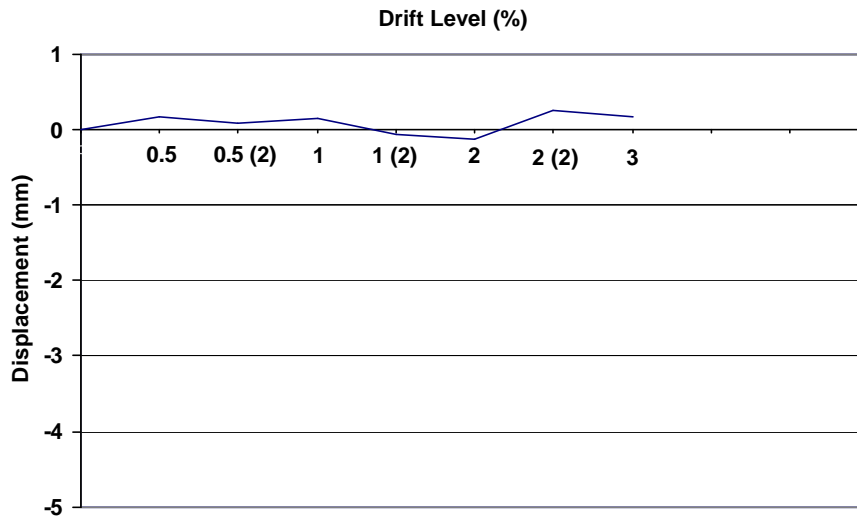
Figure 6-8. The vertical displacement of the hollowcore unit versus drift

As can be seen in Figure 6-8 the hollowcore unit did not drop with time. This was due to the unit retaining its seat.

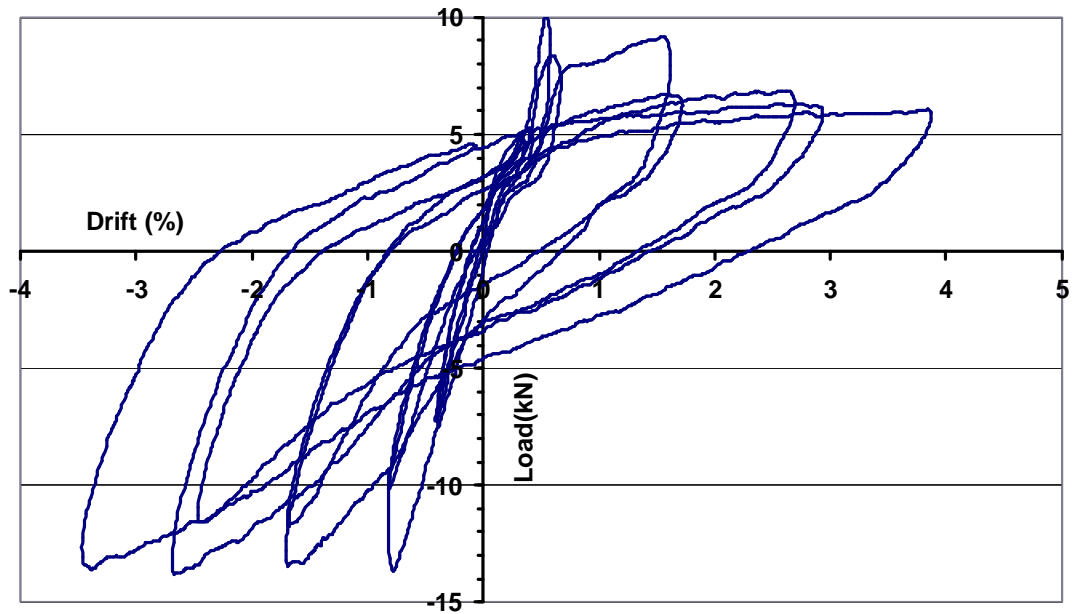
Figure 6-9. Hysteresis plot for HC3

The hysteresis plot from this test (Figure 6-9) was very similar to that for HC1 (refer Figure 6-1). The first cycle to 0.5% (0.43%) saw a larger force than any other of the positive cycles. Since this unit had a low friction bearing strip, the end of the unit did not fracture until later into the test. The level of applied load was greater than the previous two tests in the positive drift direction due to the paperclips that had been placed in the first and third cores. The paperclips significantly increased the positive moment capacity of the units.

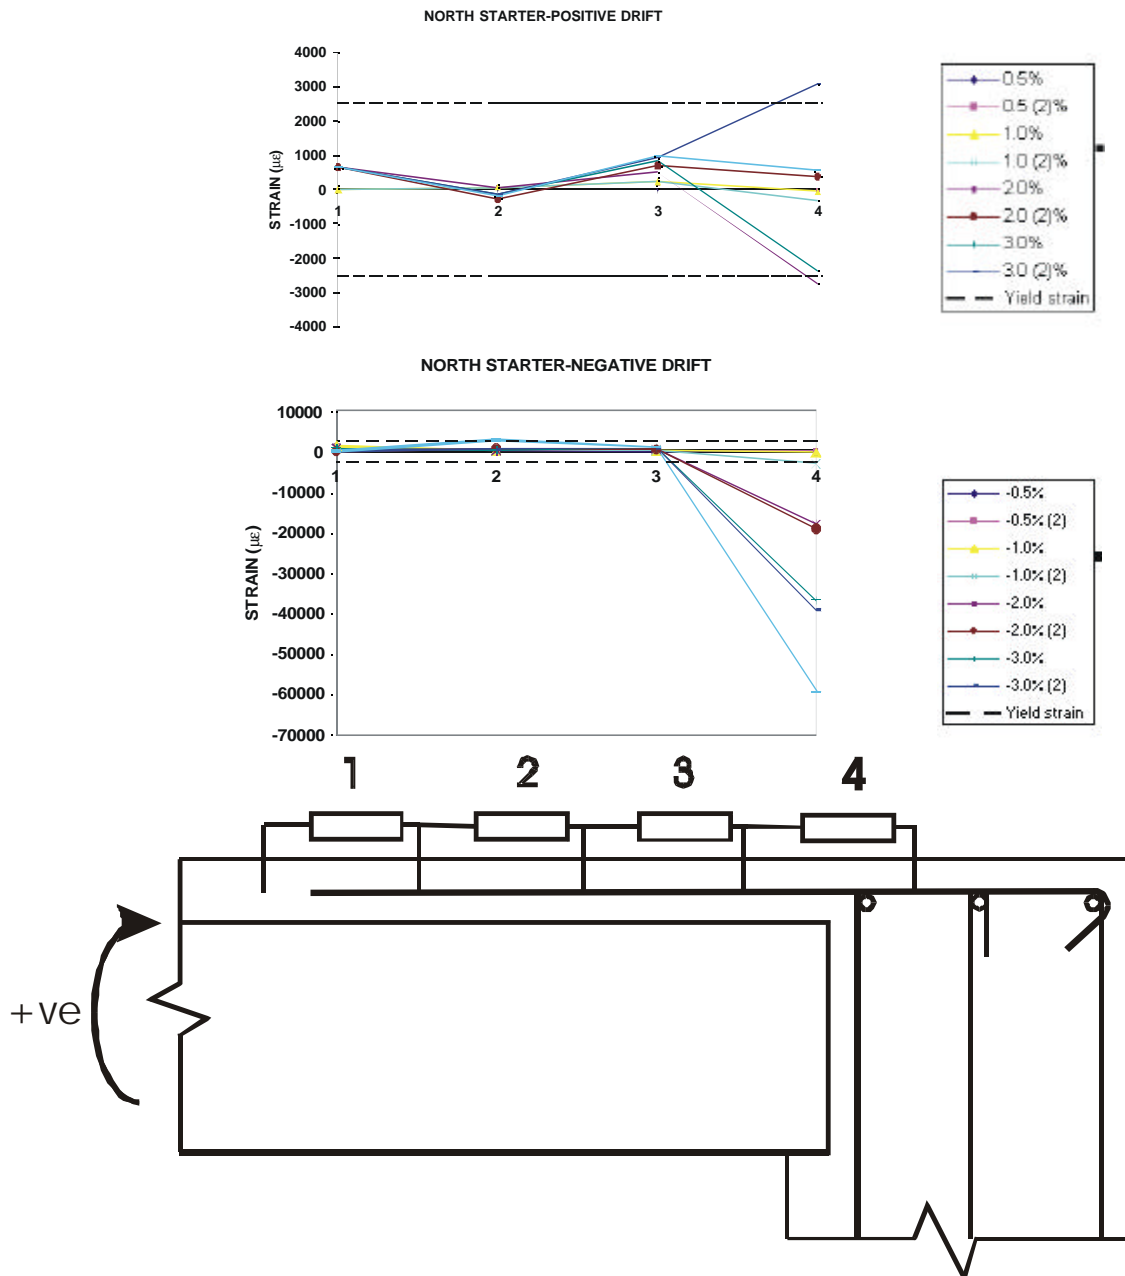
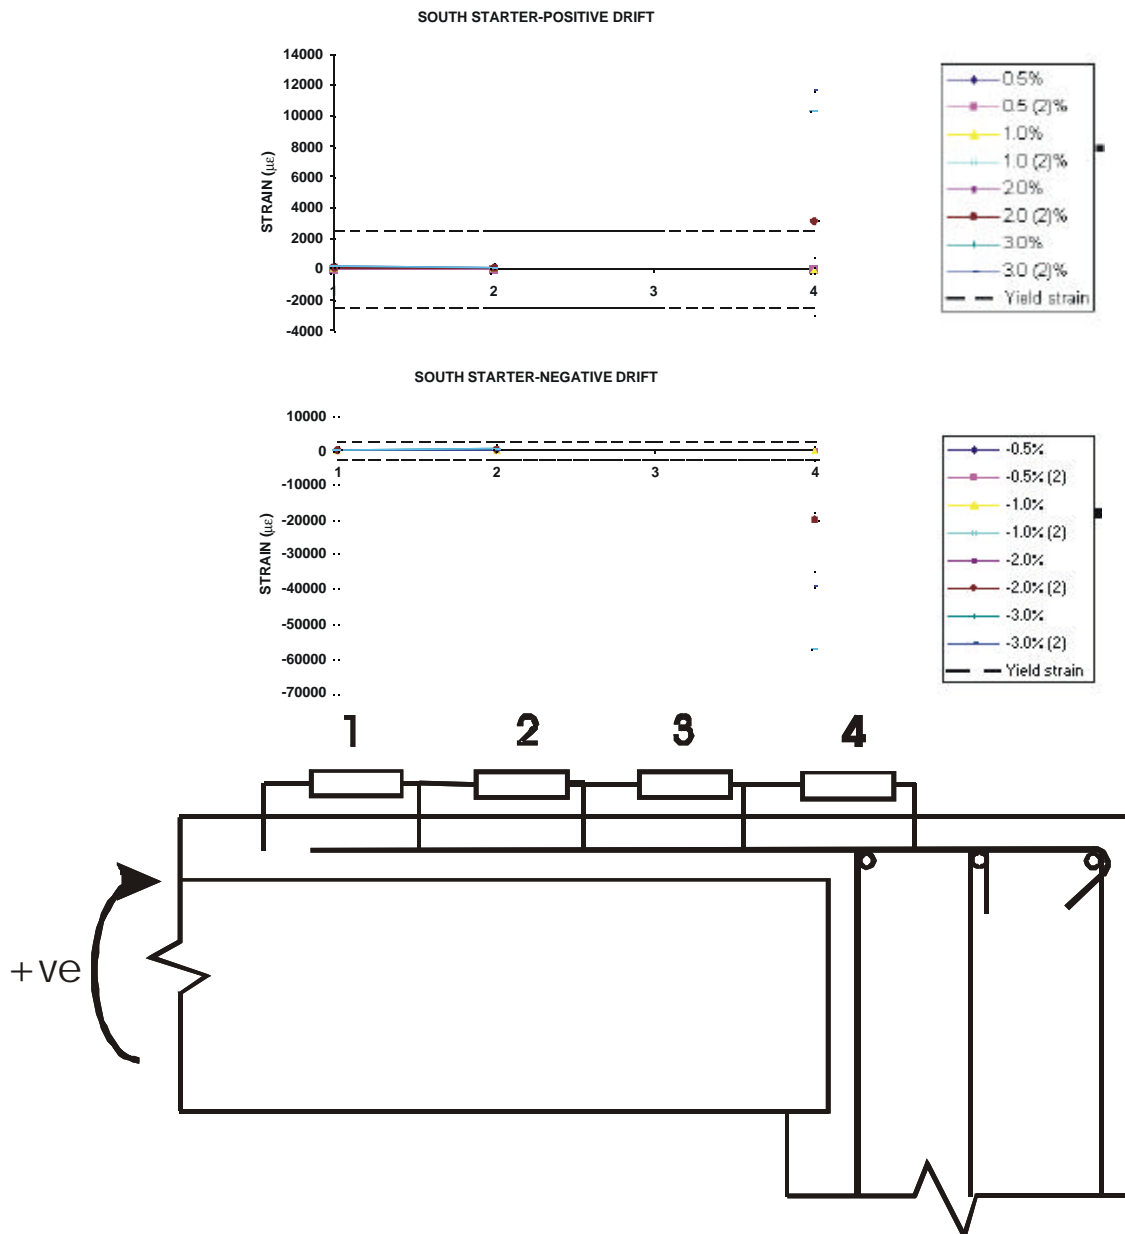
Very little activation of the starter bars occurred during HC3. This can be seen in Figure 6-10 and 6-11. However relatively high strains occurred in the region at the end of the starter bars.

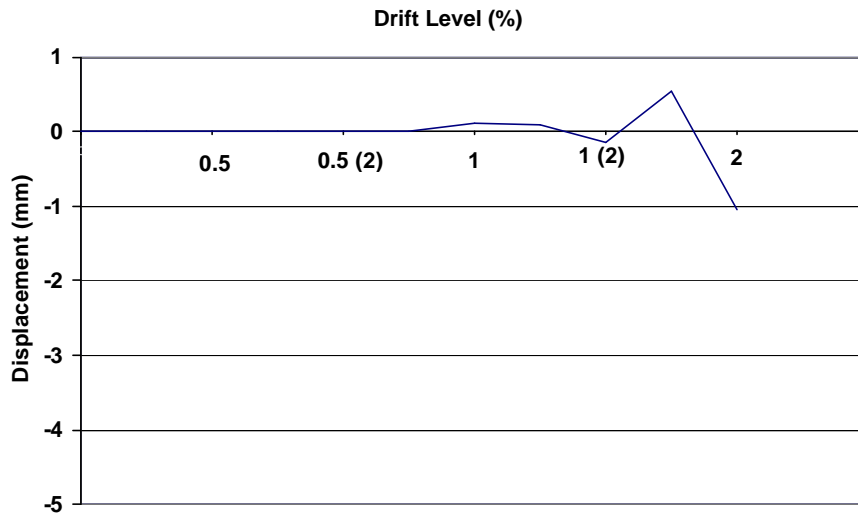
Figure 6-12. The vertical displacement of the hollowcore unit versus drift

Figure 6-12 shows the hollowcore only slightly dropped through the duration of the experiment.

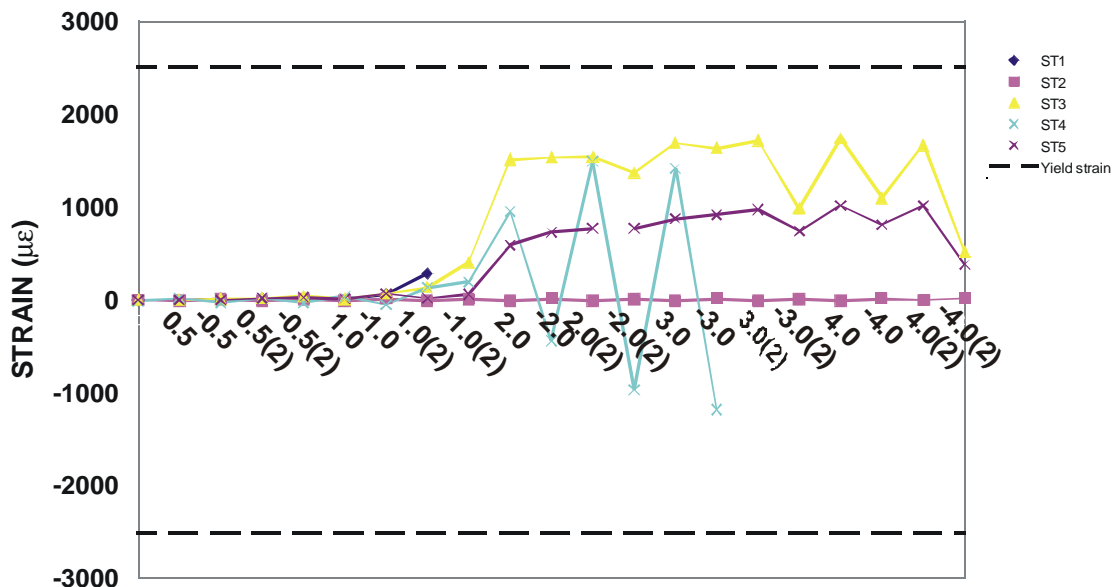
Figure 6-13. Paperclip strains

As can be seen from Figure 6-13 at no stage during the test did the paperclip appear to yield (see Figure 3-9 for the location of the strain gauges). Two of the strain gauges attached to the paperclip failed during the test, these were ST1 and ST4. There are several possibilities as to why they failed, the most probable is that the starter may have started to slide within the infill concrete and this movement dislodged the strain gauges.

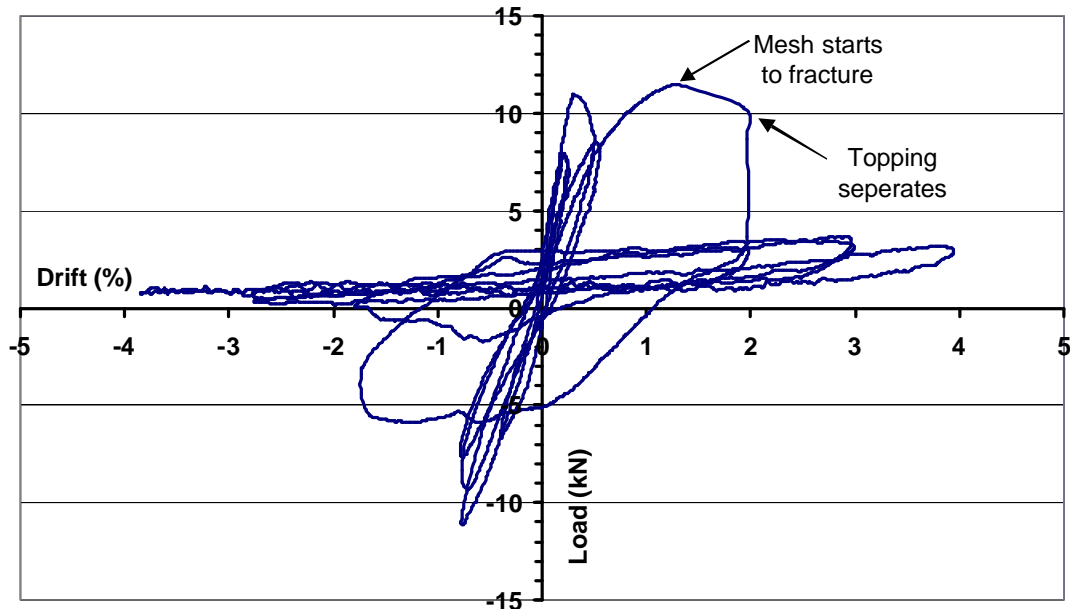
Figure 6-14. Hysteresis plot for HC4

The shape of this hysteresis plot was significantly different to the other three tests. Initially, up to the completion of the $\pm 1.0\%$ (0.56%, -0.76%) cycles the plot looked to be essentially elastic. After that it changed significantly, as shown in Figure 6-14. At -1.8% (-1.60%) drift the reinforcing mesh at the termination of the starter bars fractured and the topping separated from the hollowcore unit. This can be seen by the drop off in load after -1.8% (-1.60%) drift (labelled in Figure 6-14). From this point onward the unit was sitting on the beam ledge alone. Therefore the only load required to articulate the specimen is the load required to overcome the friction of the unit sliding on the beam ledge. As can be seen from the hysteresis plot the force to overcome friction is relatively very small.

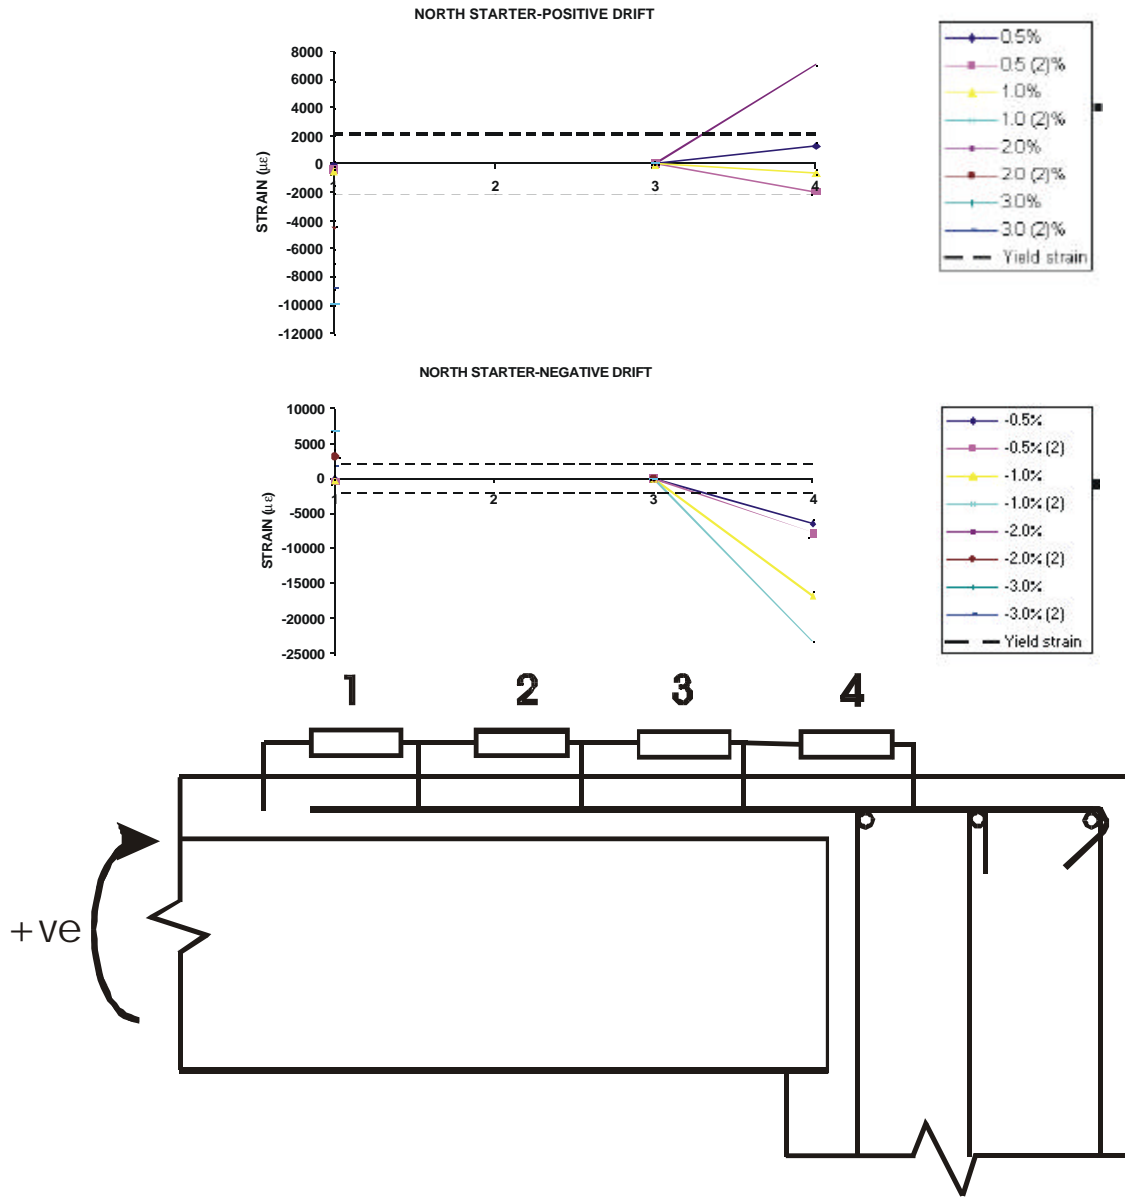
Figure 6-15 Starter bar strains for the north starter—HC4

Due to the failure that occurred the apparent strain in the concrete between the termination of the starter bars and the stub cast in the concrete is high. The largest strain in the starter bar was seen at the continuity crack. It was only at this point that the bar yielded. This can be seen in Figure 6-15 and 6-16.
