# Strengthening of Grinding Building Slab at Batu Hijau Copper-Gold Mine

Nusa Tenggara Barat, Indonesia

Submitted by Vector Corrosion Technologies

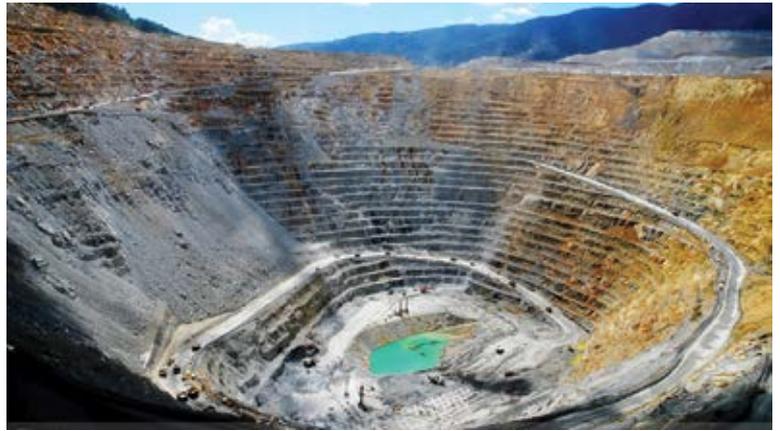
*The Batu Hijau mine was the world's largest greenfield mining project when it was developed by PT Newmont Nusa Tenggara*
