Hydrogen Embrittlement In Titanium Steam Surface Condenser Tubing *Truths, Myths & Misnomers*

Dennis J. Schumerth
Titanium Tubular Consultants
4811 E. La Palma Ave
Anaheim, CA 92886 USA
E-mail schumert@AOL.com
dennisschumerth@Gmail.com

Thomas Demers
System Specialist, NB Power
Point Lepreau Generating Station
122 County Line Road
Maces Bay, New Brunswick Canada E5J1W1
TDemers@nbpower.com

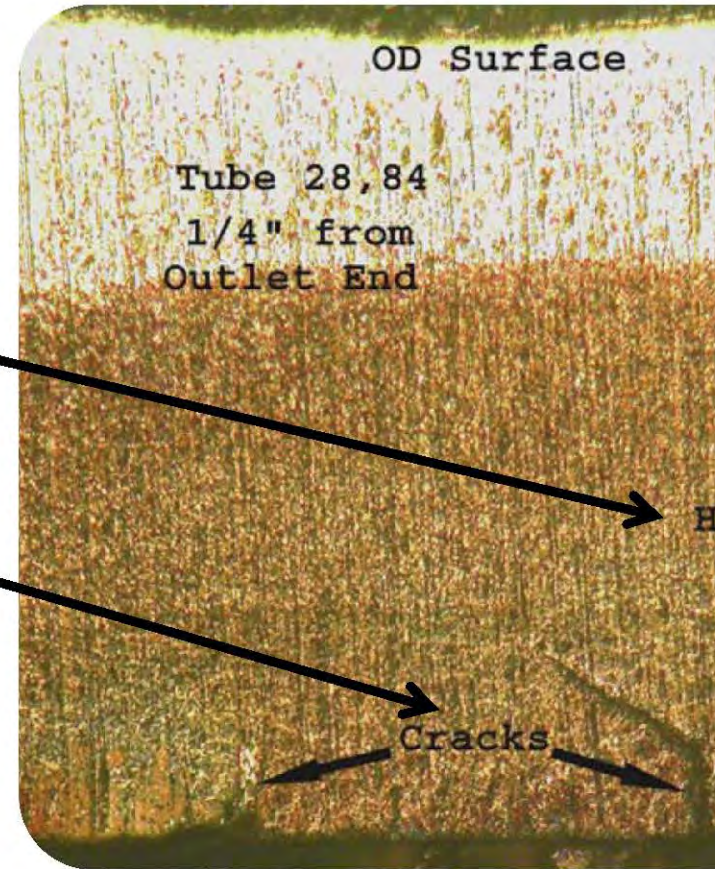
Localized tube cracking was also observed. It was suggested that excessive applied cathodic potential could have caused the hydriding. Subsequent computer simulations identified voltages in the range of -1.345 V_{SCE} to -1.36 V_{SCE} were applied to the titanium outlet tubesheet tube ends – the area of highest concentration of wall hydriding.

Mineral Deposits (calcium & magnesium)
General Titanium Tubing Hydriding
Localized Tube Cracking

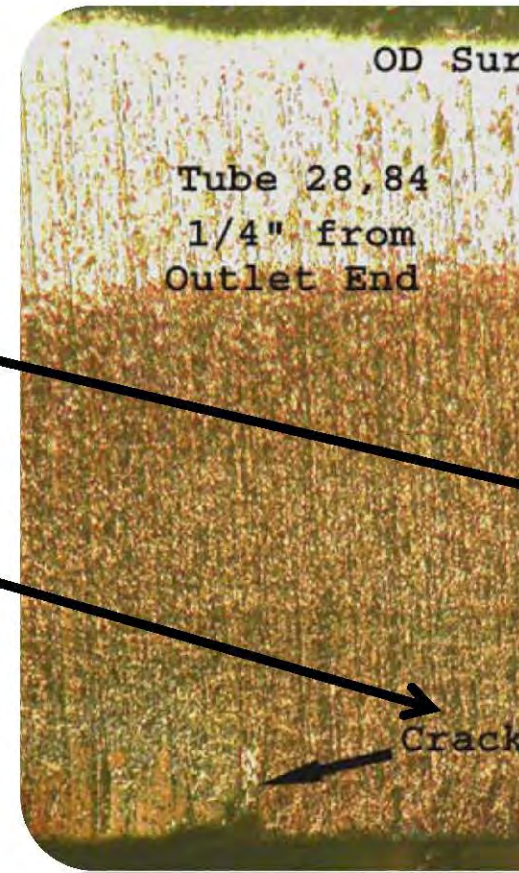
- Excessive Cathodic Potential Voltages

ACTUAL IC OPERATING POINTS (CALCULATED)	
TUBESHEET	-1.345 V _{SCE} to -1.36 V _{SCE} OR -1.23 V Ag/AgCl

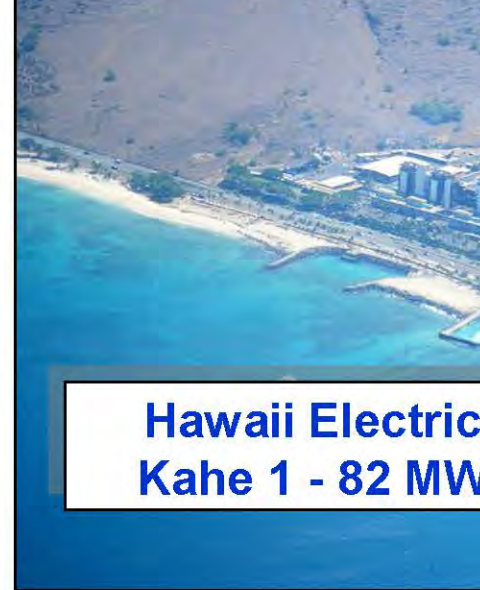
Eddy Current testing at the time indicated possible weld defects and wall thinning [12, 15]. Even more troubling was the discovery of circumferential cracks within the confined annulus space within the tube/tubesheet joint area. This cracking was determined to be hydriding as a result of over rolling the tube joint and an excessively applied IC system.

...o weld anomalies

...xpanded Zone due to overrolling

To ameliorate the situation, a sleeving process was undertaken in 2008. This operation appeared to have prevented further leaks at the tube joint but inhibited future effective cleaning activities which ultimately affected the plant heat rate. Ultimately a titanium-tubed modular changeout with proper IC protection was ordered for installation in 2012.
