CITY OF PHOENIX EMBRACES FIVE YEAR REHABILITATION PROGRAM FOR THE VAL VISTA TRANSMISSION MAIN

*By Brandy A. Kelso, P.E. (City of Phoenix),
Bethany A. Williams, P.E. (Brown and Caldwell),
and Gary Schult (Kiewit Western)*

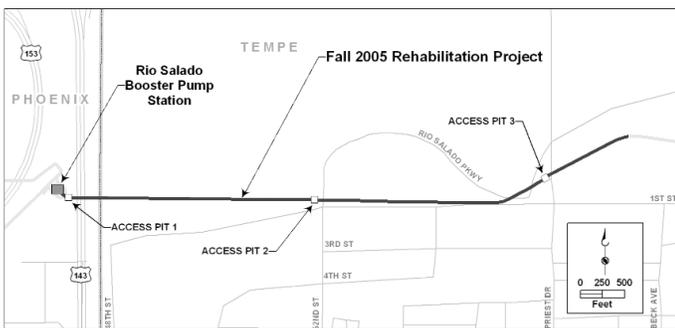
Having never used steel sliplining to rehabilitate a large diameter water transmission main, the City sought to gain experience by beginning the program with the rehabilitation of a relatively short, straight section of pipeline located along the less developed area of the pipeline alignment. The 6,300-foot section of 72-inch PCCP immediately upstream of the Rio Salado Booster Pump Station, as shown in Figure 1, was selected.

Figure 1 — Fall 2005 Rehabilitation Project Limits
