BUILDING ENVELOPE FAILURE CASE STUDIES IN HIGH-RISE CONSTRUCTION

Pierre-Michel Busque, P.Eng.¹

ABSTRACT

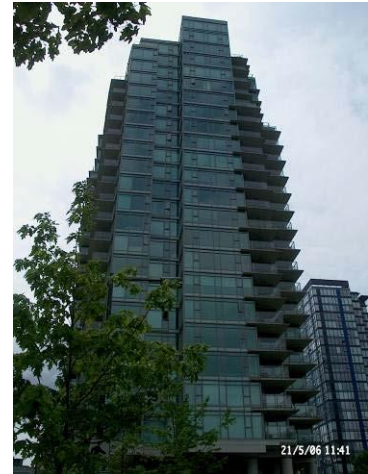
PHOTOGRAPH 3: Exterior view of the building.

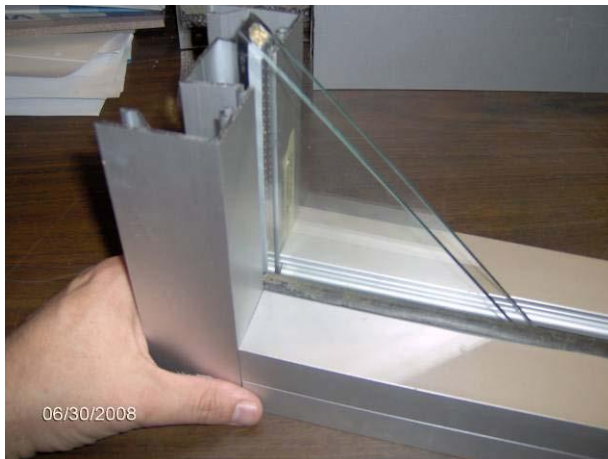
Storefront windows are aluminum framed windows usually reserved for use on the façade of retail establishments. These are often used in lieu of curtain wall systems partly because of lower product costs. The design of their frames is such that at the junction of the jamb with the sill, there is a hole that is formed in the glazing pocket.

PHOTOGRAPH 8: A storefront window frame with a sealed unit inside of the glazing pocket.

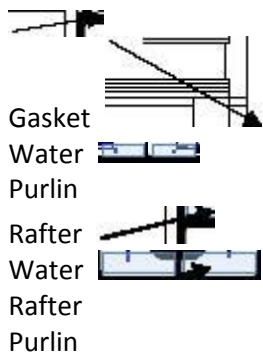
FIGURE 4: Raised Leg, Overlap Skylight

A vast improvement to the design of the skylight in Figure 4 is to raise the level of the bottom of the drainage gutter of the purlin. Thus the joint between the purlin and the rafter is not exposed to water for long periods of time.

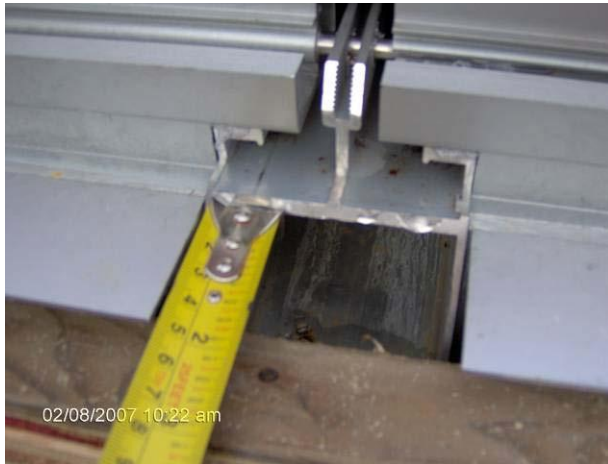
PHOTOGRAPH 12: Exterior view of a raised leg skylight with overlapped drainage gutters.
