**2020 ISSA Preservation Performance Award  
Nomination – Cape Seal Benalla Victoria**

## Project Overview;

## Treatment undertaken;

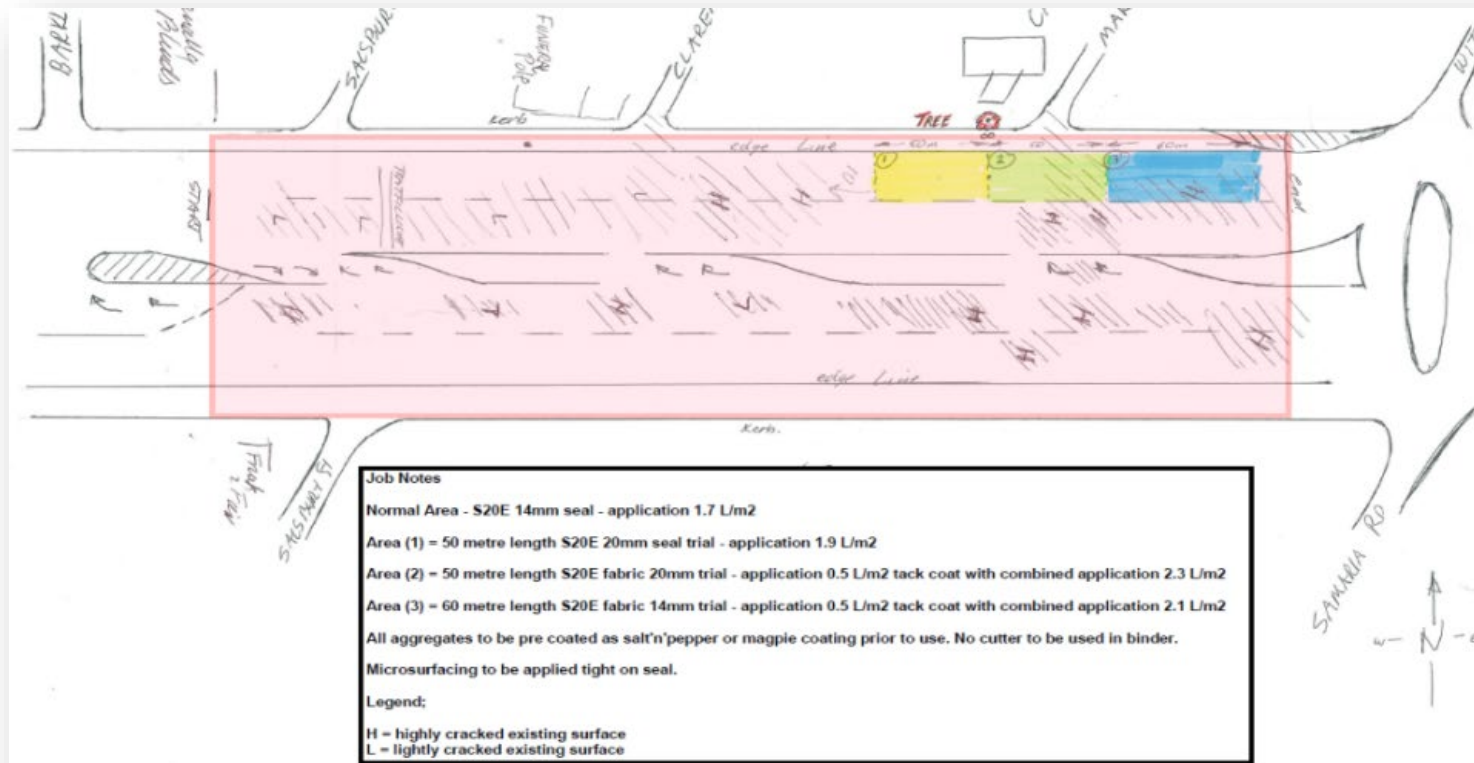
*Overview map of trial areas undertaken as part of the works*

The works also include trials of alternate treatments including use of 20mm aggregate in the spray seal and use of geotextile reinforced spray seal in areas of heavy existing block cracking.

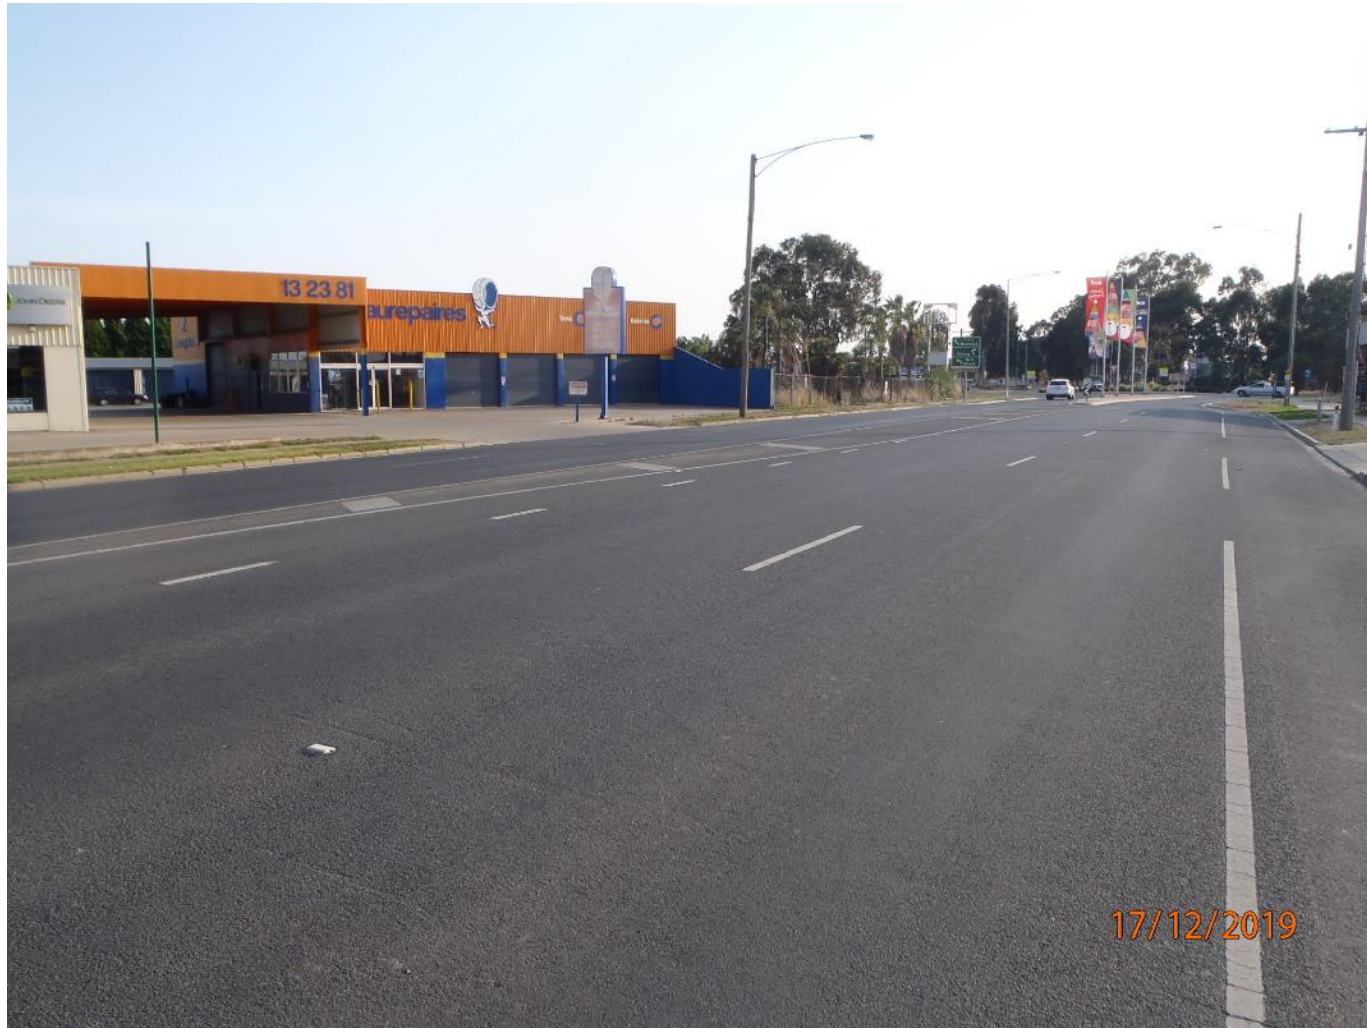
## Performance Review December 2019

*Aesthetic review of the site undertaken in Dec 2019 shows the pavement in good condition.*

*Some areas exhibit minor reflective cracking and there is some binder flushing, however turning and screwing action of traffic have been resisted and the surface texture has been maintained. The site has been scheduled for a further flexible spray seal treatment this season to continue to maintain waterproofing of the pavement.*

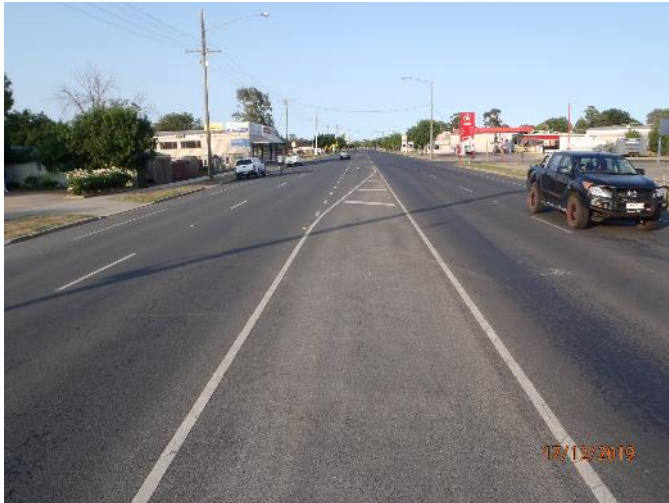
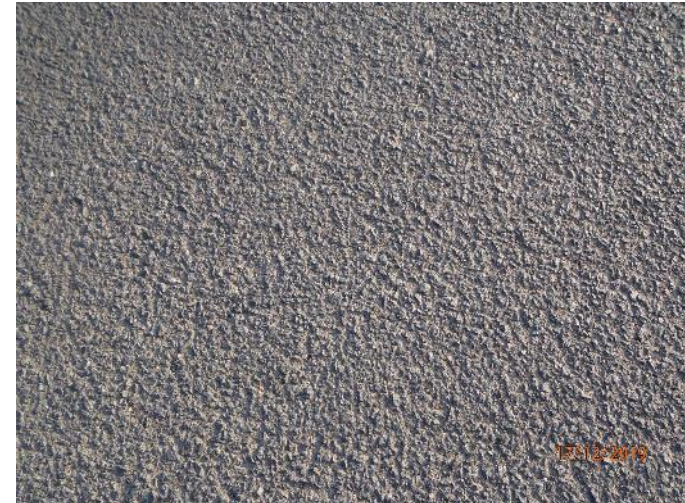
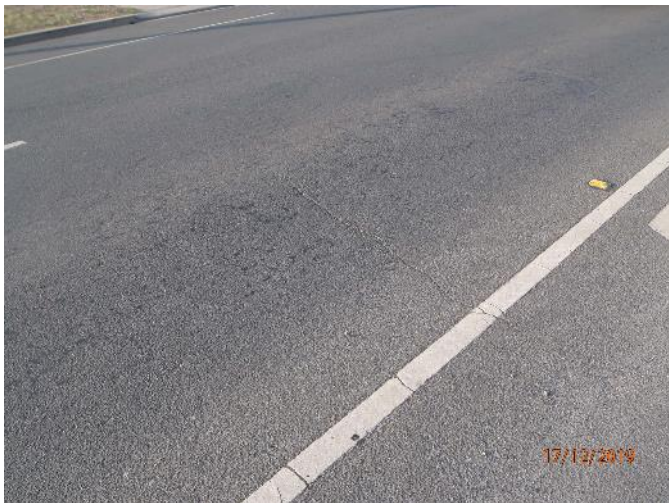
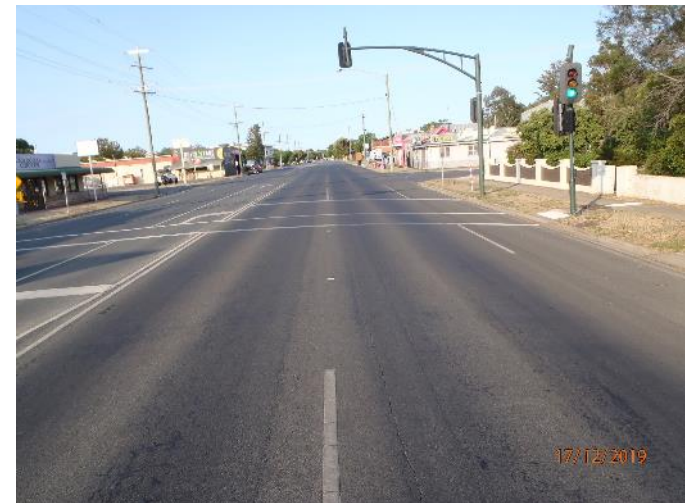
## Performance Review December 2019

Inhibition of surface cracking has been effective with only minor comparative reflection of pre-existing cracking and surfacing failures emerging through the delivered pavement surfacing. Pavement shape and ride have been maintained and the site is suitable for further preventative treatments to extend its life further mitigating more reactive type treatments and reducing whole of life costs.
