SOUTH RANGITIKEI RAILWAY BRIDGE - CONSTRUCTION ENGINEERING

GRAHAM FROST¹, CLIVE TILBY²

SUMMARY

The South Rangitikei Rail Bridge is the southernmost, and longest, of three major NIMT prestressed concrete bridges that were constructed as part of the Mangaweka to Toitoti Deviation which opened in 1981.

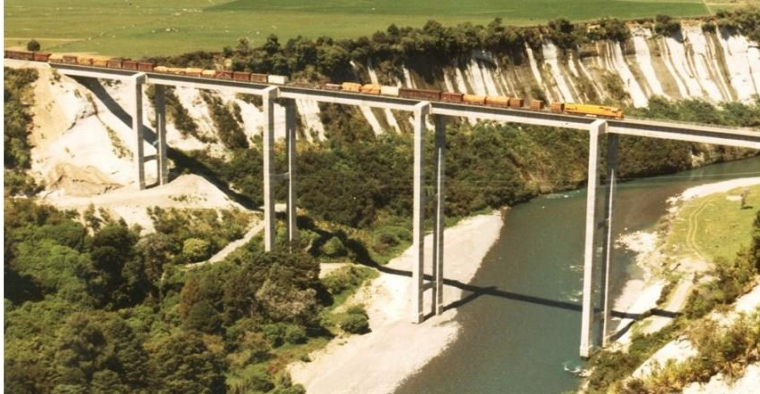
Figure 2
Completed bridge
looking Downstream

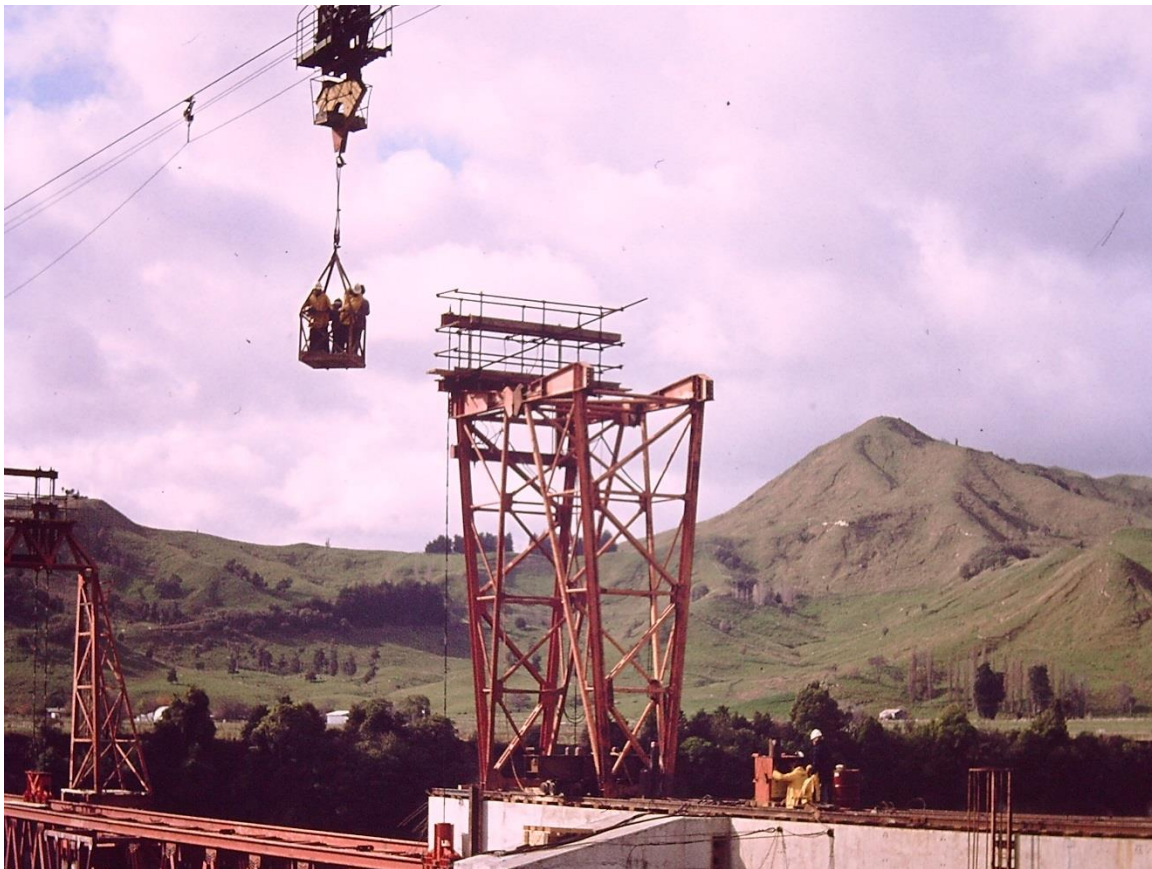
Figure 4 – the 3tonne capacity Blondin cable way was supported on towers spaced at 450m and delivered workers, equipment and concrete to any working level over a 14m plan width.

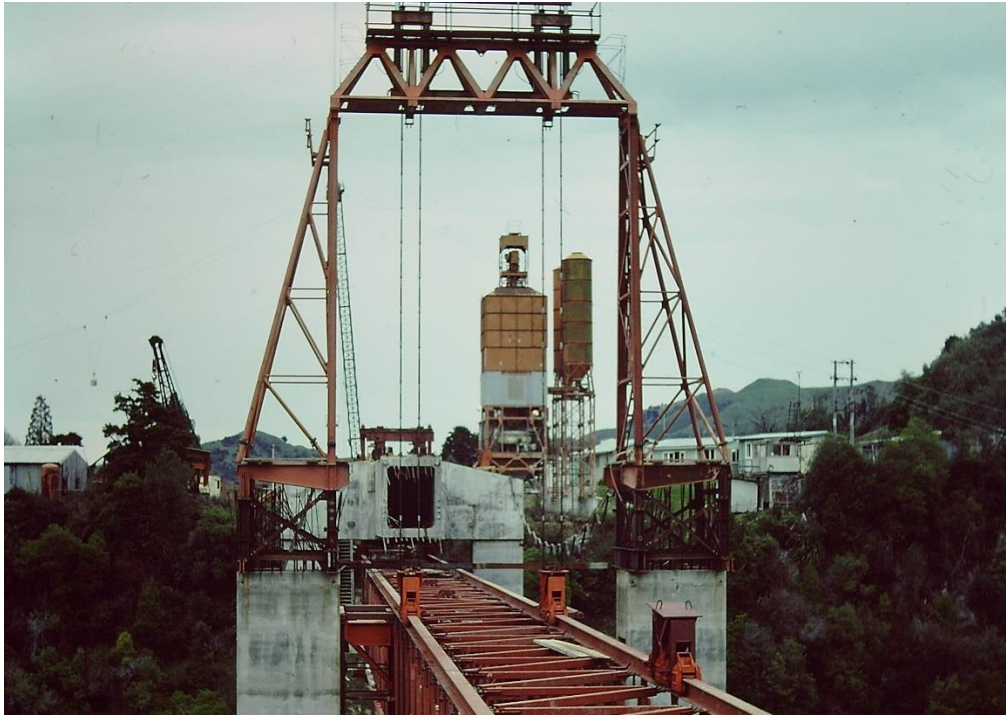
Figure 5 – Background from left to right: workshop, cableway tower slewed to left, 1m³ CIFA batching plant, canteen, and office and control room for flying fox. Visible in the foreground are the temporary towers, transverse truss and hydraulic jacks at Pier 5 during assembly LG.

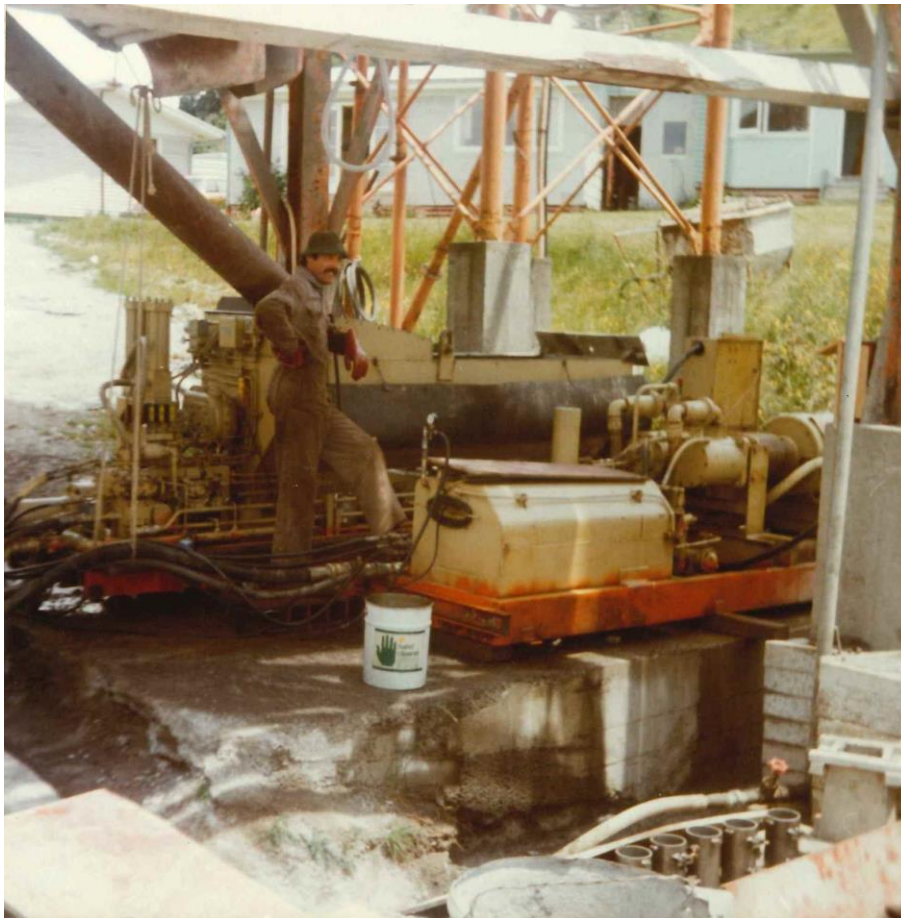
Figure 6
Concrete
Pump
beneath
1m³ CIFA
Batching
Plant.
Concrete
was
pumped
up to
320m
along top
of bridge.

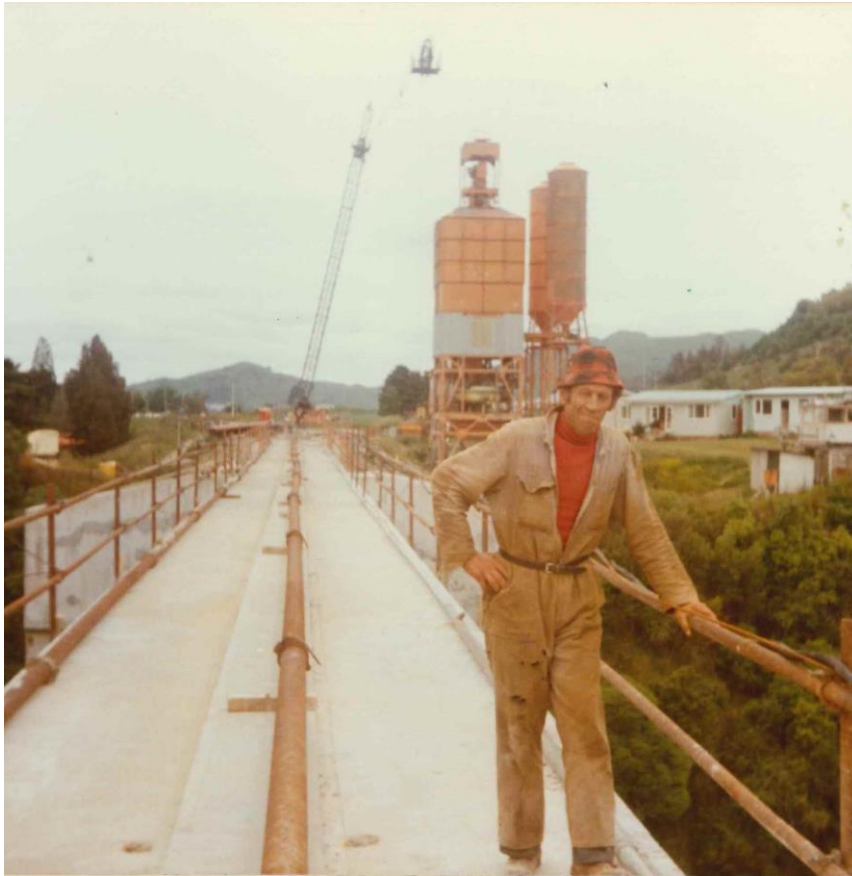
Figure 7
Slick line
along top of
bridge with
batching
plant and
flying fox
tower in
background

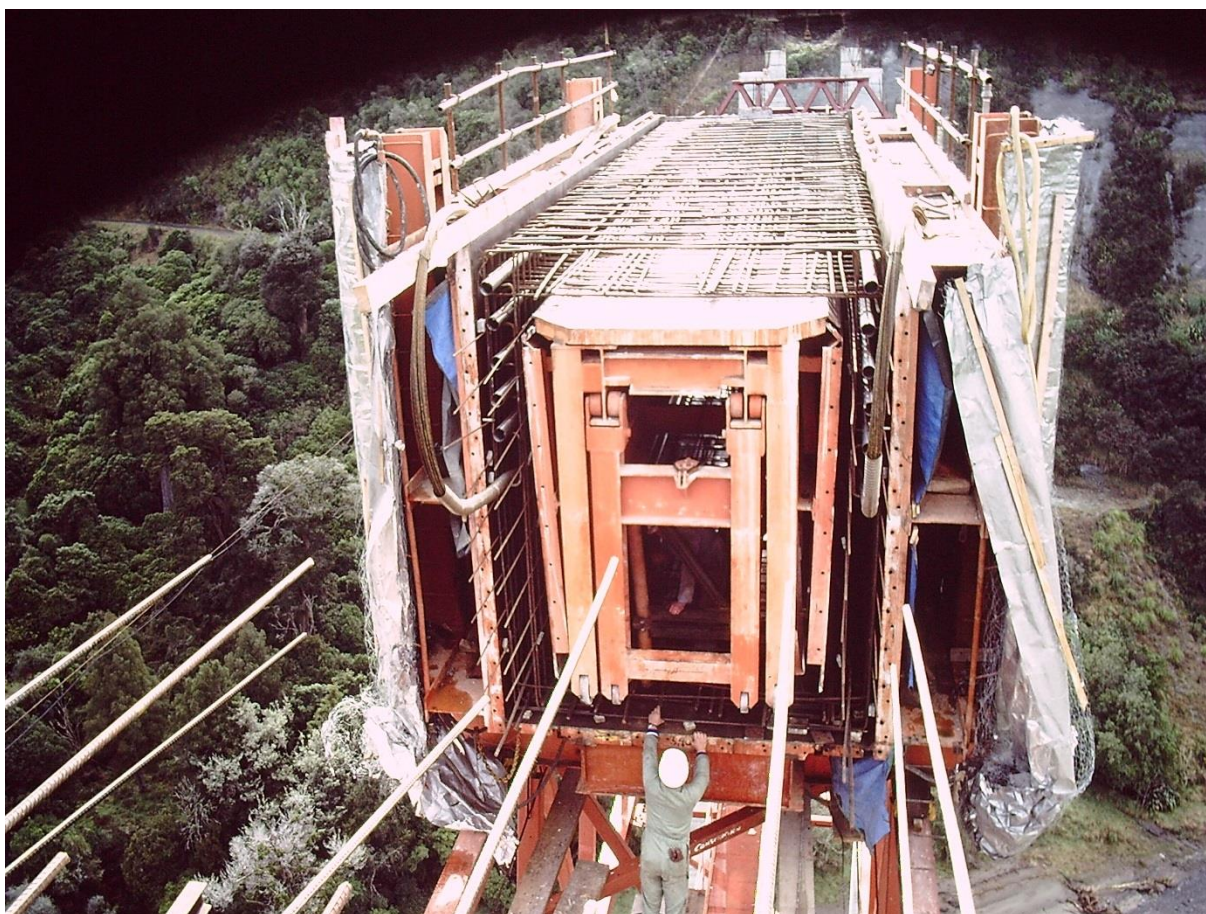
Figure 9 – 80tonne steel form – temporarily over-advanced, cleaned, oiled and rebar installed for cantilever segment while waiting for piercap formwork and rebar to installed concurrently. Rolled back to join piercap form prior to combined pour.

As the 80 tonne steel form was advanced to a new pour location, hydraulic jacks were activated to 'prop' completed segments off the launching girder. To reduce the risk of displacement due to hydraulic equipment failure, steel 'cans' and shim plates were incorporated around each jack (see Figure 11 and red arrows in Figure 8 above). Jack loads were equalized and shims adjusted prior to each new pour. Larger lock-ring jacks were used at one end of the understay system (see Figure 10 and blue lines in Figure 8 above) and the load in these jacks was also adjusted prior to each pour to help compensate for the increasing elastic deflection that would otherwise be occurring with each successive pour. Our analysis of the combined permanent works and temporary works for all the construction stages in a typical span showed that all these measures would still not be enough to prevent unacceptably high stresses being introduced at the construction joint between the first pour and the front end of the cantilever segment from the previous cycle – mainly during the placement of the Pour 2 concrete – if Segment 1 was poured full depth against the end of the previous cantilever – as had originally been planned. The downward movement of the launching girder during Pour 2 placement would have overstressed the reinforcing in the top flange of the concrete box at that construction joint. To eliminate this overstress situation we opted to form a structural gap in the webs and top flange at this joint. The length of the gap matched the lap length of the bars in those zones. While this effectively created a pinned joint at bottom flange level, we determined that the bottom flange alone had adequate strength to resist the shear load demands throughout the remaining stages of each span's cycle. The structural gap section was poured during the final stages of the combined Pour 5 (cantilever) and Piercap pour, so that we had a continuous box and adequate strength (31MPa minimum) when the span was post-tensioned.

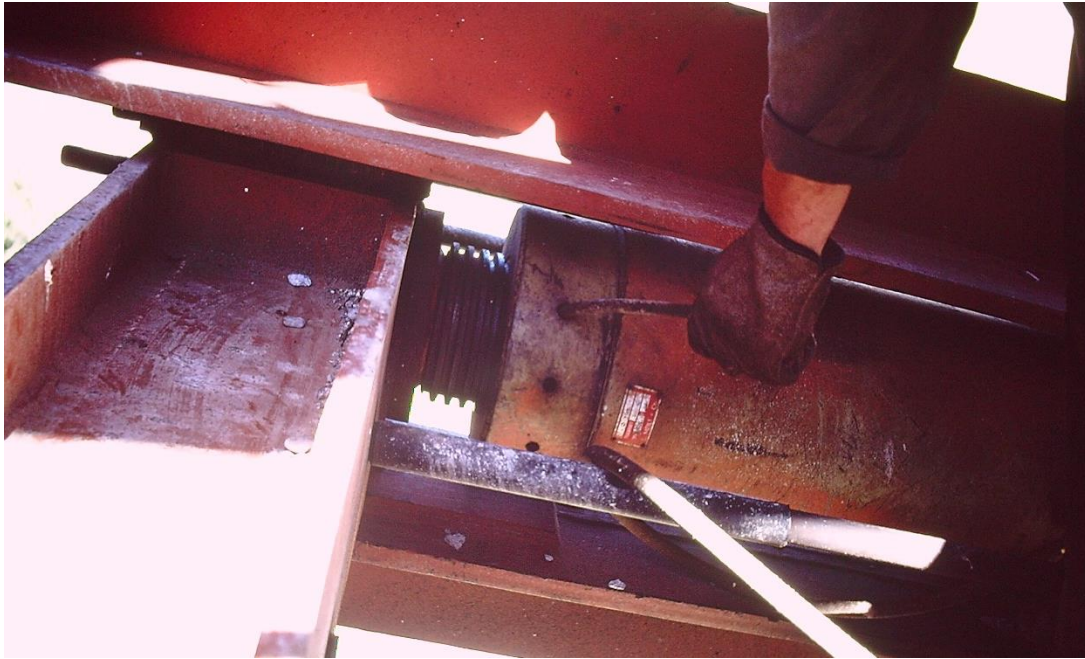
Figure 10 – Lock-ring jack for adjusting load in Macalloy bar understay system.

too difficult and risky to attempt this multistage operation by adjusting the load and shims at the jacks under each pour. Instead we released the load in the understay lock-ring jacks in three stages during the post-tensioning process.

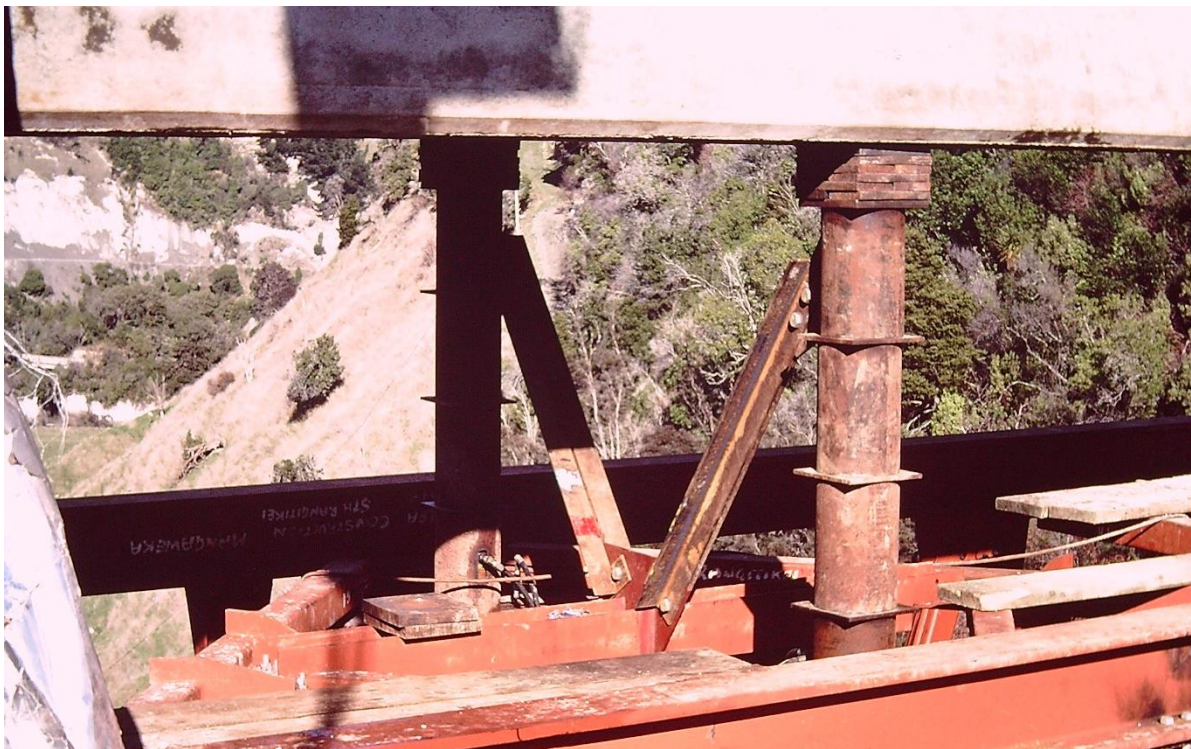
Figure 11 – Packing system and shims around hydraulic jacks supporting each segment until completed span post-tensioned.

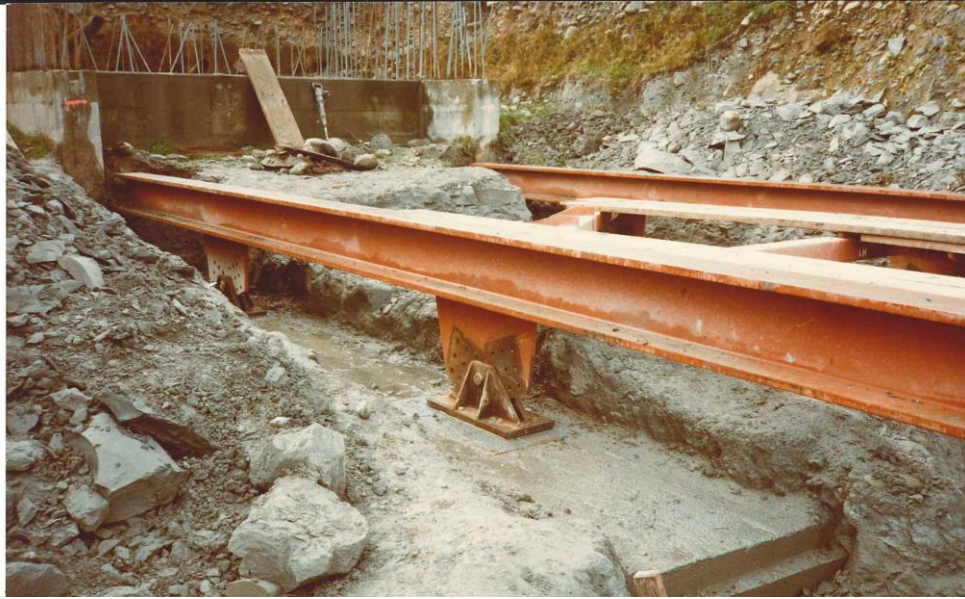
Figure 13
Sliding
bearings
under top
chord
nodes
near North
Abutment

While the pier legs were free-standing, having the sun shine on one face all morning was enough to cause the top of those legs deflect approximately 75mm away from a neutral position. By evening, with the sun shining on the other face, differential temperature effects were great enough to cause the pier top to deflect back by 150mm or 75mm towards the other side of a neutral position. The longitudinal bracing system we developed easily locked the pier we were about to incorporate with the superstructure. It incorporated a ring frame around each pier leg with spaces to drop in timber wedges when the pier had migrated to the 'correct' location. The actual forces required to restrain the piers longitudinally were not large. Longitudinal temperature effects were little more difficult to accommodate. The superstructure was stressed back to the south abutment throughout the construction of the superstructure, so any thermal expansion and contraction occurred relative to that end of the bridge. By the time the superstructure reached the northern abutment we knew we were likely to experience longitudinal thermal movements from the combined superstructure and launching girder of up to 50mm over a time frame of one calendar month. We made allowance for this by keeping the launching girder locked to the pier legs nearest the rear and introduced roller bearings under the bottom chord nodes of the launching girder at their ground supports in a short trench cut into the cliff adjacent to the north abutment (see Figure 12). The top chords had to extend approximately 10m longer - right up the abutment – with no web members to support them. At top chord nodes where the web members had been removed we introduced sliding bearings (see Figure 13).
