DEVELOPMENT AND TESTING OF RETROFIT SOLUTIONS FOR HOLLOW-CORE FLOORS IN EXISTING BUILDINGS

MIKE PARR – University of Canterbury, DR. KEN ELWOOD – University of Auckland, DES BULL – Holmes Consulting, FRANK BUEKER – University of Auckland, DR. LUCAS HOGAN – University of Auckland, DR. ASHWARYA PURANAM – University of Auckland, DR. RICK HENRY – University of Auckland, DR. NIC BROOKE – Compusoft Engineering

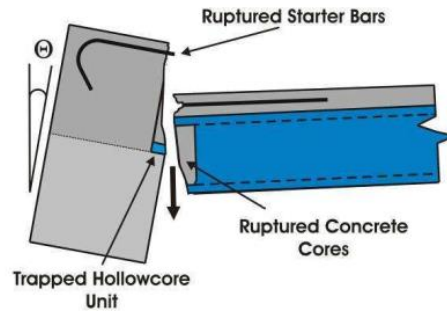
Figure 1: LOS Mechanism (Sourced from Woods, 2008)

Two of the critical failure mechanisms to avoid with hollowcore units under earthquake loading are known as "loss of seating" (LOS) and "negative moment failure" (NMF). LOS is undesirable because it describes a unit falling off insufficient ledge seating during an earthquake, which compromises the life safety of building occupants on and below the affected floor. NMF is undesirable because it describes cracking and eventual collapse of the unit away from the ledge support – meaning it will also drop onto the floor below, compromising the life safety of building occupants. Hollowcore is known to perform poorly when subjected to negative moment demands (which imposes tension on the top of the unit), because it only has reinforcing steel near the bottom in the form of pre-tensioned strands. This means the unit itself must withstand tension demand at the top of the unit by the tensile capacity of concrete alone - which is relatively small and unreliable. The only steel reinforcing at the top of a hollowcore floor system (beyond the end of the starter bars) is mesh in the topping, which is insufficient for large earthquake demands. A depiction of LOS is displayed in Figure 1 and a depiction of NMF is displayed in Figure 2.

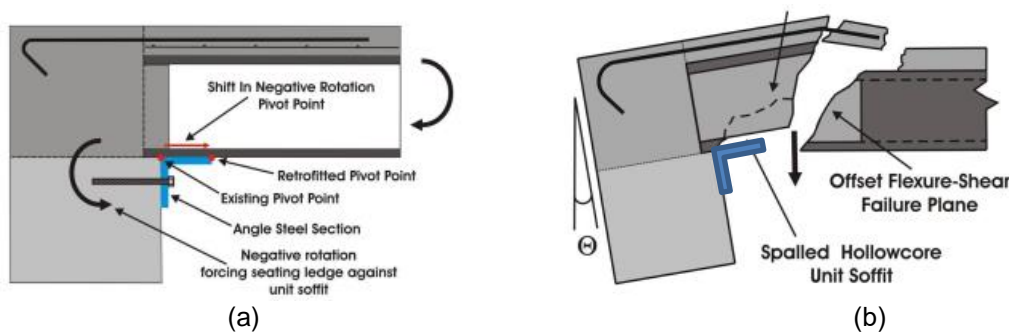
Figure 2: Promotion of NMF by the Seating Angle Retrofit (Sourced from Jensen, 2006)

The critical parameter determining if LOS will occur is the available seating length. The critical parameters determining if NMF will occur are the seating length, the length of the starter bars and the strength of the starter bars across back face of the hollowcore unit (where the unit ends against the support beam). A longer seating length is beneficial to prevent LOS but provides a more critical case for NMF. The interaction of the strength vs length of the starter bars is particularly important for NMF, because it is a scenario where the strength of one member in the structure needs to be weaker than the rest, thereby acting as a “fuse”; allowing the structure to deform safely in an earthquake. In this case, it is favourable for the “fuse” and damage concentration to occur at the back face of the unit (a crack forming at the interface of the back of the unit and face of the supporting beam; stretching (plastically deforming) the continuity bars). With the crack forming at this interface, the unit remains supported by the seating ledge. However, if the starter bars are too strong across the back face of the unit or too short, the damage will instead be pushed out to the section at the end of the starter bars where there is a sudden drop in floor strength. Unfortunately, a retrofit detail commonly used in the early 2000’s to address LOS has also had the unintended consequence of promoting NMF. This retrofit called the “seating angle retrofit” is a steel angle bolted to the support beam underneath the unit, providing additional seating for the hollowcore unit. This retrofit is shown in Figure 2.

The issue with the seating angle retrofit is that it can hasten the onset of NMF when the angle is installed in direct contact or “hard up” against the hollowcore unit soffit (bottom of the unit). In this case, the unit becomes restrained by the angle when it is rotated (as it would be in an earthquake), changing the support reaction (or pivot point) under negative rotation from the end of the ledge further out towards the end of the angle, as shown in Figure 2. This has two undesirable consequences:

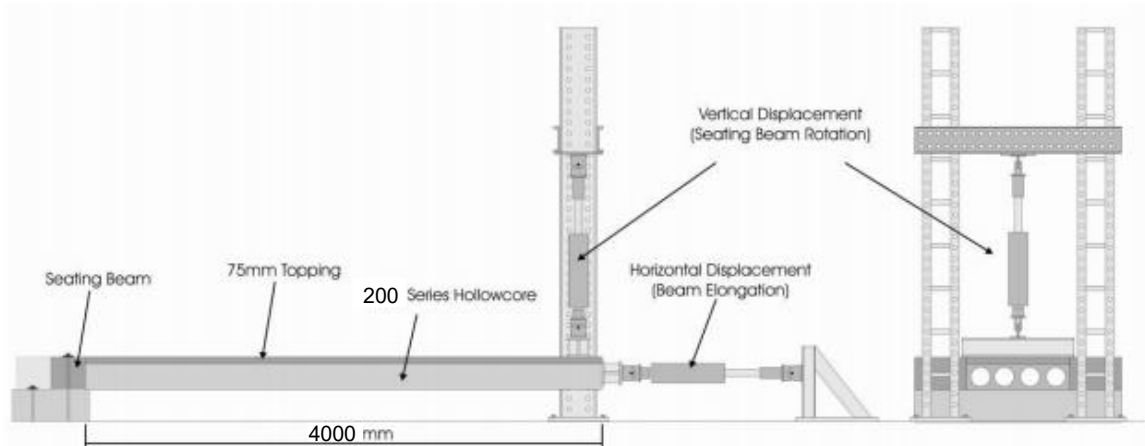
Figure 3: Single Unit Test Layout

Multiple tests were required to determine how each mechanism forms: the NMF and the more favourable mechanism of cracking at the back face of the unit over the support ledge. As part of this testing programme, the testing of retrofits to remedy the NMF cases was done. To accomplish this, the single unit testing method used previously by University of Canterbury and University of Auckland researchers was employed. This method used a hollowcore unit supported on one end by a beam segment with the desired ledge seating connection for testing and supported on the other end by a vertically oriented actuator. An additional horizontal actuator attached to the end of the hollowcore unit was also used to impose axial tension on the unit for one test case. This applied axial/longitudinal tension was used where it was appropriate to account for beam elongation (a process through which concrete beams stretch during earthquakes, pushing the hollowcore ledge supports apart). This setup is displayed in Figure 3.

The vertical actuator was used to impose rotational demands on the beam-hollowcore seating connection by rotating the hollowcore unit. Downward rotation of the unit (causing negative moment in the unit) is recorded as negative drift and upward rotation is recorded as positive drift.

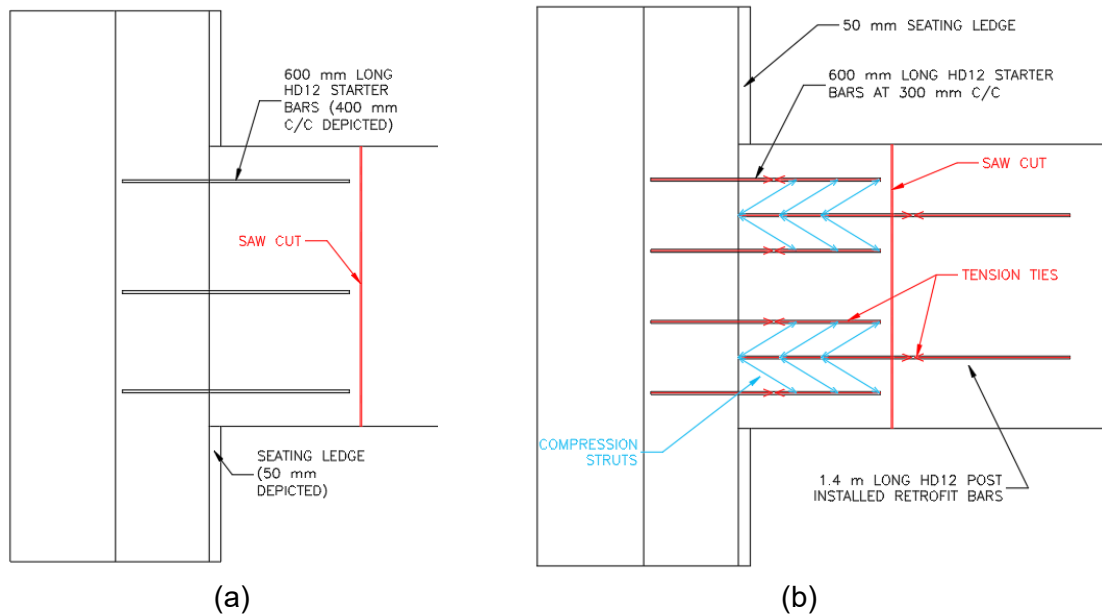
Figure 4: Plan View of General Specimen Seating Connection Layout (a) and Post-Installed Bar Retrofit Layout with Strut-and-Tie Solution (b)

The general layout of the seating connection details is displayed in Figure 4 and Figure 5 and the specific details and objectives for each specimen are listed in Table 1. The layout of a post-installed bar retrofit is shown in Figure 4 including a depiction of the designed strut-and-tie solution.

Specimen 5 was used to test a potential retrofit strategy of installing two 1.4 m long HD12 bars into the topping along the critical section for NMF, as shown in Figure 4 and Figure 10, to prevent the NMF triggered in Test 4. Note, it is important for this retrofit that the post-installed bars do not cross the interface between the unit back face and the support beam front face. The retrofit performed well and prevented negative moment failure up to the monotonic limit of -3.5% drift and then through a set of cyclic loading up to -6% drift. Many cracks formed in the topping and progressed into the unit, but none went beyond half the depth of the unit. Instead,

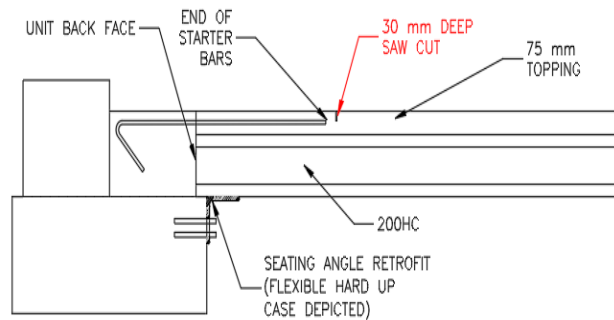
Figure 5: Elevation of General Specimen Seating Connection Layout

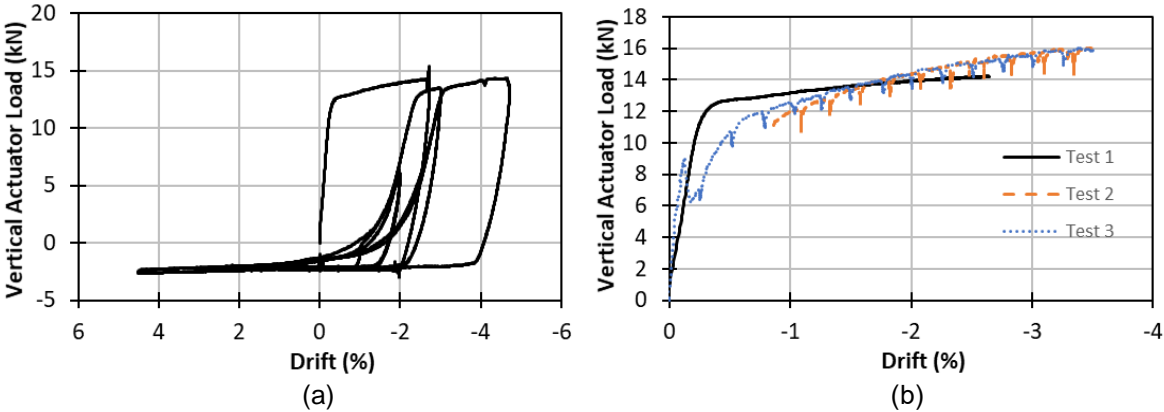
Figure 6: Test 1 Cyclic Load-Drift Plot (a) and Test 1-3 Monotonic Load-Drift Plot Comparisons

The first test was set-up as a control case to display the performance of the hollowcore seating connection layout without the addition of any angle or other alterations. Tests 2 and 3 used an unstiffened steel angle seating retrofit to check if the retrofit would push the failure mechanism to NMF. The only difference between Test 2 and 3 was the addition of a crack initiator at the end of the starter bars for specimen 3, as it was considered unreliable to depend on the uncracked properties of the topping to prevent NMF. As shown in Figure 6 and 7, none of these specimens displayed NMF. The primary failure mechanism for all three was a crack opening at the back face of the unit. The effect of the angle was found to be less severe than initially anticipated due to its relative flexibility. It did still increase restraint on the unit though, as seen in Figure 6(b). The stiffness of the system was higher with an angle retrofit up until crack initiation at the back face of the unit occurred leading to a sudden loss of strength. The stiffness of the connection beyond yield of the starter bars in the retrofitted cases was also greater due to the increased restraint. This led to more cracking in the topping compared to the unretrofitted case as displayed in Figure 8, but it did not initiate a critical negative moment crack.

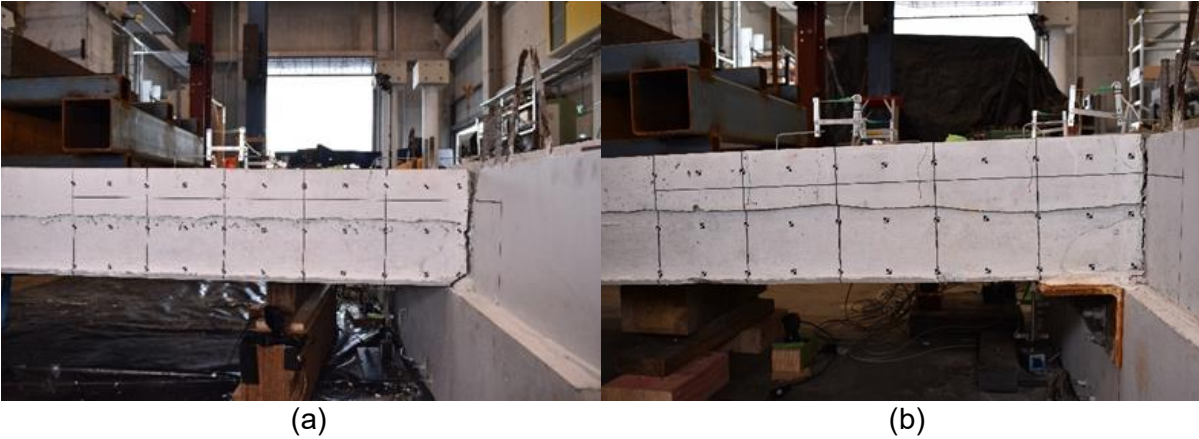
Figure 7: Specimen 1 Residual Crack After ±4.5% Drift (a), Specimen 2 at -2.75% Drift (b)...

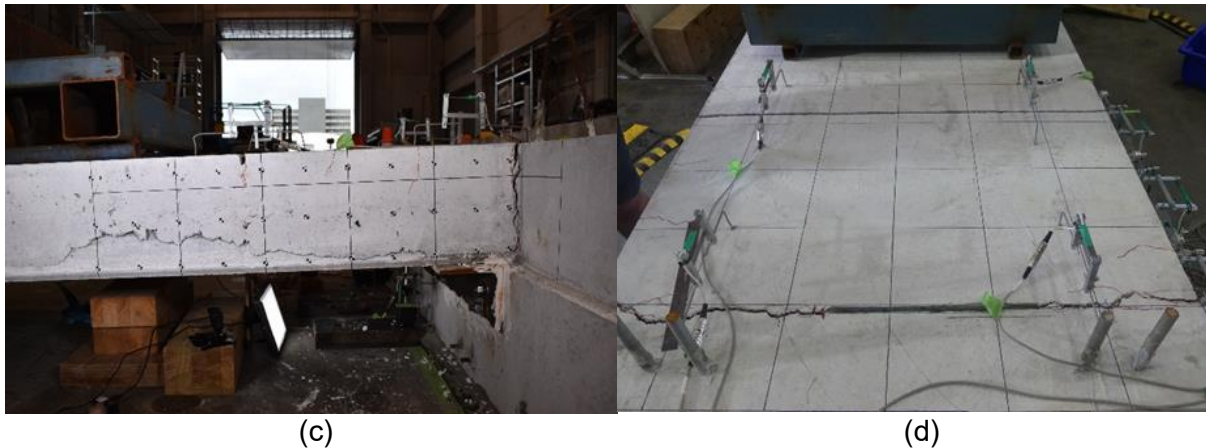
Figure 8: Specimen 3 at -3.5% Drift (c) and Specimen 3 Topping With Saw-Cut (d)

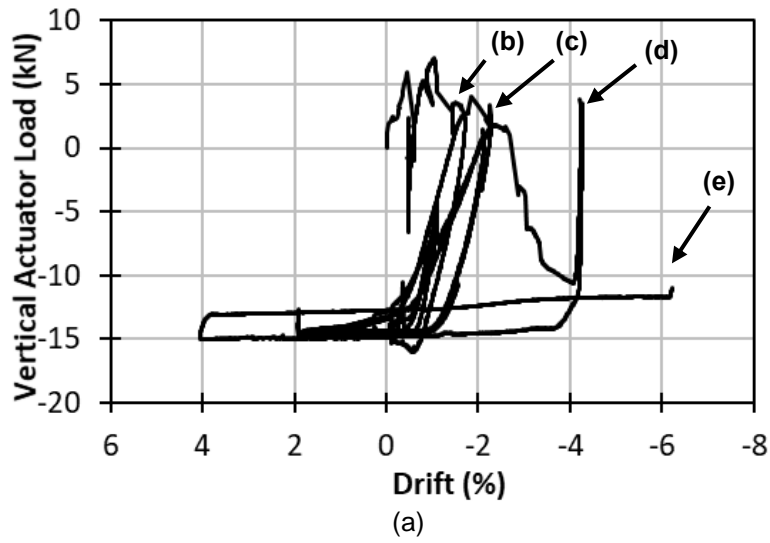
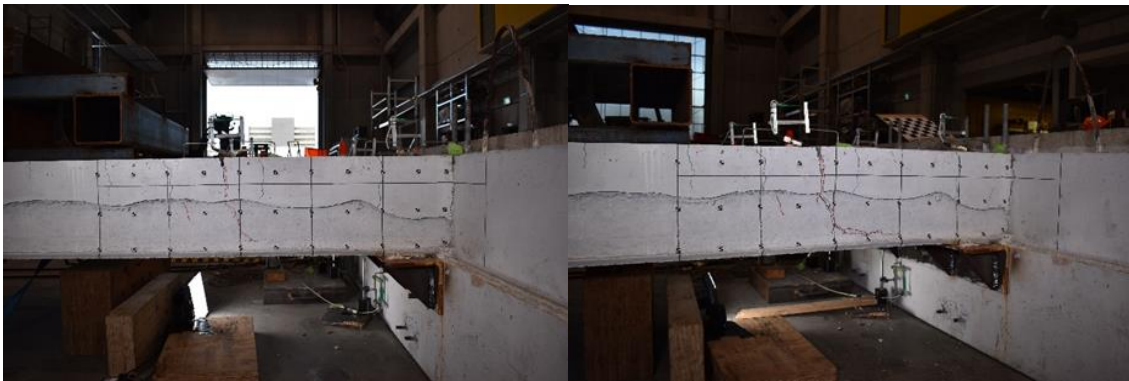
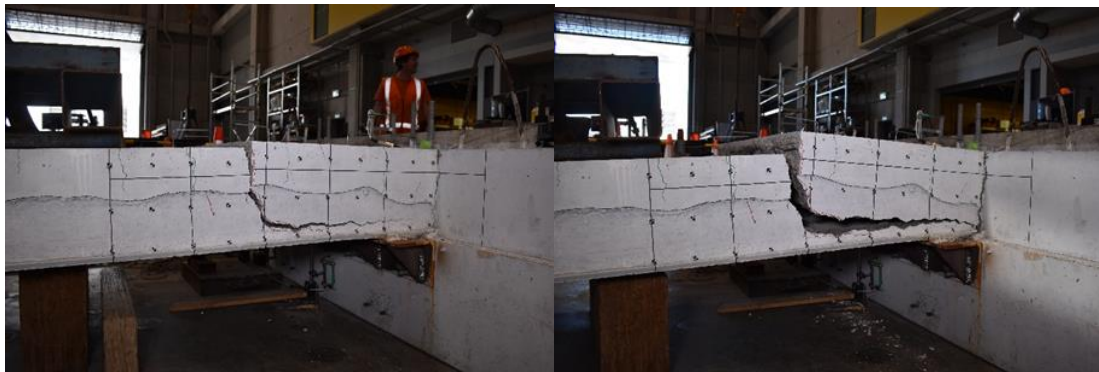
Figure 9: Test 4 Load-Drift Plot (a), Specimen 4 at -1.6% Drift (Directly After NM Crack Initiation at -1.0% Drift) (b), at -2.0% Drift (Crack Propagation Along Strands) (c), at -4.25% Drift (After Complete Loss of Stiffness upon reaching -2.25% Drift) (d) and at -6.0% Drift (e)

Specimen 4 used the same configuration as Specimen 3 except for the addition of five 12 mm thick stiffeners for the angle retrofit. This relatively extreme case for angle stiffness was used to further investigate the effect of angle retrofit stiffness on the performance of the seating connection while aiming to avoid NMF. Initial cracking occurred at the back-face of the unit at approximately -0.45% drift displacement. This caused an instant loss of stiffness and the unit dropped to -0.6% drift before picking up load again. Negative moment cracking occurred at -1.0% drift displacement. At this stage, the crack at the back face of the unit had opened to approximately 2 mm wide. The negative moment crack did not appear during loading, instead forming approximately 30 seconds after loading stopped. A loud cracking was heard and the unit lost stiffness, increasing the drift to -1.6% instantaneously. The unit at this stage of loading is displayed in Figure 9(b). This result was useful, because it showed that for negative moment cracking to occur, the crack at the back face of the unit needed to open first to sufficiently stress the starter bars to cause NMF. Note the peak load sustained by the seating connection before the sudden failure initiated was less than half of what was observed for the flexible angle cases, as shown in Figure 9(a). This suggests that angle retrofits much more flexible than used in this configuration but stiffer than a Grade 300 12x150x150 equal angle retrofit would also initiate NMF. This will require further investigation in parametric analyses. After this point, loading was continued up to -1.75% drift where it was confirmed that all additional deformation was now occurring at the negative moment crack instead of the unit back-face crack. The specimen was then returned to 0% displacement and a cyclic load protocol of was started. In the first 2.0% drift cycle, the negative moment crack had a sudden extension at -1.8% drift causing the unit to drop instantly to -2.15% drift, which is displayed in Figure 9(a) and (c). At this stage the crack reached the depth of the prestress strands and propagated along them half way to the angle support. A vertical offset of 3 mm was observed at the top of the unit across the NMF crack (initiated by the saw cut). This vertical offset can be considered failure of the unit. In the 3.0% drift cycle, the unit reached -2.25% drift before complete loss of stiffness occurred and the actuator supported end dropped. The wires of the topping mesh were heard snapping one after another as this occurred. The unit would have landed on the floor at the actuator end but was caught by dunnage placed under the unit near the actuator to avoid this. It was caught at -4.25% drift which is shown in Figure 9(a) and (d). Further cycling displayed that from this point on, the pieces of the unit on each side of the negative moment crack were completely separated and the unit was only being supported as a pinned connection by dowel action of the tension strands as shown in Figure 9(a) and (e).

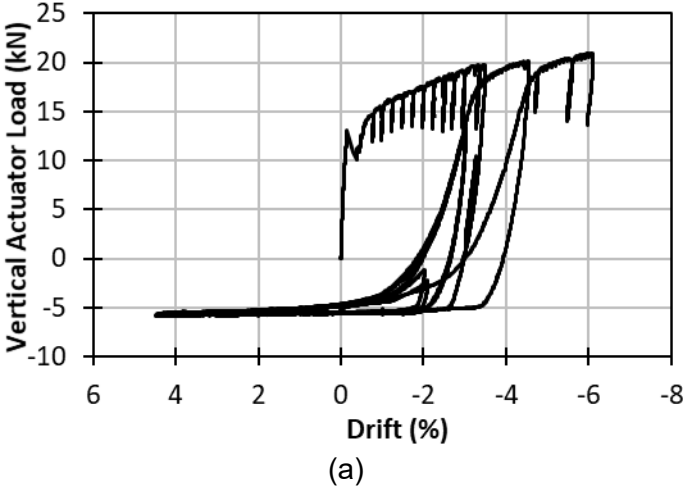
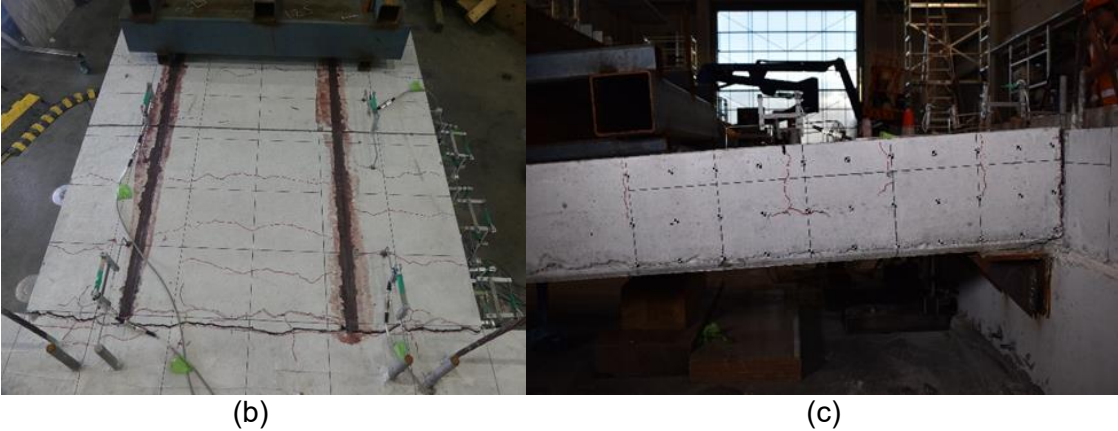
Figure 10: Test 5 Load-Drift Plot (a), Topping at -4.5% Drift (b) and at -6.0% Drift (c)

they propagated a short way for 0.25-0.75% drift then stopped after another section cracked. This repeated as the retrofit bars became engaged over more of their length until there were cracks across the full width of the unit topping at regular intervals of approximately 200-250 mm as shown in Figure 10(a). Overall, the top of the unit in the first 1-1.4 m from the back face behaved much more similarly to a beam in the plastic hinge zone than Specimen 4. On reaching approximately -2.25% drift, most of the damage stopped in the unit and concentrated at the back face instead. At -4.5% drift, some cracks developed in the epoxy over the NMF sawcut crack initiator. The NMF saw cut crack propagated a short way horizontally on both sides, but it was at the mid-height of the unit, as shown in Figure 10(c), in contrast to Test 4 where it propagated right down to the prestressing strands.

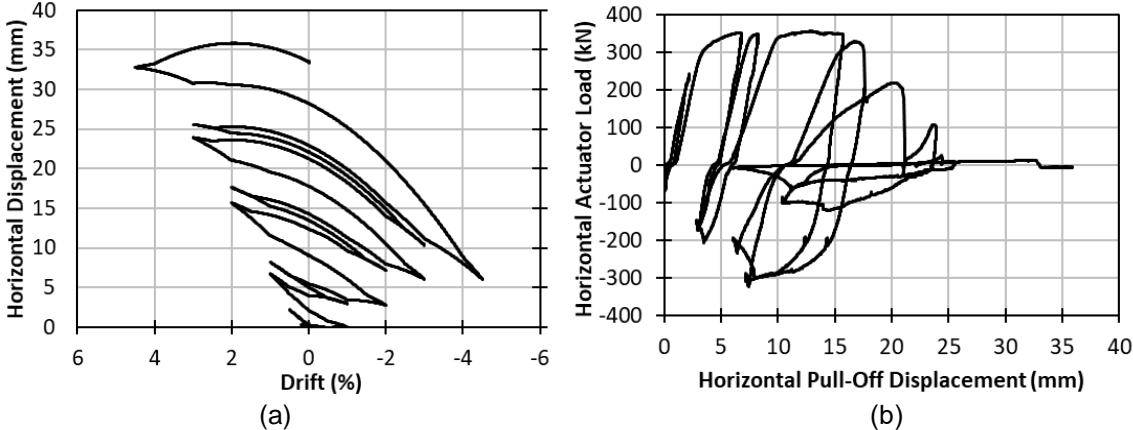
Figure 11: Test 6 Loading Protocol (a) and Horizontal Load-Displacement Plot (b)

Specimen 6 was used to test lowering the seating angle away from the unit soffit as a potential retrofit strategy to prevent the NMF triggered in Test 4. The aim of this retrofit was to remove the over-restraint of the unit while still providing additional seating in the form of a catch-frame to avoid LOS. To test the performance of the unit while falling from the ledge onto the seating angle and model the effects of beam elongation in a concrete frame building, tensile load was applied to the end of the unit through a horizontal actuator as shown in Figure 3. A 30 mm ledge was used because a smaller seating width is the critical case for LOS. An initial monotonic push was not appropriate for this test, so only a cyclic rotational loading protocol with elongation effects was used. The loading protocol and load-displacement plots for the test are displayed in Figure 11. Note the asymmetric applied elongation between positive and negative drift cycles. This was due to the unit only being a 200HC unit with a ledge relatively

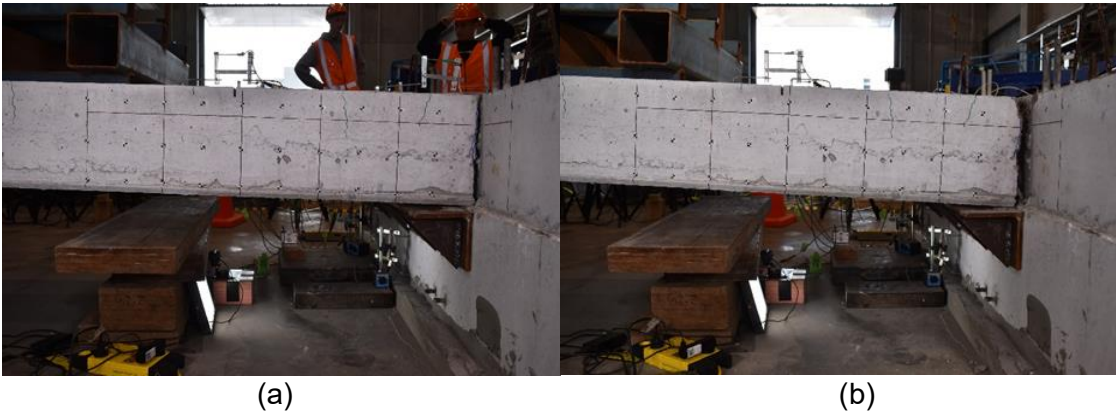
Figure 12: Specimen 6 at +3.0% Drift (25 mm Pull-Off) (a) and at +4.5% Drift (b)

high on the support beam. This meant the rotation component to LOS about the centroid of the support beam was more critical for positive drifts than negative. Initial cracking of the unit occurred as a full depth hairline crack at the back face of the unit in the first 0.5% drift cycle. Damage remained concentrated at this crack for the rest of the test. No further interesting damage occurred until the second 2.0% drift cycle. As the unit reached -2.0% drift, the middle starter bar ruptured, and the reaction and restraint of the seating connection greatly reduced as seen in Figure 11. In the first 3.0% drift cycle, the unit began dropping off the ledge support on the eastern side during the first +3.0% cycle as shown in Figure 12(a). The outer starter bar on the eastern side of the specimen also ruptured as the unit was approaching -3.0% drift. Only having one remaining point of connection between the hollowcore unit and beam section (that was off-centre in plan) changed the structural system of the experiment. To allow the completion of the test up to a cycle at 4.5% drift with complete LOS of the unit, the final starter bar was manually cut. The 4.5% drift cycle was completed with the unit completely supported by the angle. There was no indication of restraint against the beam ledge or cracking occurring away from the support as shown in Figure 12(b).
