ASBA TECHNICAL MEETING & TRADE SHOW  
DECEMBER 3-6, 2024 | ORLANDO, FLORIDA

# *Performing and Communicating an Asphalt Inspection for Running Tracks*

Troy Rudolph CTB, CFB, CTCB / President at Elite Sports Builders

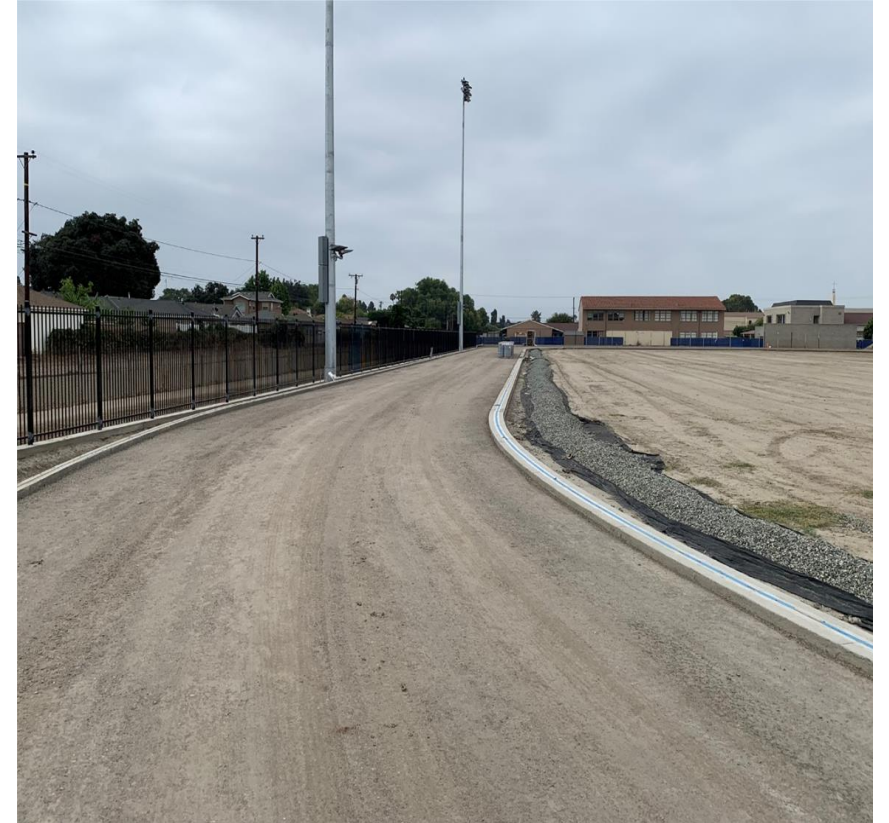
# DESIGNER QUALITY CONTROL PRIOR TO PAVING

- Submittals for asphalt mix and aggregate to meet the design specifications reviewed by the engineer or architect and approved by the owner.
- Conformance surveys and verification of curb elevations (as built) reviewed by the engineer or architect and approved by the owner.
- Some projects require string line and or conformance survey of the subgrade and stone base. This may be more common for a rolled goods type surface or high-level competition tracks.

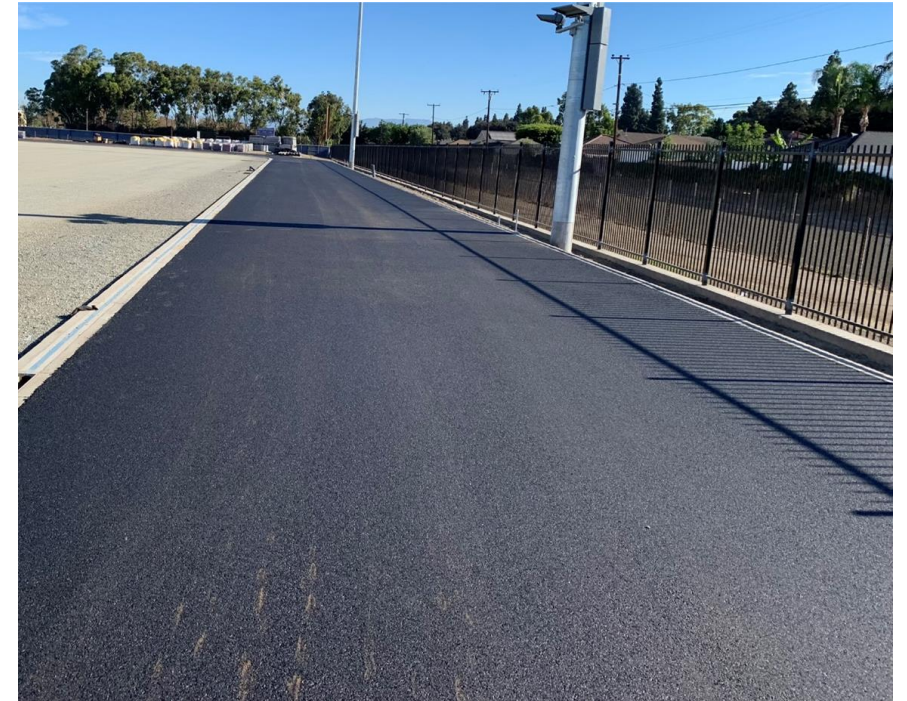
# DESIGNER VISUAL OBSERVATIONS PRIOR TO FLOOD TEST

- Smooth consistent sheen with specified aggregate size.
- Seams and edges flush and smooth
- No loose, uncompacted, or unconfined aggregate
- Clean saw cuts and patch back to existing asphalt where applicable
- Review site with the plans and confirm grades & grade breaks are per plan
- 10' straight edge at designated intervals per the engineer's specifications with tolerance of 1/4". Some specifications or applications may require less deviation under the straight edge.

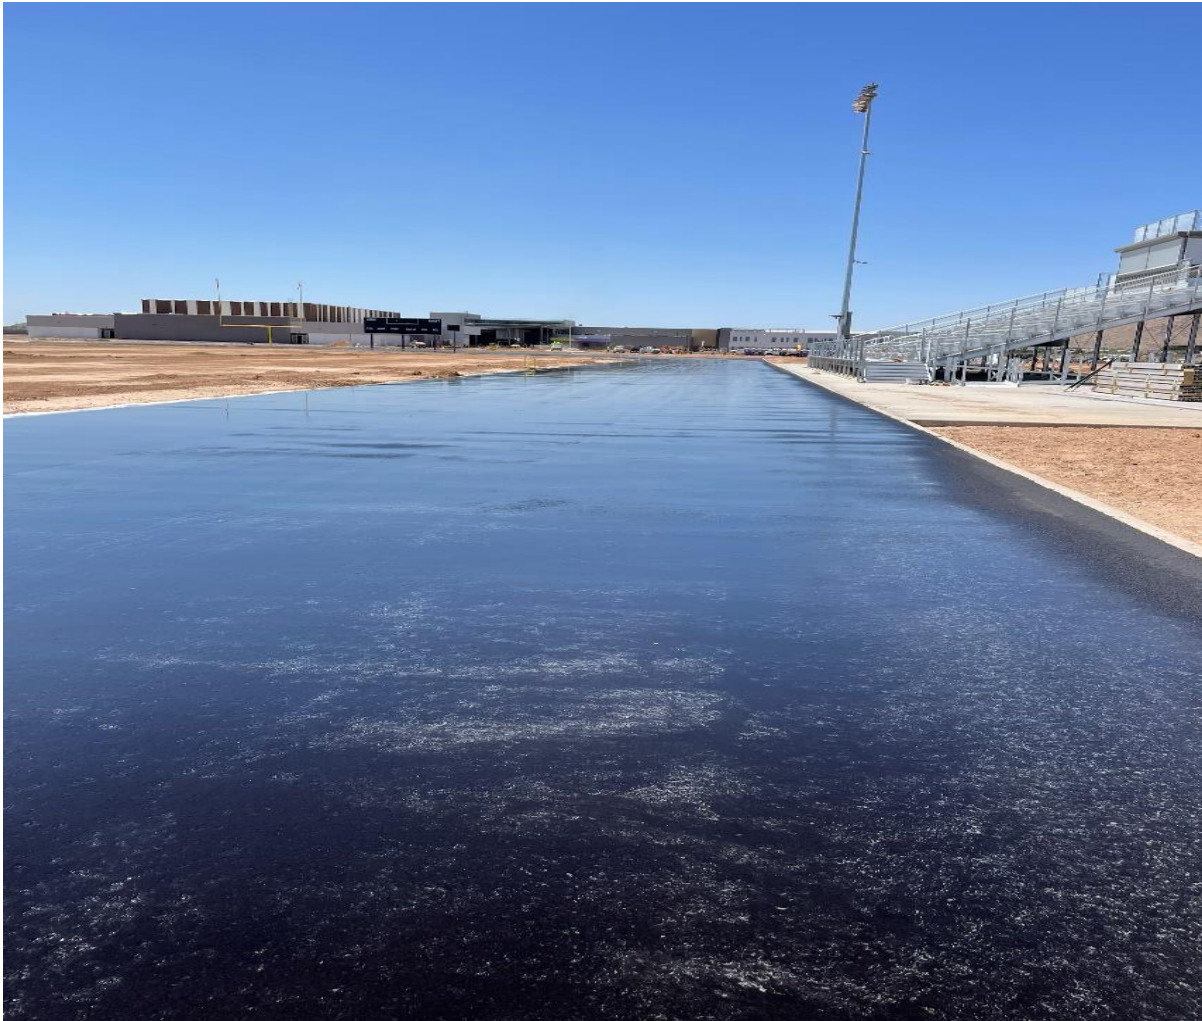
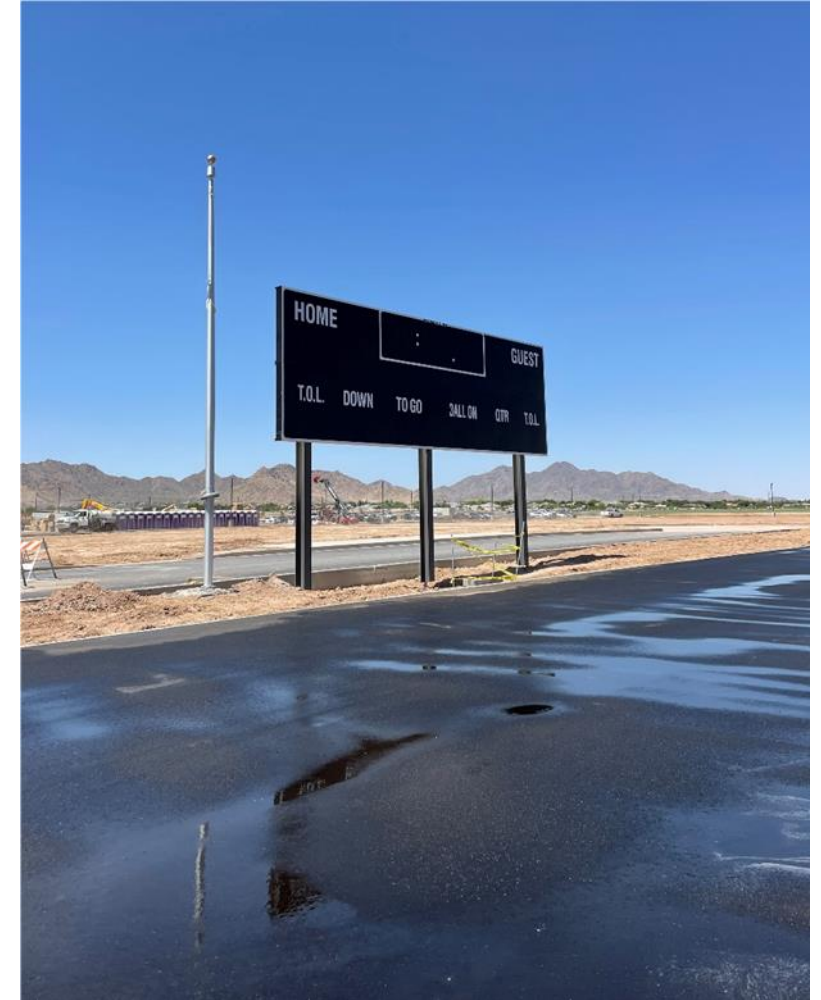
# DESIGNER FLOOD TESTS

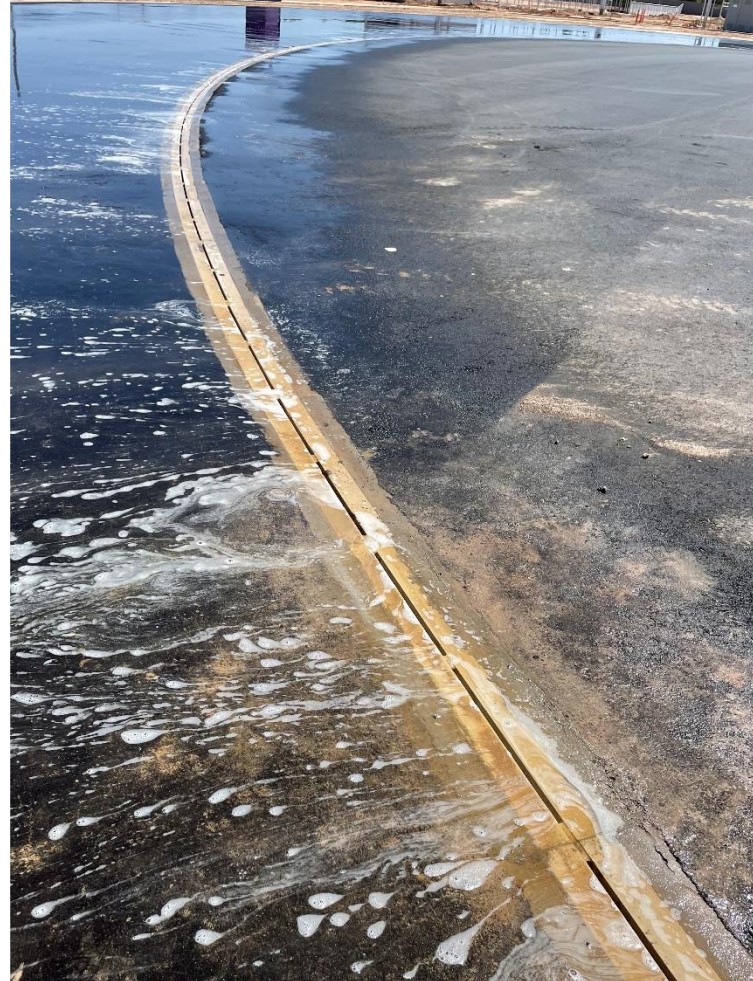
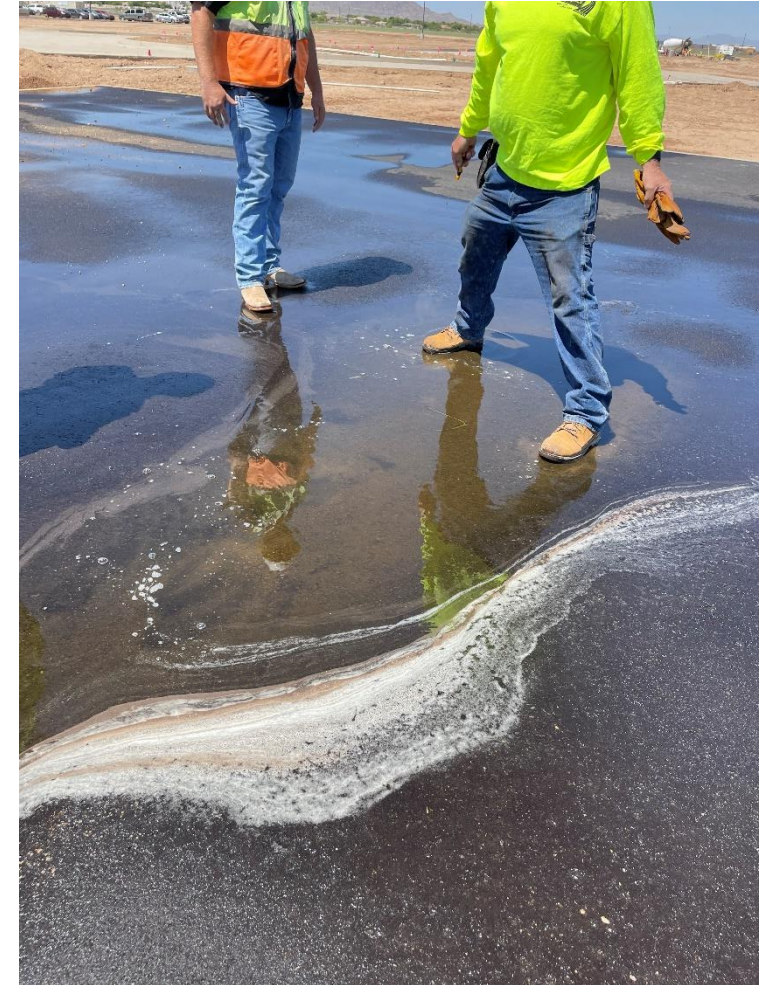
# DESIGNER FLOOD TESTS

- Water flowing to drains or pervious surfaces per plans.
- Slot & Trench drains flush and performing properly.

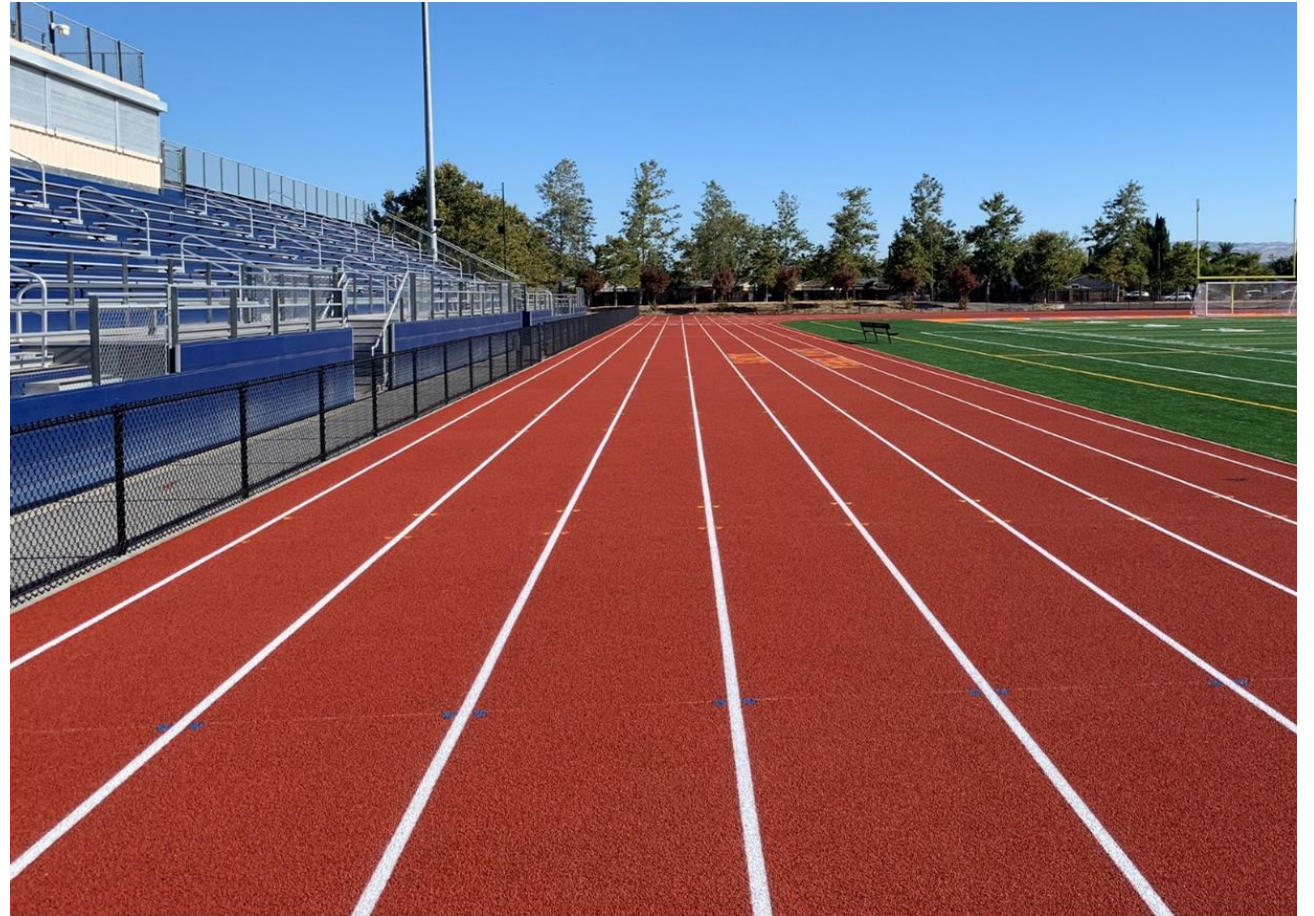
# DESIGNER FINAL ACCEPTANCE

- Engineer or architect provides field report for items to address or not exceptions taken
- Acceptance by the synthetic track surfacing manufacturer/installer that the asphalt surface meets the manufacturer requirements for installation of the track surface

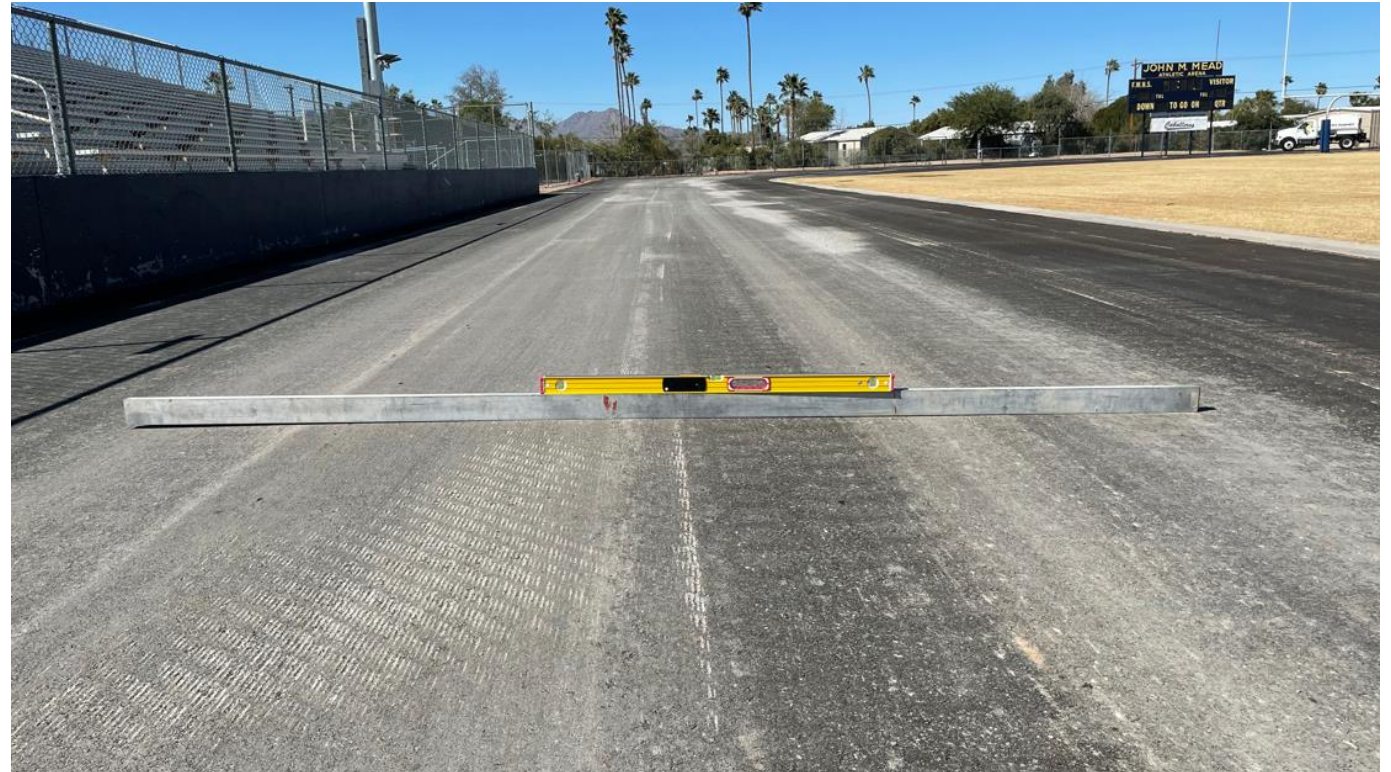
# Certified Track Builder Inspections – Straight Edge Test

- Use a 10' straight edge to check for variations exceeding  $\frac{1}{4}$ " in 10'. This includes high and low areas.
- Measure the variance using a measuring wedge, tape measure or other appropriately accurate measuring tool.
- Mark the area using marking paint, wax Crayola or other marking tool to clearly identify the extent and location of the concern area.
- Use photographs to document the measuring of the deficient area.
- A smart level can be helpful in determining slope of the asphalt section being tested.

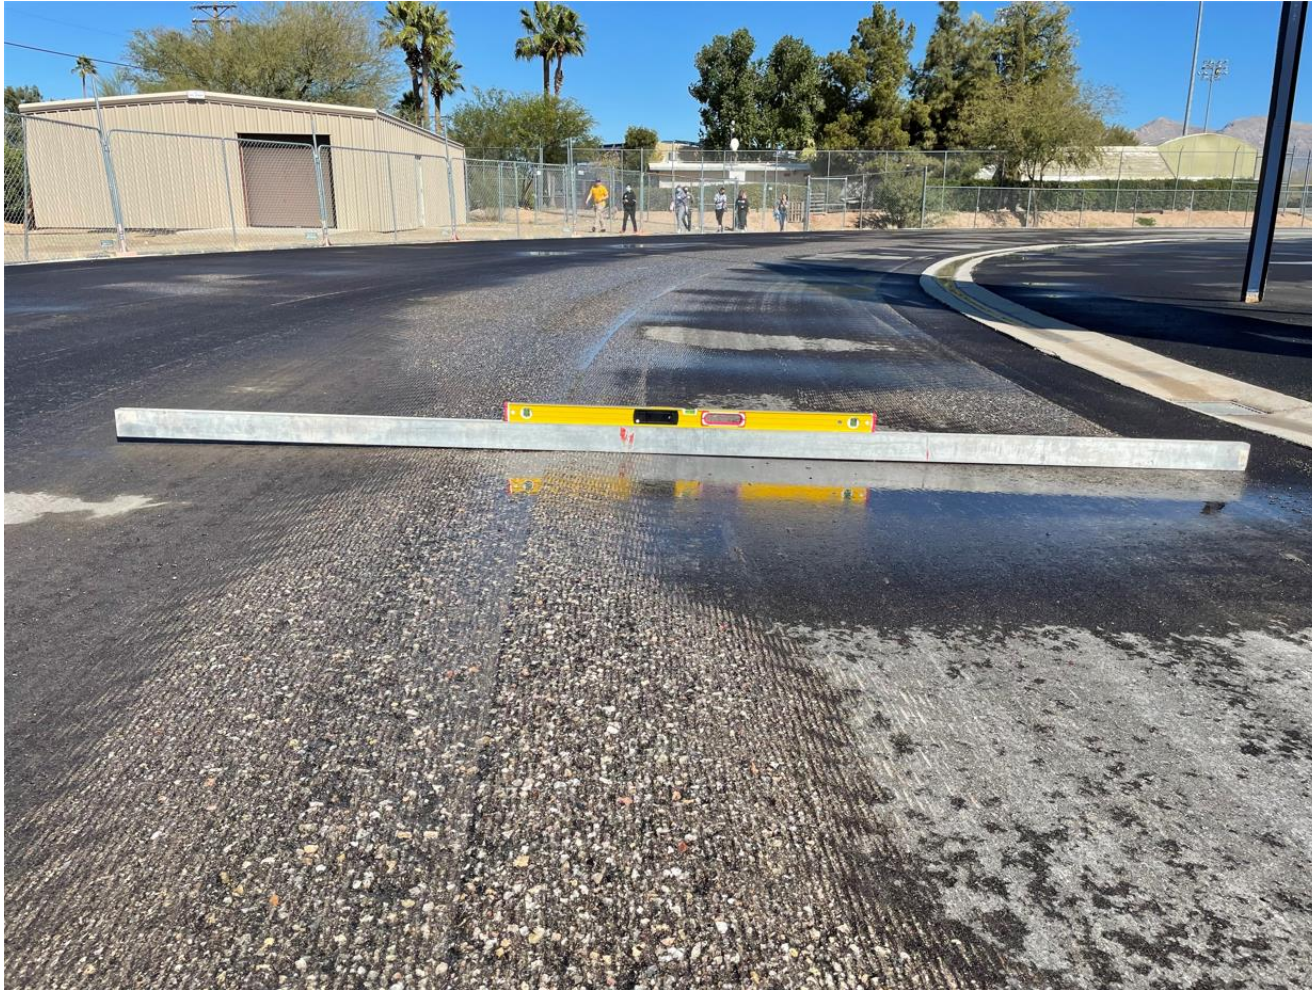
# Certified Track Builder Inspections – Straight Edge Test

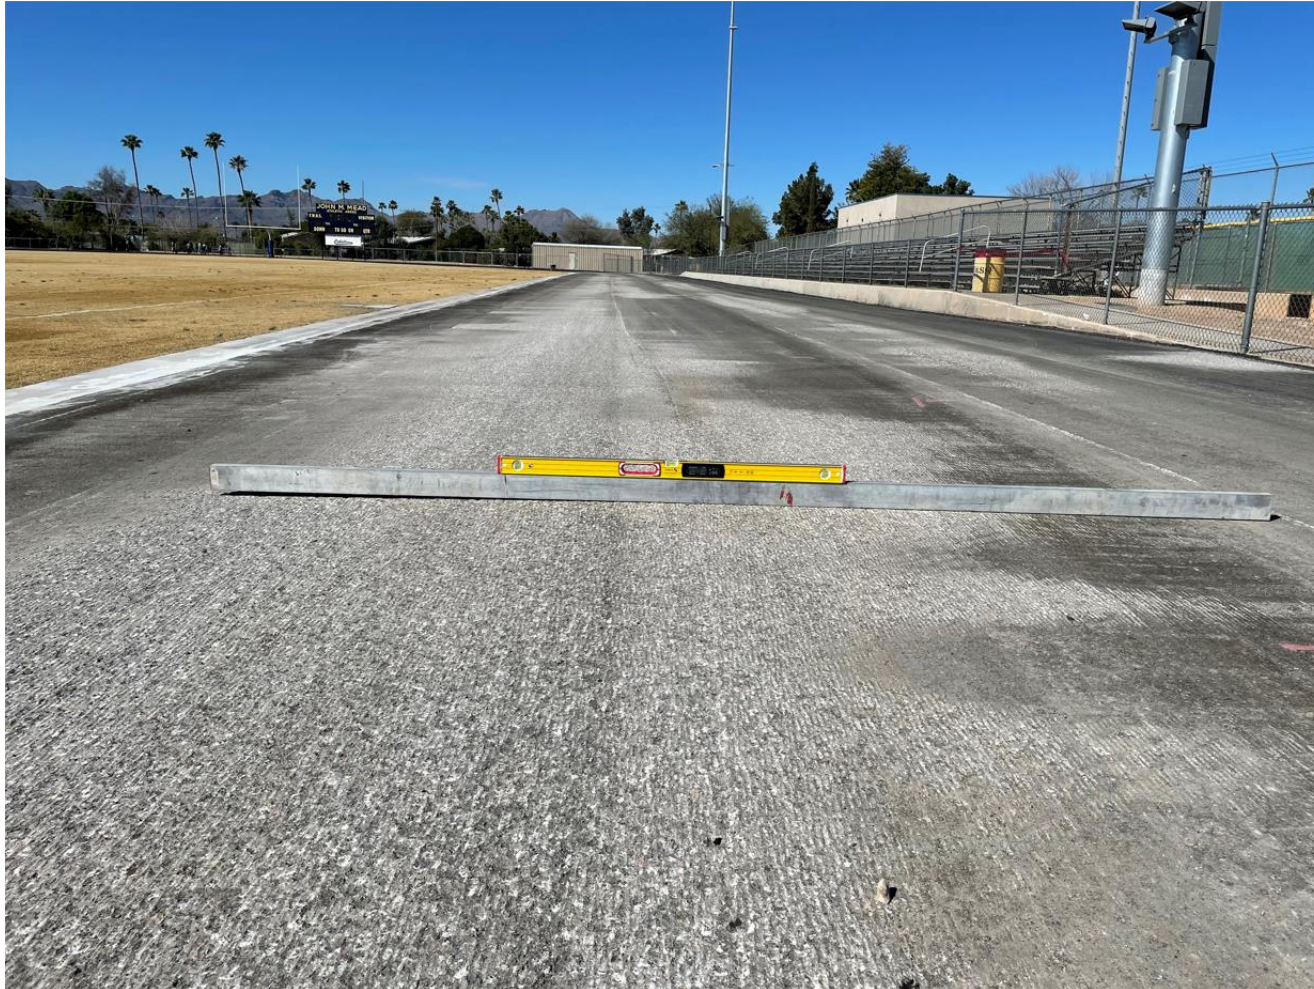
# Certified Track Builder Inspections – Straight Edge Test

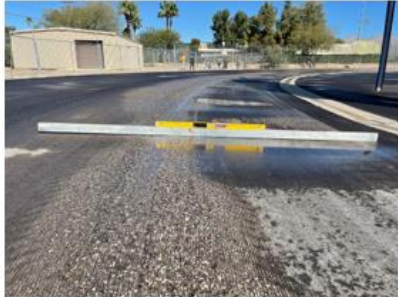
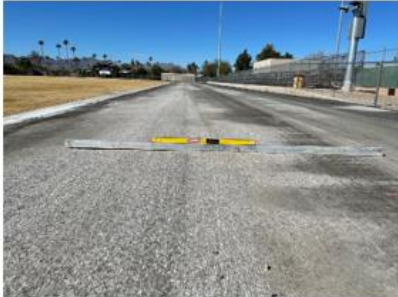
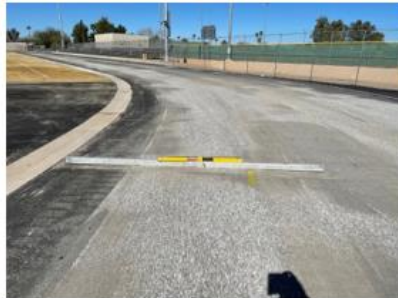
The following are a couple of pictures that show a sampling of the conditions described above.

Following the visual inspection, I performed a basic planarity check utilized a 10' straight edge with smart level attached placed upon the asphalt pavement multiple directions and areas. It was quickly identified that the paving pass joints remain substantially uneven with "ridge" type peaks that exceed .4" under a straight edge. A sampling of these areas was marked with yellow paint around the track oval for your examination, with the paint marking at approximately the high point of the paving seam. This condition well exceeds the ASBA's tolerance of ¼" in 10' when measured in any direction.

It was also observed that there are inconsistencies in the asphalt pavement in the lateral or traveling direction of the paving pass as well. A 10' straightedge was placed and relocated across the entire width of the track paving to examine the overall planarity of the asphalt pavement in the lateral direction.

- The asphalt pavement should be level with the concrete valley gutter and curbing that border the pavement to provide positive drainage of water from the asphalt and track surfacing system. It should be noted that this condition was being substantially corrected by grinding the concrete valley gutter flush with the asphalt pavement.
