THE EFFECT OF WINDOW-WALL INTERFACE DETAILS ON WINDOW CONDENSATION POTENTIAL

W. Maref¹, N. Van Den Bossche², M. Armstrong¹, M.A. Lacasse¹, H. Elmahdy¹ and R. Glazer¹

1-National Research Council Canada, Institute for Research in Construction, Ottawa, ON, Canada

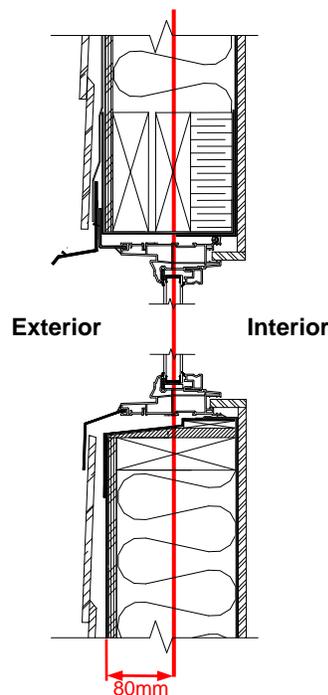
Figure 1. Installation detail for box window

The nominal size of the test frame incorporating the wall-window interface was 1.22-m wide by 2.44-m high, and framed with 51 by 152-mm Spruce-Pine-Fir lumber. The test assembly was intended to be representative of typical North American wood frame construction practice. The exterior cladding of the assembly was hardboard wood composite siding, installed in accordance with current building practice, and directly to the sheathing membrane (Weather Resistant Barrier-WRB-spun bonded polyolefin). The membrane overlays an oriented strand board (OSB; 11-mm) wood sheathing panel affixed over the wood frame. Glass fibre batt type insulation was placed in the stud cavities adjacent to the window opening and the interior finish was gypsum board (12.7-mm). A fixed (non-operable) non-flanged PVC window (610-mm by 1220-mm) was centered vertically within the specimen. The window was installed with the glazing aligned with the plane of thermal resistance of the wall. Figure 1 provides installation details of a box window incorporating pan flashing, sloped sill, up-stand and related details that help promote drainage of water from the windowsill if subjected to inadvertent water entry. Figure 1 shows the location of the plane of thermal resistance of the wall in relation to that of a box window installed along the same plane.

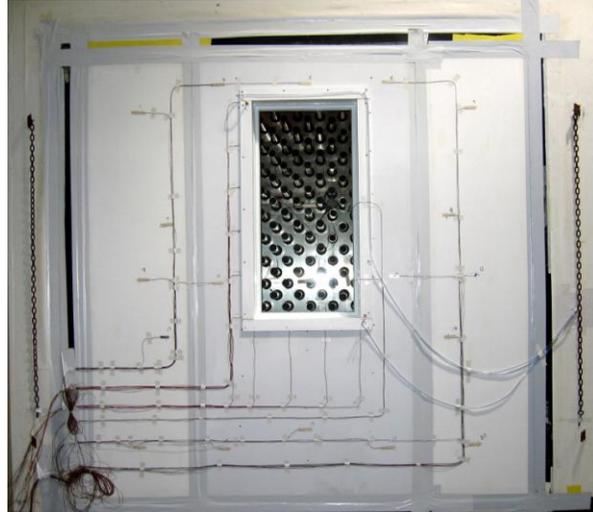
Figure 2. Instrumentation of the sample in the guarded hot-box with thermocouples and pressure sensors.

To analyze the effect of different installation methods, the space between the window frame and wood frame wall was left empty (Test set 1), was filled with glass fibre insulation (Test set 2) or spray-in-place polyurethane foam (SPF) (Test set 3). Finally, given the interest in using installation details that included a sill pan, thought was given to possible paths of air leakage through the assembly at the sill and the type of deficiencies that might arise at these locations due to improper installation of components or premature failure of seal components. The introduction of two deficiencies at the wall-window interface provided a means to evaluate whether air leakage across different components of the window assembly caused condensation to form on the warm side of the wall assembly when leakage was induced in the test assembly. A first deficiency was located at the exterior of the wall-window interface and at the juncture of the cladding and window frame at the lower extreme corner of the window, whereas the second one was situated at the interior of the assembly at the interface between the window frame and the interior finish but located at the upper most and opposite corner of the window assembly.

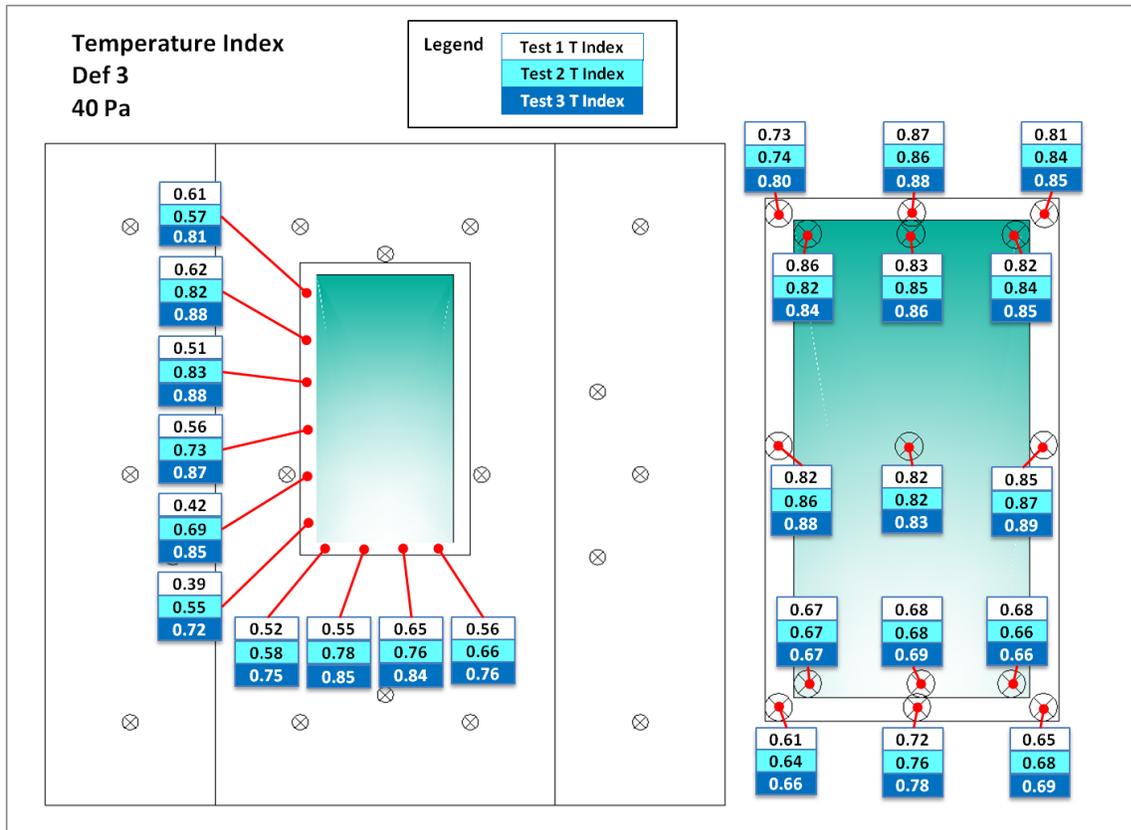
Figure 3. temperature index in the window-wall cavity and at the interior surface of the window.

For each of the three installation methods, tests were done with and without deficiencies, at 0Pa, 20Pa and 40Pa, which renders a total of 18 tests. This section only reports and analyses the results of a 3 tests: the three installation methods are compared for the situation where a pressure difference is applied and deficiencies are present (figure 3).

The figure clearly indicates that the interior surface temperature of the IGU is very similar for the different installation methods. Due to thermal stratification in the cavity of the IGU, the lowest temperature indexes can be found at the window sill, and the spacer of the IGU causes an additional temperature drop which is most pronounced in the corners. In general, the surface temperature of the IGU proved to be insensitive for the installation method, the presence of deficiencies, as the pressure difference over the sample.

The surface temperature of the window frame is more affected by the cold air drawn into the construction due to the pressure difference. Again, the lowest temperatures can be found at the sill, but the installation with SPF results in surface temperatures which are significantly higher compared to those for installation without insulation. The use of mineral fibre reduces the effect of air flows through the construction but cannot block it completely. It should be noted that the analyses shows two major pathways for air flows: first of all along the deficiencies introduced at the window-wall interface, but secondly – and more surprisingly – there were air flows through the window frame itself which had a significant effect on the surface temperatures of the frame. A closer examination of several samples of the window typology used in this study revealed imperfections at the mitre joint of the welded vinyl frame. The mitre joint was chamfered after welding, but in some instances it apparently was cut off, thereby revealing a small opening (slit) at the exterior corners of the window frame. As well it was observed that at the top and bottom side of the window there were minor perforations caused by staples; these staples were used to secure the wood protection strapping in place during transport of windows. It was also evident that there were no weep holes at the bottom side of the window (contrary to good practice). In general the windows were poorly fabricated and several deficiencies were present in the frame specifically at the corners both inside and outside. These deficiencies rendered it possible for

Finally, the temperature index in the interface between the frame and wood frame wall was also recorded. At the jamb, a vertical gradient was recorded for all configurations, with and without pressure difference. Figure 3 clearly shows that the temperatures rises going from no insulation over mineral fibre to SPF, whereas the thermal gradient declines. Very low temperature indexes are evident for the installation without insulation, where the cavity is open to the outside by way of the drainage opening between the window sill and subsill, and the deficiencies introduced in the corners. Although this solution promotes the evacuation of rain water that might infiltrate, the installation without insulation is sensitive to a temperature drop when a pressure difference is applied. For more details see Maref (Maref & al, 2011).
