Technology REPORT

Technology Advancements & Gaps in Underground Safety | 2020

Released, May 2020

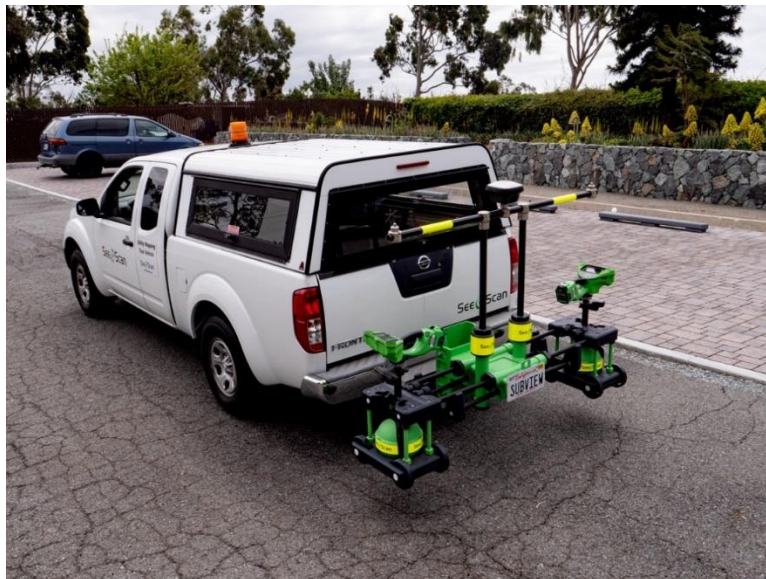
Figure 1—Geolocating receivers mounted to a custom vehicle hitch.

The geolocating receiver includes advanced motion processing that enables a user to passively⁴ locate utilities while driving a vehicle. This allows for a fast way to identify multiple utilities in an area without having to disrupt traffic. Operators can mount two geolocating receivers to a custom vehicle hitch. A survey grade global navigation satellite system (GNSS) instrument between the receivers logs positional data while the vehicle is in motion.

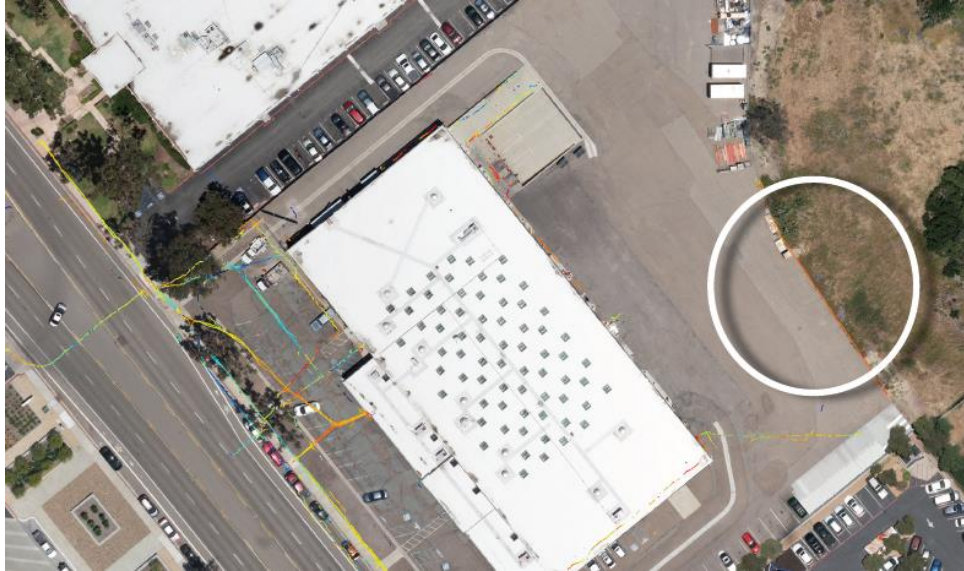
Figure 4—The map data in SubView shows multiple distinct utilities throughout the front and back parking lots. A line running along the canyon edge reveals a separate utility energized via signal bleed.

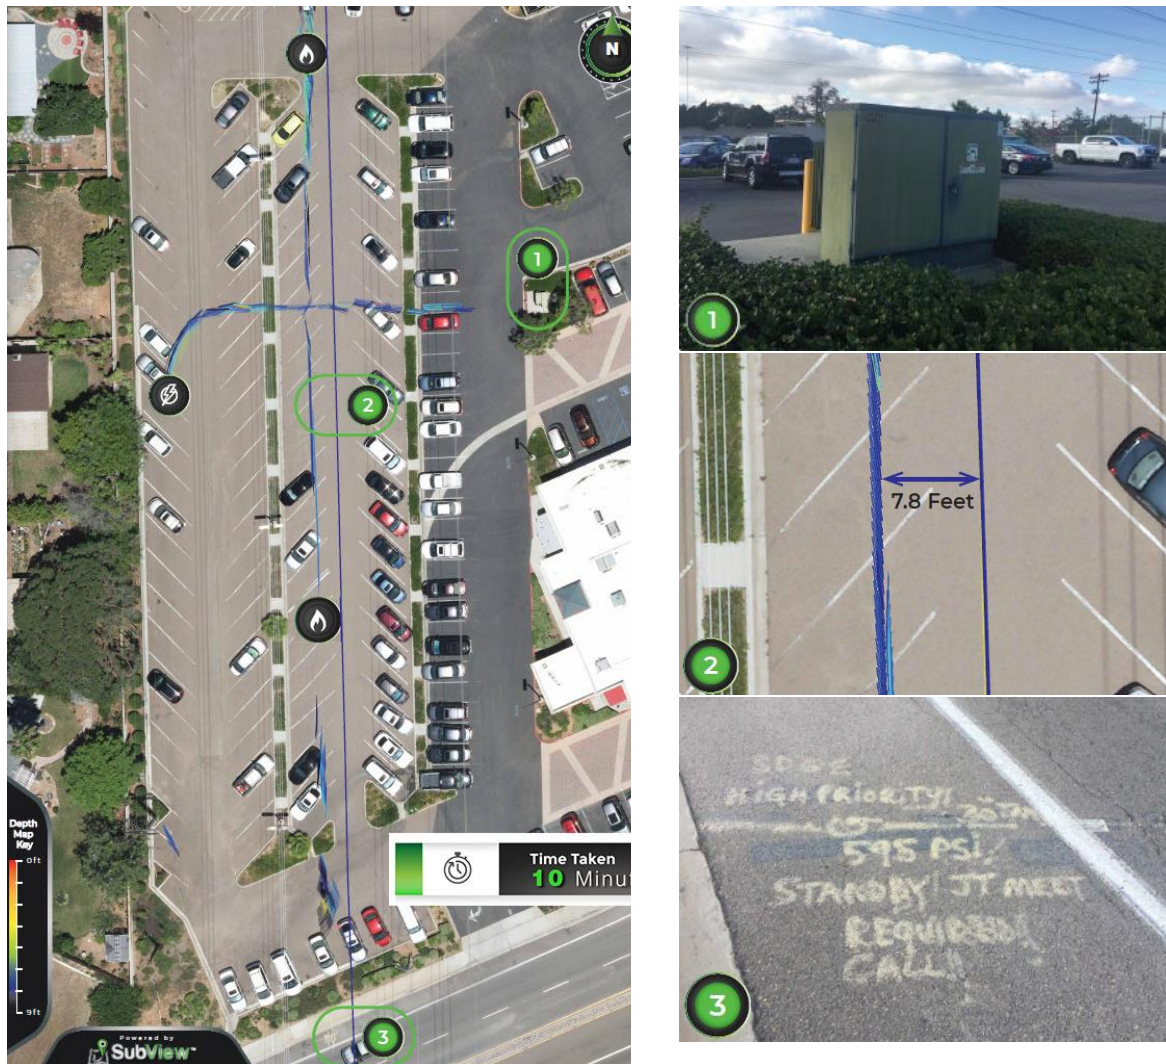
Figure 5—The map in SubView reveals a shallow electrical line that crosses over the pipeline (1). The transmission pipeline lies approximately 7.8 ft to the west of the position in the SDG&E map (2). The pipeline's location lines up with paint markings in the street from a recent locate (3).

The locate map in SubView reveals the location of the SDG&E transmission pipeline at 7.8 ft (2.4 m) west from its indicated position on the pipeline map, well outside of the utility's tolerance zone.⁶ The depth is approximately 7 ft (2.1 m); no depth information is available on the pipeline map. The utility's estimated position in SubView lines up with paint markings in the street from a locate performed by SDG&E.

Data gathered from the receiver shows an additional buried utility that crosses over the pipeline, which terminates at an electrical box, indicating an electrical line.

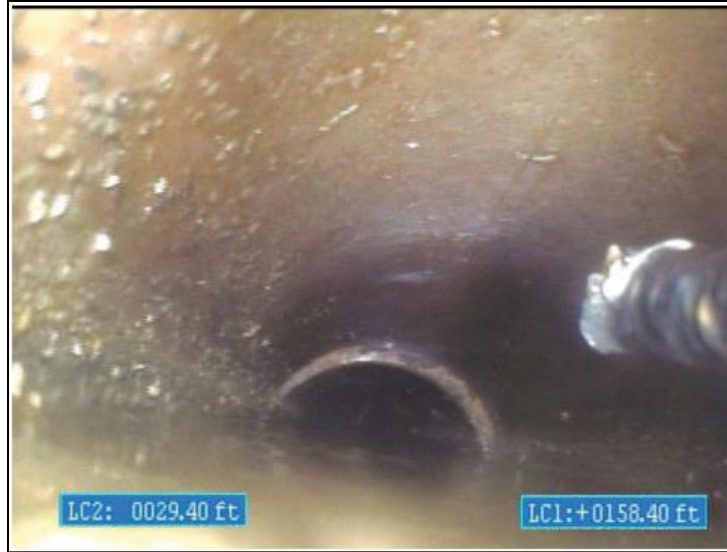
Figure 6—Example of water at the base of the interior of a sewer lateral as viewed by an inspection crew's camera.

Water obstructions (Figure 6) generally occur when there are sags or small obstructions within the sewer lateral. The ability to see below the water line is required to confirm that no cross bore is present. If the water could be extracted, then the optical cameras would be able to take imagery of the lower half of the sewer lateral, allowing for confirmation of the presence or non-presence of a cross bore.

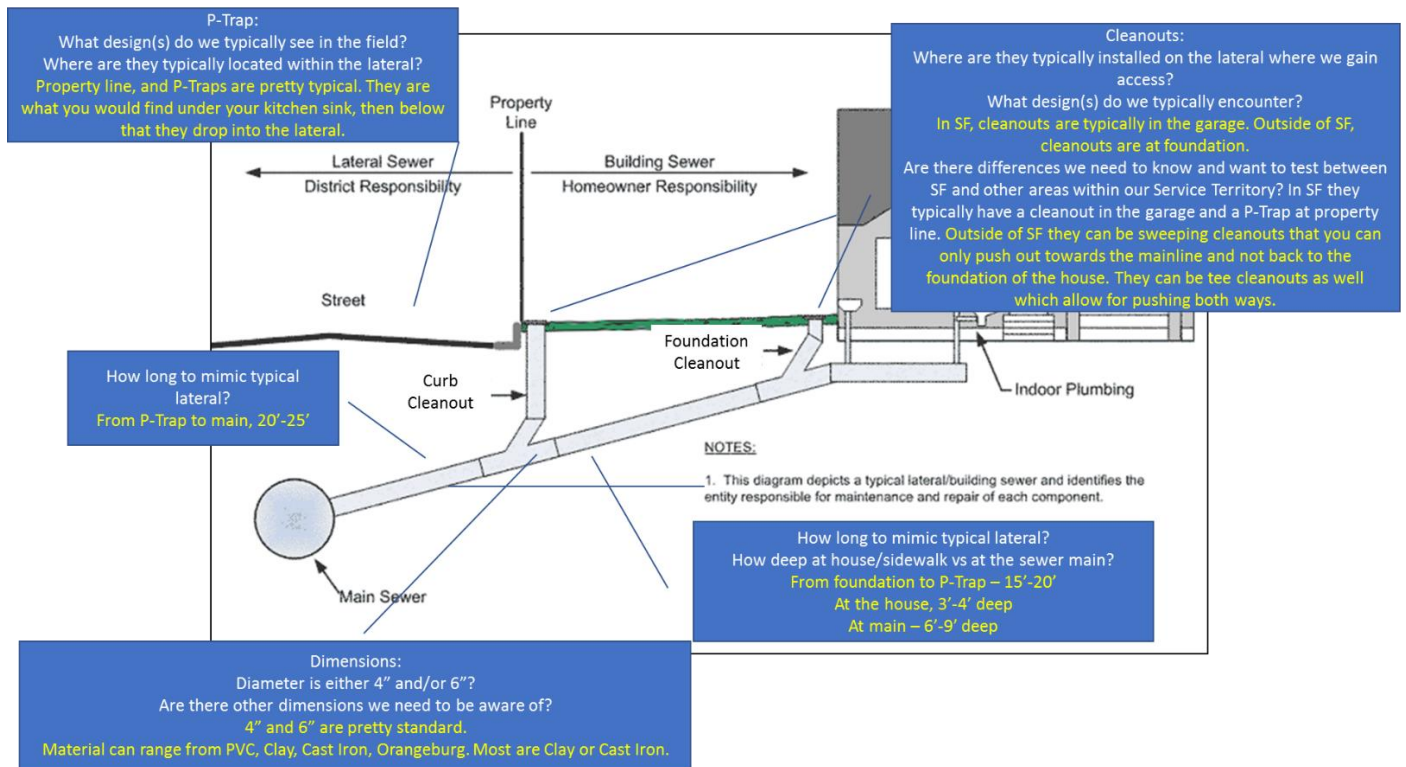
Figure 7—Generalized sewer lateral with questions (white text) and Cross Bore Program responses (yellow text).

snagging, and maximum allowable diameter to manage small spaces. In addition to field visits, ServPro solicited information from PG&E’s Cross Bore Program personnel (Figure 7).

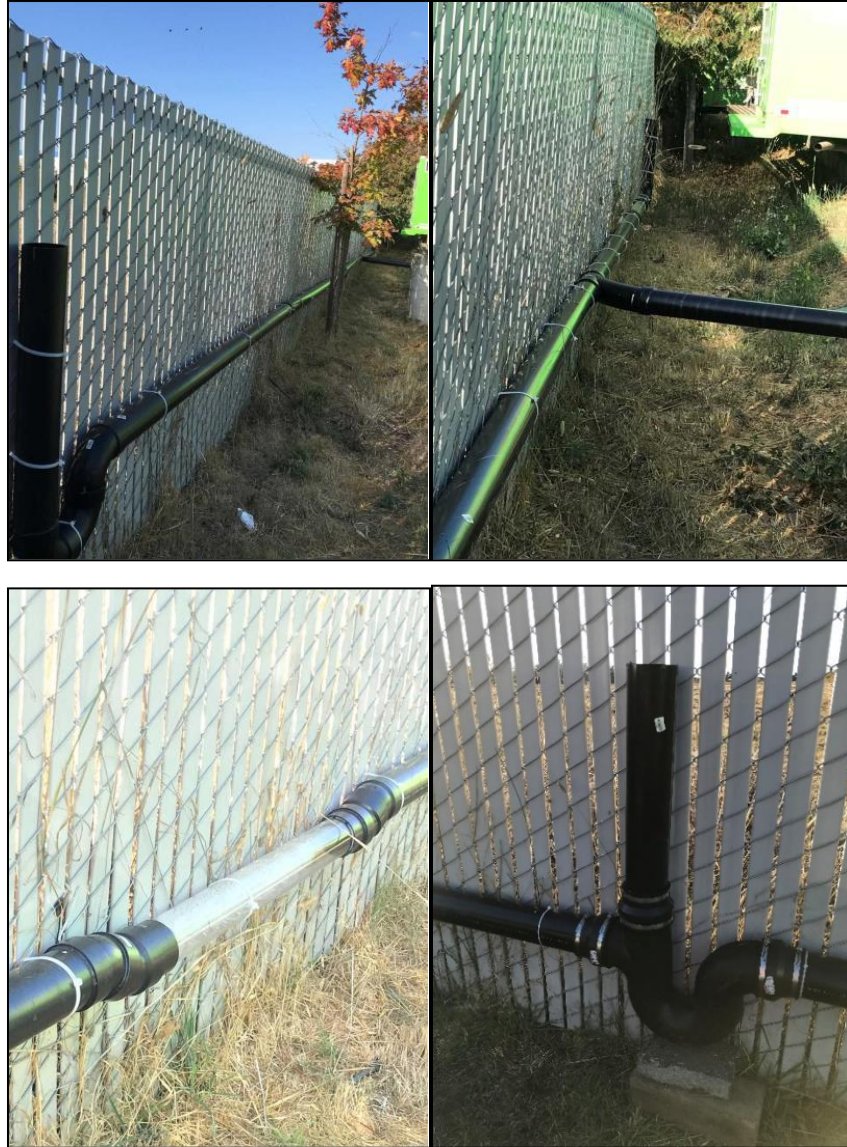
*Figure 8 (clockwise)— Foundation access.
 Branch in sewer lateral.
 Curb access with p-trap.
 Sag in sewer lateral using clear PVC for viewing water extraction
 in progress.*

ServPro built a sewer lateral prop for testing the WET at its local headquarters in Cotati, CA. The testing prop was constructed of 4-in.-diameter PVC and was 53 ft in length. The testing prop included foundation and curb clean outs, a sag, and a branch. Water was fed into the system to simulate partial or fully flooded water obstruction (Figure 8).

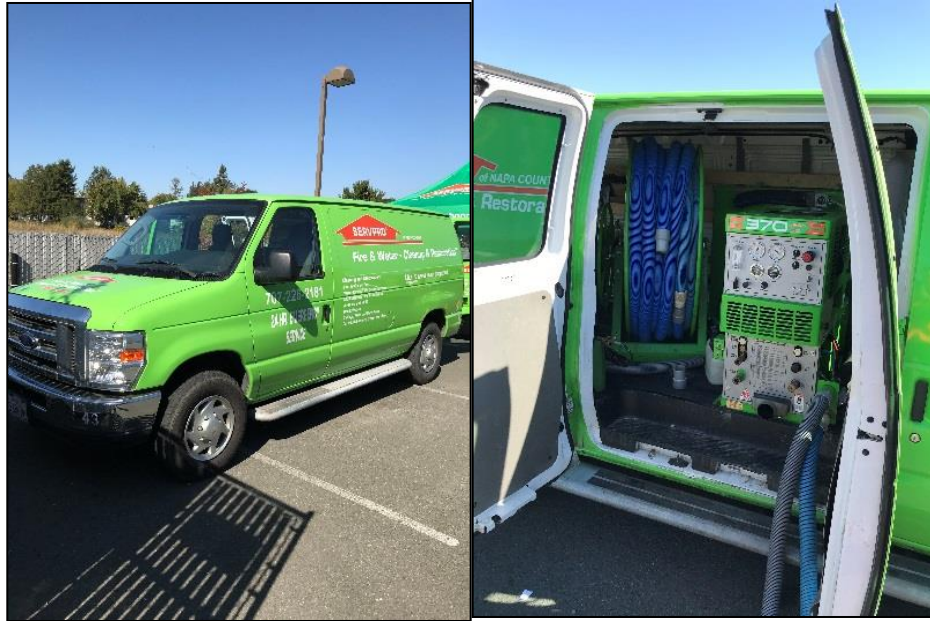
Figure 9 (left-right)—ServPro van and the interior showing vacuum hose and pumping system. Water storage tank (not pictured) is directly behind the pump.

ServPro already has existing pumping capabilities built into its fleet vehicles to support its core business. Additionally, ServPro has existing arrangements for disposal of waste (black) water per state and federal requirements. The project utilized their existing system installed into a standard van (Figure 9).

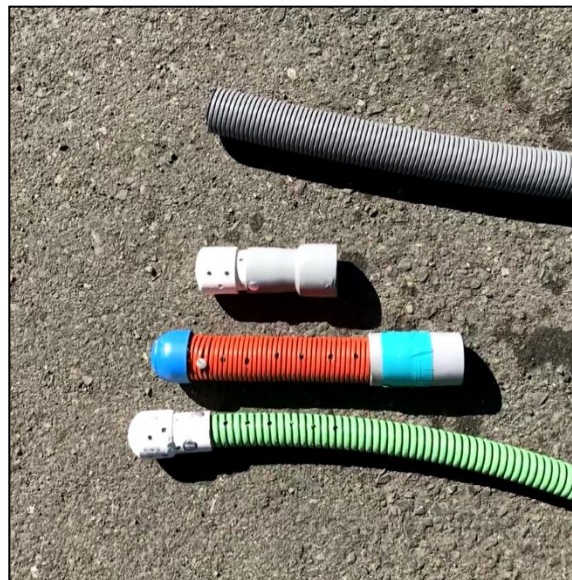
Figure 10—Hoses and tips used during initial testing. Perforations can be seen on the hoses.

A variety of hose types, sizes, and tips were developed and tested. Hose sizes included 1-in., 1.25-in., and 1.5-in. diameter. All hoses were 50 ft in length and could be connected if longer distances were required. Hoses were perforated to allow water to be extracted while the hose lay on the inside surface of a sewer lateral. Tips were designed to prevent larger objects such as rocks and gravel from clogging the hose. Figure 10 shows the hoses and tips.

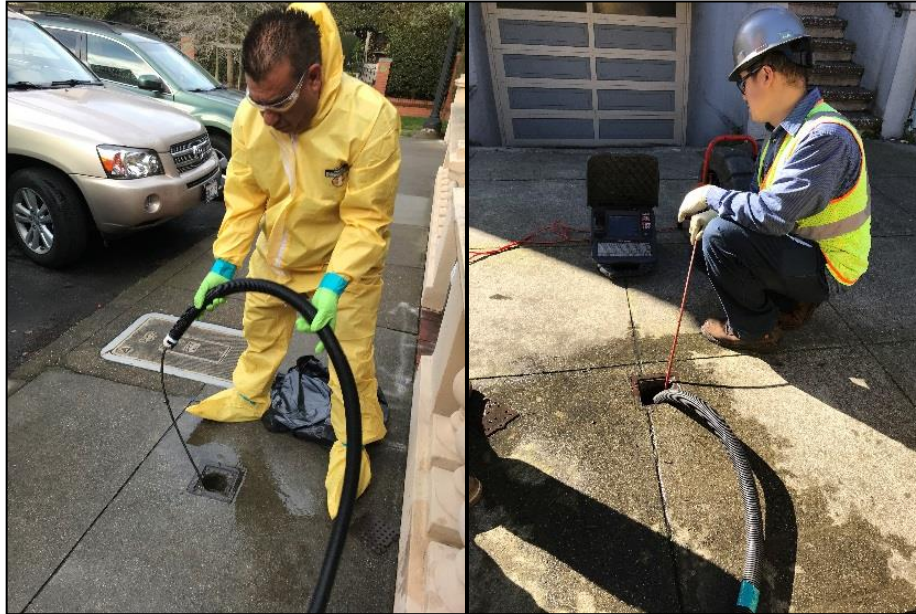
Figure 13 (left-right)— Plumber’s snake modification to the hose to assist with p-trap navigation. Water extraction and camera inspection occurring simultaneously at a multifamily complex.

Generally, the WET navigated the p-trap with little or minimal effort. Following testing at its Cotati HQ and from prior field experience, ServPro had developed an adaptation of the hose that included the assistance of a plumbing snake (Figure 13). This adaptation was developed to assist with navigation of the p-trap. Additionally, during testing the snake was able to gently loosen sand and gravel that had accumulated within the sewer lateral, making extraction possible and increasing the utility of WET. In

two instances, the WET was used to extract water simultaneously while conducting the camera inspection. In one such instance at a multifamily complex, the water needed to be extracted continuously because water usage in the building was continuous and obscured the inspection camera (Figure 13). Ultimately, the sewer lateral inspector conducted a successful inspection of the sewer lateral and determined no cross bore was present.

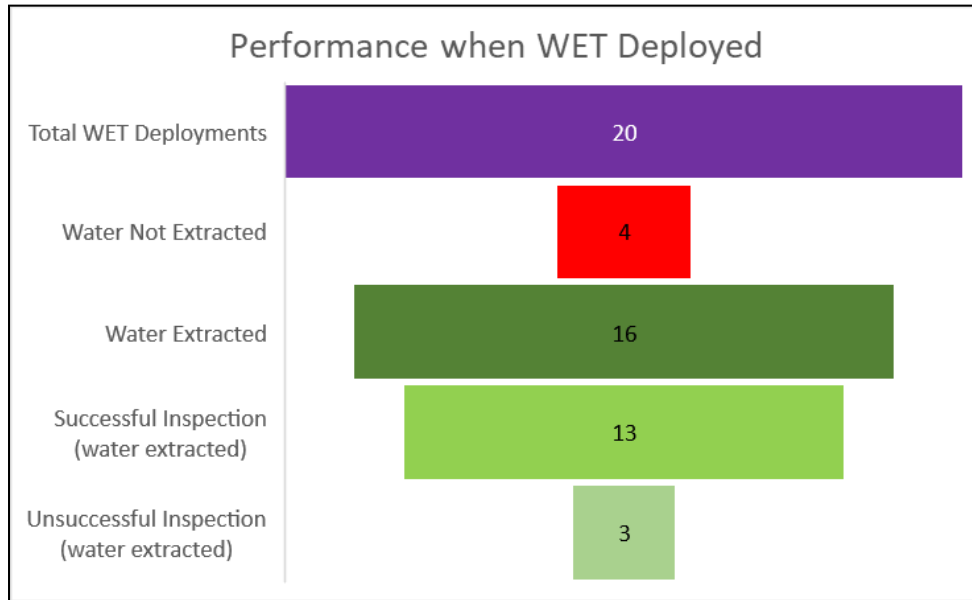
Figure 14—Performance when WET was deployed.

Thirteen WET deployments resulted in successful sewer lateral inspections, none of which contained a cross bore. Figure 14 shows the performance of WET when deployed.

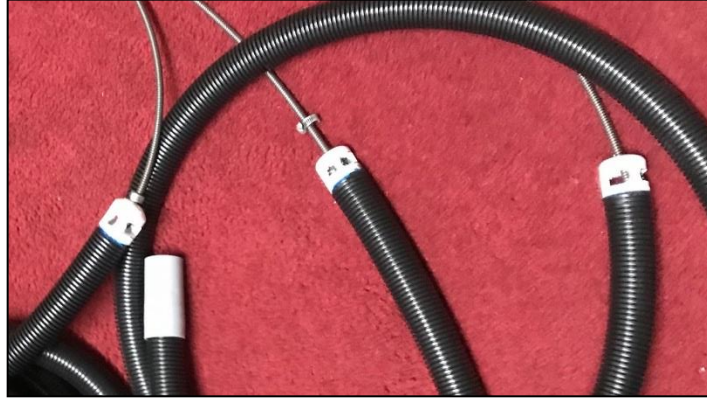
Figure 15—Final 1.25-in.-diameter hose configuration with plumber's snake.

ServPro successfully designed, built, and tested a water extraction tool (WET) that consistently navigated sewer laterals in the field and sufficiently extracted water within the sewer lateral such that inspections of the bottom half of the sewer lateral were successfully completed. A variety of hose types, sizes, and tips were developed and tested. Hose sizes included 1-in., 1.25-in., and 1.5-in. diameter. The 1.25-in.-diameter hose proved the most effective and easy to use. All hoses were 50 ft in length and could be connected if longer distances were required. Hoses were perforated to allow water to be extracted while the hose lay on the inside surface of a sewer lateral. Tips were designed to prevent larger objects such as rocks and gravel from clogging the hose. Lastly, to assist with navigation of the p-trap, a plumber’s snake was incorporated into the design (Figure 15).

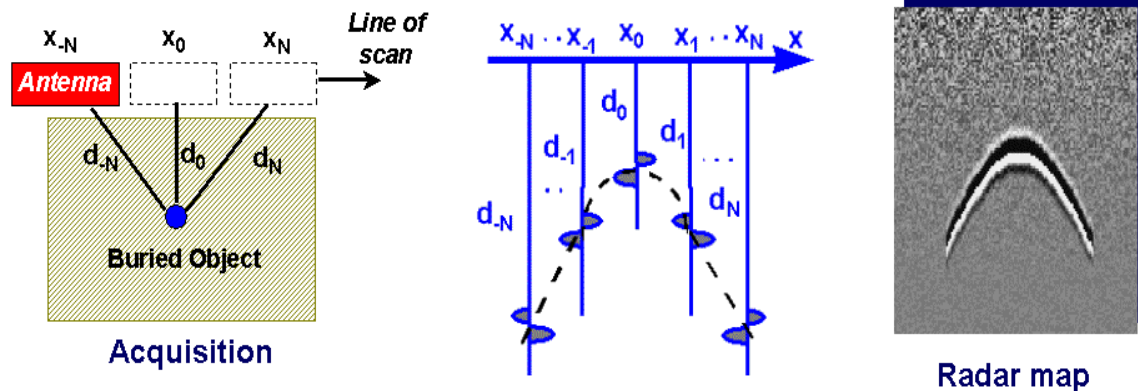
Figure 17—Visualization of how a hyperbola is formed

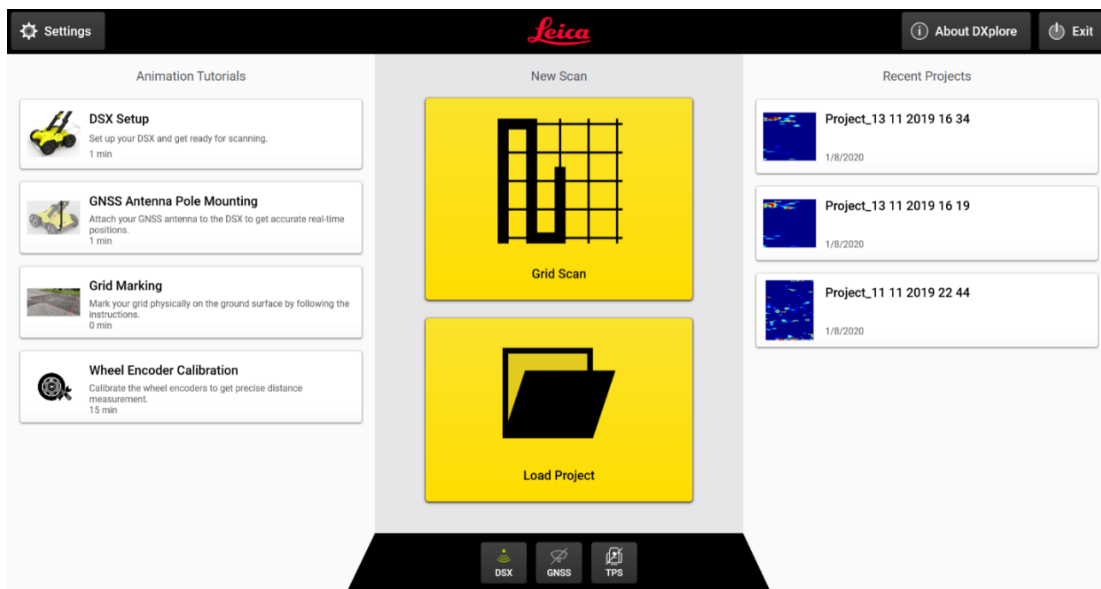
Figure 21—Home screen of the DXplore.

The software’s easy-to-use tutorials cover the main aspects of using and collecting data with the GPR system. The user will have confidence to set the system up, connect a GNSS/GPS antenna to the controller, and correctly mark the acquisition grid for accurate and reliable data collection. Training time has been dramatically reduced with this software.

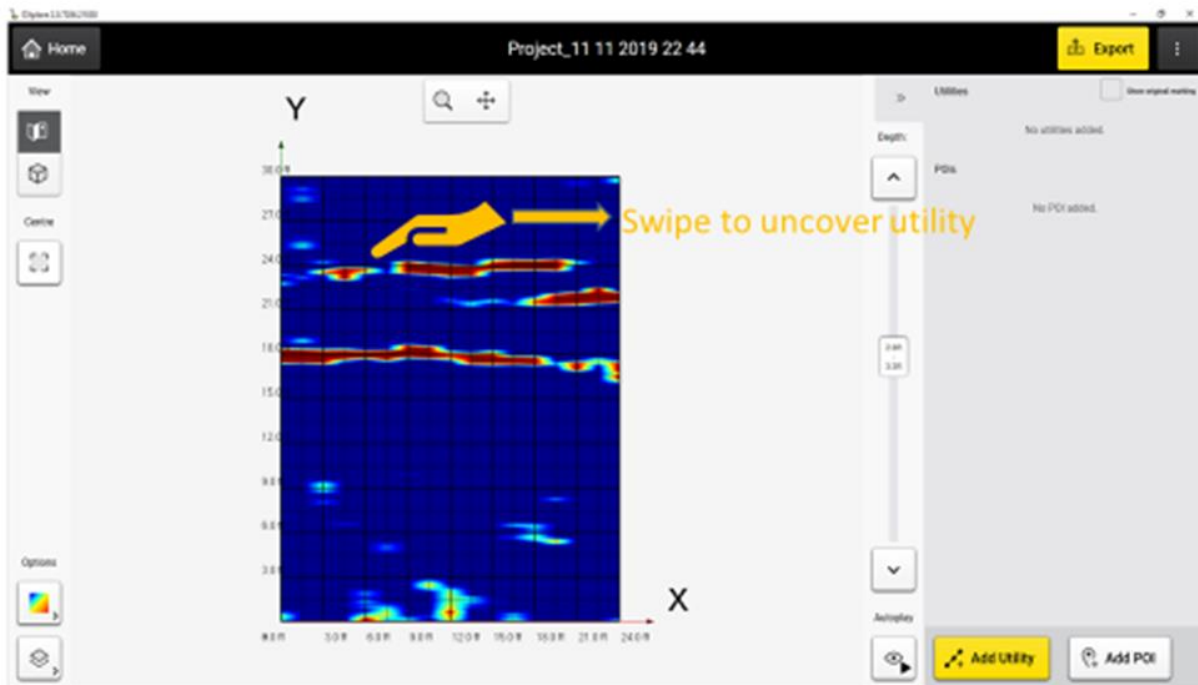
Figure 22—Screen shot of finger swipe to identify utility.

To determine if a utility is present, the operator simply uses their finger to swipe across the screen where they believe the software should show an indication of a utility (Figure 22). At this point, a unique software algorithm determines if the path drawn is a utility. If the software confirms a utility, it draws it on the map. Additionally, the software also confirms the actual path of the utility, not necessarily where the operator drew it. The software alerts the operator if it does not confirm that a utility is identified.

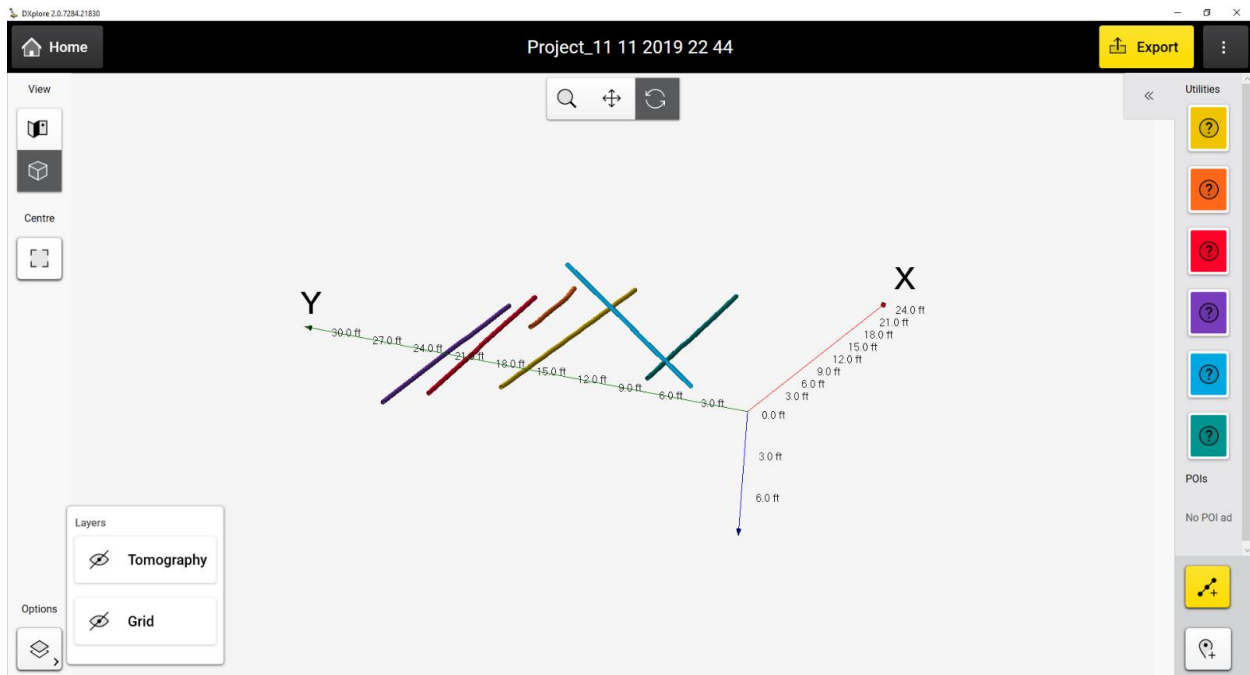
Figure 23—3D view of detected utilities.

Once all utilities have been drawn, the utility line can be viewed in a 3D space. The software displays each utility's GNSS/GPS or TPS position and the calculated depth. This allows the operator to see how the utility tracks and interacts with other utilities in the subsurface.
