FAST THINKING SAVES HIGGINSVILLE'S CITY LAKE

It started as a trickle and could have led to catastrophe, if not for the keen eye of a fisherman who spotted the spillway breach on City Lake just east of Higginsville one early August morning. By then, water was flowing freely through a four-foot gap under the old concrete structure between the upper and lower reservoirs.

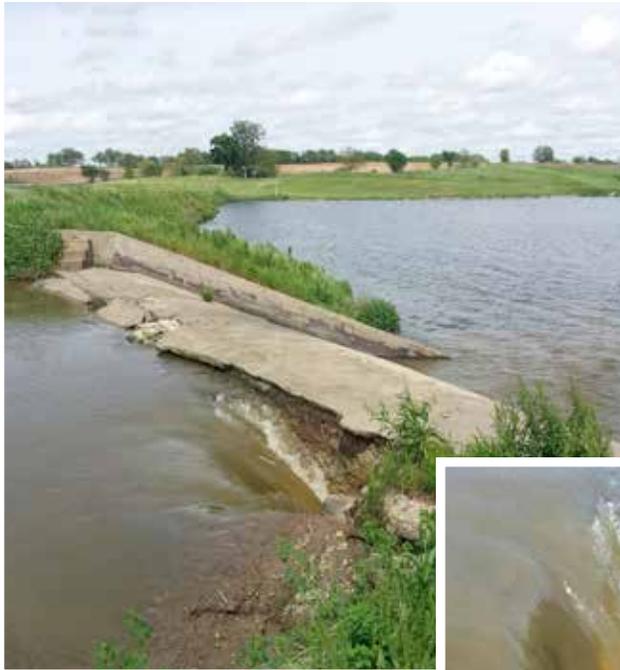
Water was flowing freely through a four-foot gap under the old concrete structure between the upper and lower reservoirs at City Lake just east of Higginsville.

Resources (MDNR). There was no immediate danger of breach, stated MDNR experts, yet they recommended filling the hole with riprap as a temporary measure to slow the water down. With that accomplished, they turned to the consulting engineers for recommendations for a more permanent repair.

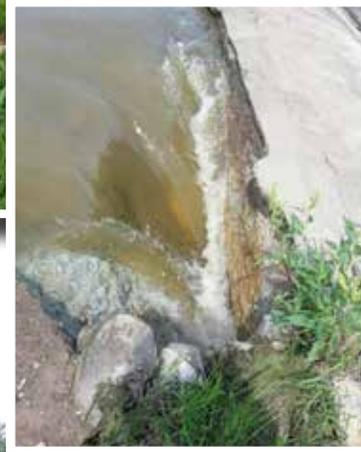
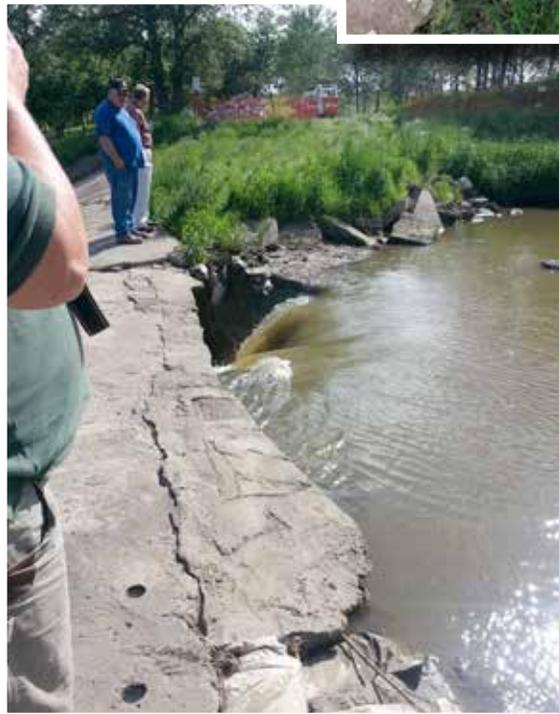
At approximately 100 feet wide, the old spillway is composed of a reinforced concrete slab with a cutoff wall at the top and bottom. Water had eroded away concrete on the upper cutoff wall; previously, the City had completed some patchwork repairs to address minor leakage. Now, however,

water was moving underneath the slab and the lower toe wall before entering the larger basin.

To facilitate repairs, the City used several siphon drains stretched over the top of the dam to reduce water levels by two to three feet in the upper lake. Then the contractor was able to place equipment on the spillway's front side in order to build a new lower toe wall. SKW specified a special, early high-strength concrete used for bridge decks, as well as locally-sourced clay material to fill the voids and recompact underneath. In all, repairs were completed and tested in a matter of weeks, right before the 2013 rainy season began.

Repairs were completed and tested in a matter of weeks, right before the 2013 rainy season began.
All article photos courtesy of the city of Higginsville.
