CITY OF PHOENIX COLLECTION SYSTEM REHABILITATION PROGRAM

By Ron Ablin, Brown & Caldwell and Paul Kinshella, City of Phoenix

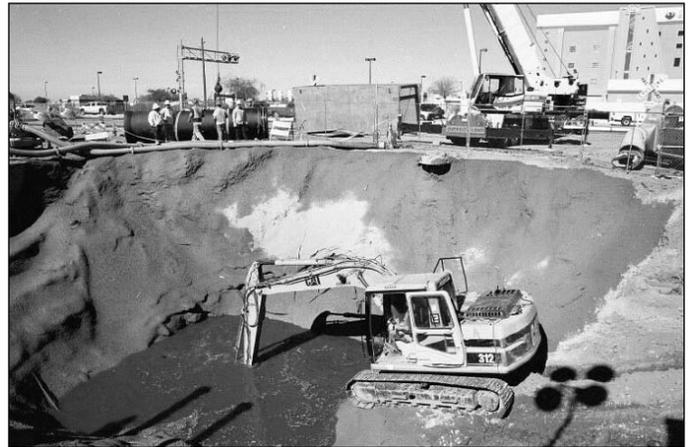
54-inch Diameter Sewer Collapse

In January 2001 a section of 54-inch-diameter concrete pipeline unexpectedly collapsed. The City of Phoenix immediately assembled an emergency response team of experts to investigate, stabilize, and temporarily repair the collapsed

area. Subsequent investigation of the 25-foot deep sewer revealed that the pipeline had severely corroded and a 15-foot-long hole had developed at the springline of the pipe.

When the pipeline collapsed, large quantities of pipe, earth, rock, and asphalt fell into the pipeline. This restriction caused the pipeline to surcharge and erosion of the surrounding soil began to occur at a rapid rate. The increasing size of the "sink-hole" threatened the integrity of adjacent roads, railroad tracks, utilities, and structures. Working during wastewater low-flow periods, between 3:00 am and 11:00 am, the emergency response team stabilized the hole by diverting a portion of the flow to the 23rd Avenue WWTP and applying shotcrete to the exposed slopes.

Alternative methods for repairing the pipeline were evaluated based on the limited availability of temporary pumps to bypass the substantial amount of flow. A temporary pipeline fix was provided by inserting a smaller-diameter fabricated-steel pipe into the existing concrete pipe and sealing the connections with sandbags, shotcrete, and oakum. The emergency repair process was completed in five days without a single spill outside of the immediate area of the break.

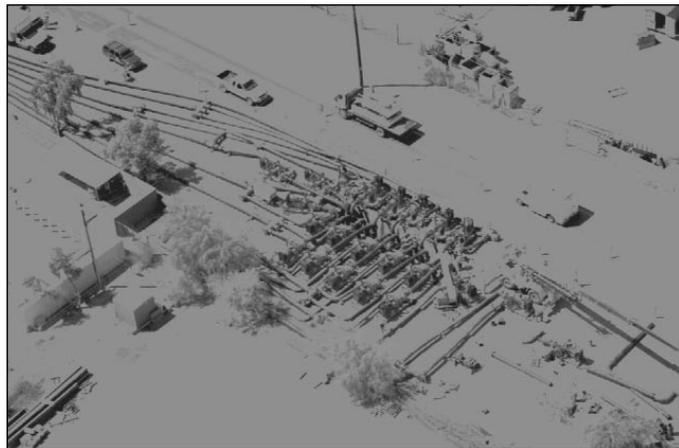
150-mgd Bypass Operation During Pipeline Rehabilitation
